All-Purpose Remote Transport System (ARTS)

Capabilities Demonstration

24-26 September 2001

United States Army
Communications-Electronic Command
Research, Development & Engineering Center
Fort Belvoir, Virginia 22060-5806

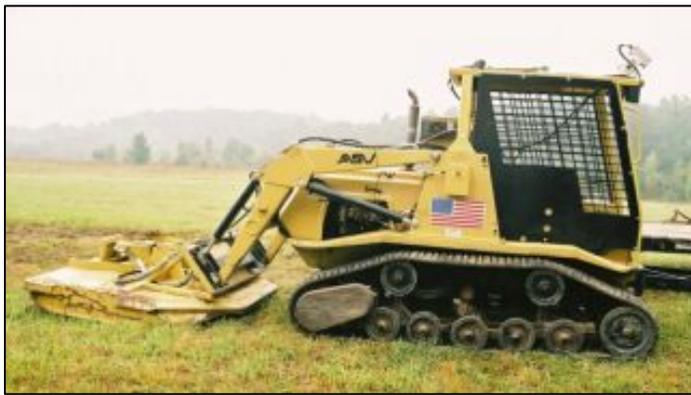
Picture 1 – ARTS with brush cutter

The ARTS consists of a prime mover (a Posi-Track™ MD70 tractor, picture 1), the Operator Control Unit (OCU, picture 2), and various tools. Tool attachments include a brush cutter (picture 1), a bucket (picture 4), pallet forks (picture 4), and a backhoe (picture 5). There are more tools available for this system such as a plow, a range clearance blade, and a water cannon, which were not demonstrated. Two cameras on top of the tractor (one camera faces forward (picture 6) and the other rearward (picture 7)) provide operational visibility when operating the vehicle remotely.

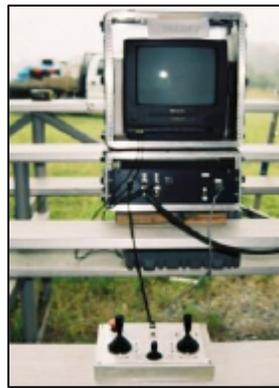
Picture 2 – OCU

The OCU is developed by ARA and provides remote operations of all tractor functions, including engine start/stop, propulsion, lights, and all tool operations. The OCU is comprised of a radio for transmitting command signals to the tractor, a receiver for audio/video signals transmitted from the tractor, a joystick control box, a television monitor with built-in videocassette recorder, an antenna (picture 3, which can be mounted on a portable tripod), and an external generator (minimum of 1kW, not included with the system). The OCU (without the antenna) is packaged in a heavy-duty, weather-tight, shock-isolated case for rugged durability. Additionally, the OCU case contains operator manuals and calibration cables.

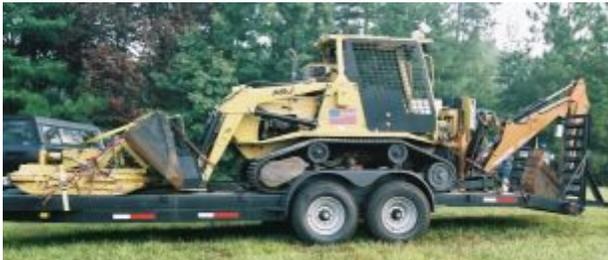
Picture 12- ARTS with tools on trailer

The system was transported on a 24ft trailer that was towed by a commercial Ford F-450 heavy-duty truck to the NVESD/CM test site. The ARTS with all of its tools loaded on the trailer is shown below in picture 12. For better utilization of trailer space and limiting the number of support vehicles required, the tools were stacked upon one another, see picture 13 below. The system does not have any transportation restrictions and does not require highway permits to be transported over land.

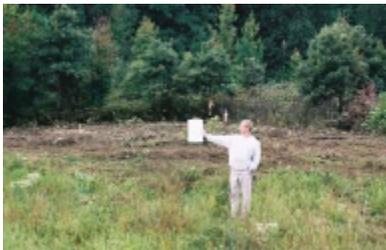
Picture 29 – Cut category 3 vegetation

The demonstration site consisted of dense sumac brush (up to 2m in height) and various trees on a slightly sloping terrain, see pictures 26 and 27. The variety of trees consisted of gum, maple, and oak and the majority of the trees were 10cm in diameter or less. The site contained one maple tree that was 23cm in diameter, which is considered to be a category 4 vegetation. The site was damp from the previous night's heavy rain, which made a lot of the mulch cling to the cutter rather than being blown away from the cutter. The ARTS cut an area of 36m x 28m in 60 minutes, achieving a cutting rate of 16.8m²/minute. Pictures 28 and 29 show the site after the ARTS cleared the vegetation. The ARTS left the majority of the site with a layer of mulch ranging from 2.5 to 7.5cm thick and a few spots with mulch piles ranging from 15cm to 23cm thick. Also, the ARTS left vegetation stumps intermixed with the mulch. The 2.5cm diameter stumps were left as tall as 30cm in height and the 5cm diameter stumps were left as tall as 1m in height. The 23cm maple tree was cut down to 1m, see picture 30. The brush cutter, at times was underpowered because the cutter was overpowered by the amount of foliage and brush that were in the cutter. About 30 minutes into the operation, the foliage that came in contact with the ARTS depressed the emergency stop button. The stop button had to be manually pulled out in order for the ARTS to continue with operations, see picture 31. If this was an actual minefield, this situation could be a dangerous situation for the operator. The contractor recommended that mounting a cage around the stop button would prevent future accidental stops of the ARTS. The ARTS demonstrated clearing category 3 vegetation.

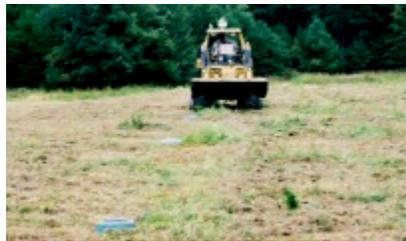
Picture 36 – Surface laid AT mine lane

Three AT mines with smoke fuzes were surface laid in a 25m by 3m lane, see picture 36. The operator manually drove the ARTS over the mines, see picture 37. The track activated all three smoke fuzes. The result demonstrated that the track applied sufficient force to activate the surface laid AT mines.

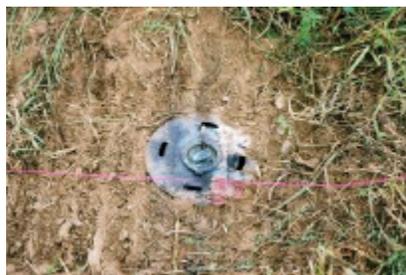
Picture 38 – Activated AT mine

Three AT mines with smoke fuzes were buried flush to the ground. The operator manually drove the ARTS system over the flush laid mines with the rubber track. Only one mine was activated when the ARTS teetered back on the mine while the track encountered a mound on the ground, picture 38 shows the functioned AT mine. Picture 39 shows a non-activated AT mine that was run over with the track.

On a level surface, the track would normally exert only 2psi. However, if there are ruts or bumps in the ground and the tractor is resting on them, then the highest point on the ground would be carrying most of the tractor's weight, therefore exerting greater than the rated 2psi of pressure at that point. The possibility for the ARTS to activate mines is less when the mines are buried in the ground as compared to when the mines are above the ground.

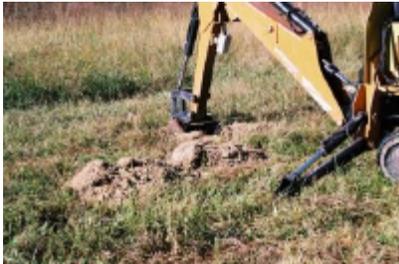
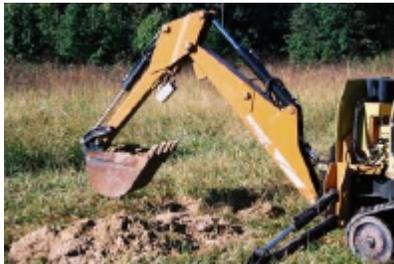
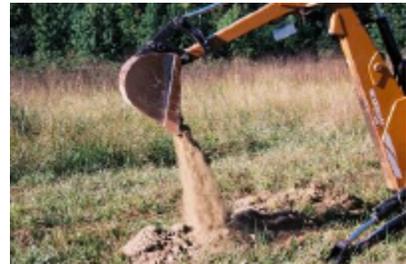
ARA personnel demonstrated the backhoe operation by excavating some dirt. Pictures 40-42 show the backhoe in operation. The excavator can dig as deep as 2.5m deep. The excavation was operated remotely through the OCU. ARA personnel gave each Humanitarian Demining team member an opportunity and instructions on how to operate the backhoe. Every member was successful in learning how to operate the backhoe within 5-15 minutes. However, to become a proficient operator would require additional 8-20 hours of hands-on time, dependent on the trainee's ability.
