Aardvark Mark IV Joint Services Flail Unit (MKIV)

Capabilities Demonstration

1-10 October 2001

Night Vision & Electronic Sensors Directorate (NVESD)
DoD Humanitarian Demining Research & Development Program

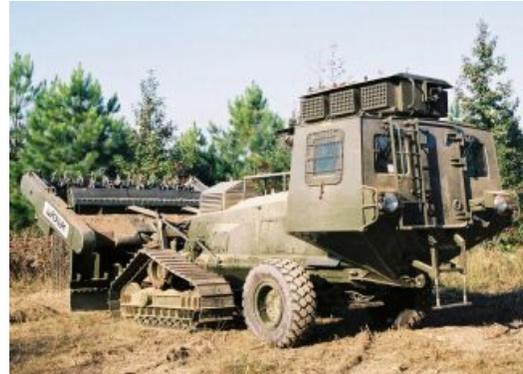
Picture 1 – Mark IV Joint Service Flail Unit

The MKIV system consists of an armored New Holland tractor and a specialized flail assembly. The tractor has a 160hp 6-cylinder in-line turbo charged diesel engine and a 3-speed power take off (PTO). The flail assembly is mechanically driven via a heavy-duty gearbox. The flail can clear a path 3m wide and consists of 72 chains with striker tips.

The Aardvark Clear Mine, Limited (a private British company) of Scotland has been designing and producing a variety of mechanical minefield clearance machines for seventeen (17) years. The Mark IV Joint Services Flail Unit (MKIV, see picture 1 on the next page) has been in production since 1999, and it is the product of years of improvement to the Aardvark Flail System basic design. Improvements affect engine performance, flail depth, flail control, steering control, operator safety, operator comfort, navigation and maintenance. The steering control (dual steering) can be switched from the operator (in the left seat) to the operator (in the right seat) and vice versa. Because the MKIV creates dust and works in many hostile environments,

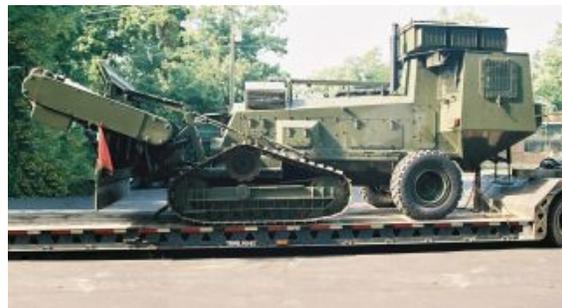
Picture 6 – MKIV on trailer

The system was transported by a sea vessel, then by a commercial truck and finally by a government truck to the NVESD/CM test site. Picture 6, below, shows the MKIV on a trailer. The system is transportable by truck, rail, vessel and C-130 aircraft (or other larger aircraft). Due to the width of the flail unit, over road transport restrictions are imposed, and some restrictions may be imposed for rail as well. For transport via a C-130 aircraft, the system must be broken down somewhat (the flail removed from the tractor and the cab roof filter removed, etc.). These procedures are documented in the system technical manual. The system has NATO standard tie down and lift points. The system can maneuver via track or tire configuration and can be changed from one configuration to another within a couple of hours. The tire configuration is better suited for long distance travel as compared to the track configuration for short distances. During mobility and maneuverability tests, the system performed very well. The MKIV system demonstrated the capability to be transportable by truck, sea vessel and aircrafts.

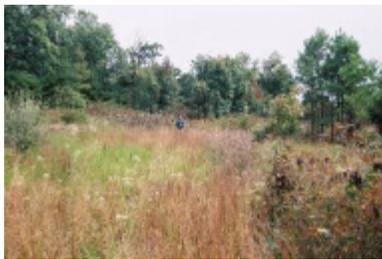
Picture 10 – Cat. 2 prior to flailing

This site consisted of moderate vegetation with brush and saplings (up to 6cm in diameter and ~2.5m in height) on light rolling hard ground. See picture 10, below. The Aardvark MKIV operated at two different speeds while cutting category 2 vegetation. For the first two passes, the MKIV traversed the site at a 1200m per hour and the last pass was traversed at a 191m per hour. At 1200m/hr, the ground penetration depth was ~14cm and at 191m/hr, the ground penetration depth was ~20cm. Picture 11 shows the MKIV cutting category 2 vegetation. The ground was completely mulched and powdery with occasional stubbles ranging from 5cm to 7.5cm in height. Picture 12 below shows the site after the MKIV cut the vegetation. The MKIV cut 479.7m² in 26 minutes with a cutting rate of 18.45m² per minute. The MKIV lost two chains and one flail head while cutting category 2 vegetation. The MKIV demonstrated the capability of clearing category 2 vegetation.

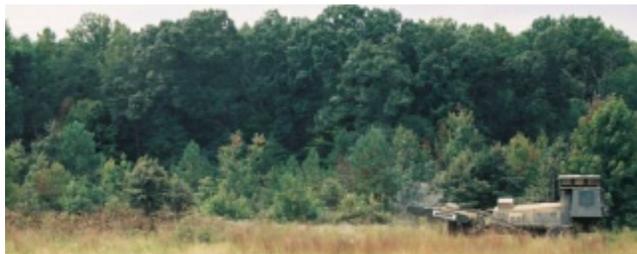
Picture 13 – Cat. 3, prior to cut

Category 3 consisted of moderate vegetation and brush with saplings and trees up to 10cm on a slightly sloped terrain with lots of ruts. See picture 13. Category 3 was cut at A4 crawler gear, at which the MKIV traveled at 191m/hr.

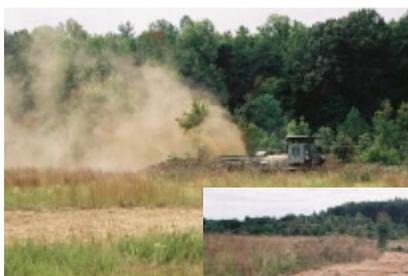
Picture 14 – MKIV cutting Category 3 vegetation

See picture 14. In a 30-minute time frame, the MKIV cut an area of 80m x 6m, with a cutting rate of 16m² per minute. The ground was turned into powdery mulch, see picture 15. Ground penetration was between 20cm to 30cm. The MKIV left occasional tree trunks and scattered pieces of trees in the lane. The tree trunks were ~7.5cm in height. During this vegetation clearance operation, the MKIV lost one chain, seven chain links and two cutting heads. The MKIV demonstrated the capability of clearing category 3 vegetation.

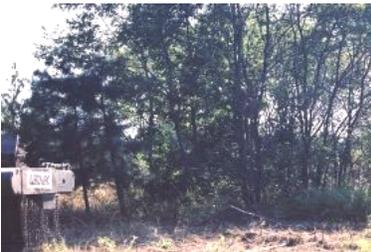
Picture 16 – Category 4

Although this site was considered to be category 4, the terrain was fairly level and the majority of the vegetation was considered category 3 and below, which is 10cm in diameter or less. See picture 16. This site contained some trees that were larger than 10cm diameter and the largest tree was 23cm in diameter. The operator used A2 crawler gear to cut this vegetation. The system traversed the site at 92m per hour. The flailing depth of the MKIV for this operation ranged from 20cm to 30cm with the average at 27cm. During a 30-minute time frame, the MKIV cut an area of 22m x 8m, with a cutting rate of 5.87m per minute. See pictures 17, 18 and 19. The ground was turned into a bumpy powdery field, see picture 20. The MKIV shredded and left most stumps in the ground, but one stump (1.3m long) was dug out of the ground. Even though the system was designed to tackle 15cm diameter trees or less, the MKIV demonstrated the capability to clear a 23cm diameter tree. During this operation, the MKIV lost two chains, seven links, two flail heads, and one weight. The MKIV demonstrated the capability of cutting category 4 vegetation.
