Operational Evaluation Test Report on Beaver Micro-Vegetation Cutter

Prepared by

**Operational Evaluation Test Report
on
Micro-Vegetation Cutter**

March 2005

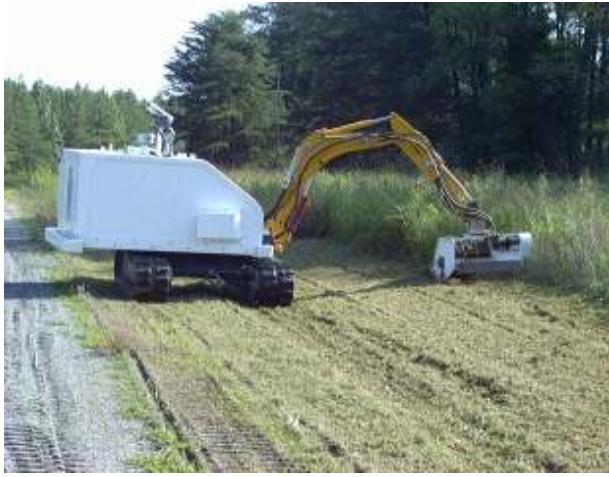
Figure 1: MVC Beaver

Lessons learned from past efforts, deployments, and operations were incorporated into the design and fabrication of the MVC. This resulted in a remote controlled system with improved performance levels that is smaller than currently fielded systems, easily transported, and economical to operate and maintain. The Beaver (the working vehicle) is a small, diesel-powered, tracked vehicle with provisions for attaching and operating a vegetation cutter, an electromagnet, or an excavating bucket. Power is provided by a Deutz BF3L1011FL three-cylinder diesel engine producing 40 kW of power (53.6 hp). The Beaver's track chassis is

A video camera is mounted on the top of the Beaver and its signal is transmitted to the operator in the Duck. Camera movement and zoom, controllable by the operator, assist in the remote driving of the vehicle and afford the operator a close look at the orientation and functioning of the attached tool.

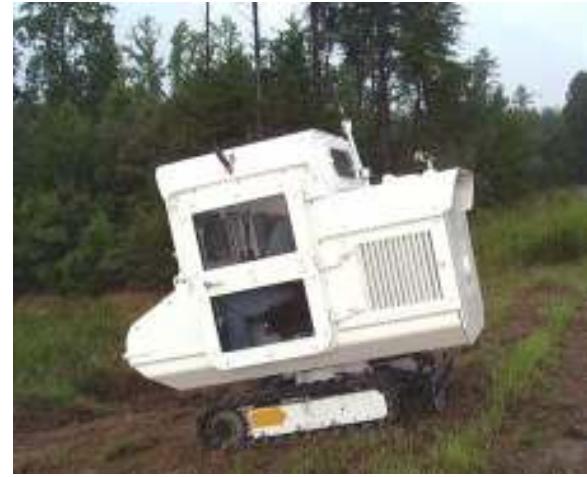
Figure 2: MVC Duck

The control vehicle, the Duck, is also a tracked vehicle. It contains the SRCS used by the operator to maneuver the Beaver and to control the operation of the attached tool. The vehicle is air conditioned for the benefit of the operator. The Duck and Beaver are independently controlled allowing the operator to move both vehicles at the same time. The engine is a three-cylinder Briggs and Stratton diesel, generating 19.4 kW (26 hp). Table 2 gives the measurements of the Duck.

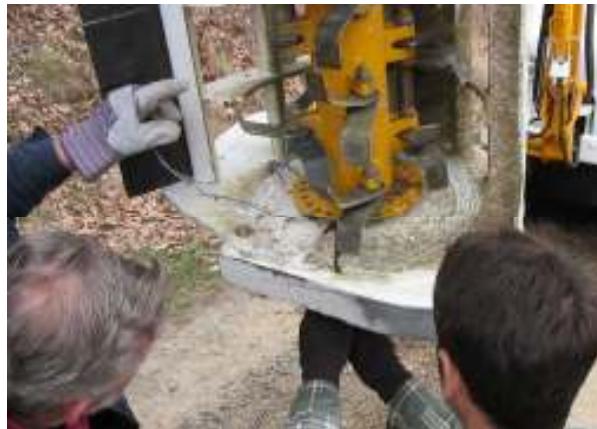
Figure 3: Pre-Test Cutters

- Vegetation Cutter: The vegetation cutter was designed and fabricated in the Humanitarian Demining Program's fabrication shop at Ft. Belvoir. A second hydraulic pump is mounted in the Beaver to power the cutter. As a result of the high failure rate of the commercially procured cutting blades used during the pre-evaluation test, new cutters were designed and manufactured in the fabrication shop and used throughout the operational evaluation test. Figures 3 and 4 show the damage sustained by the two-piece cutters used during the pre-evaluation test (wt. = 434 grams); Figure 5 shows the pre-test cutters (left) and the T-1 steel machined cutter (right) used during the

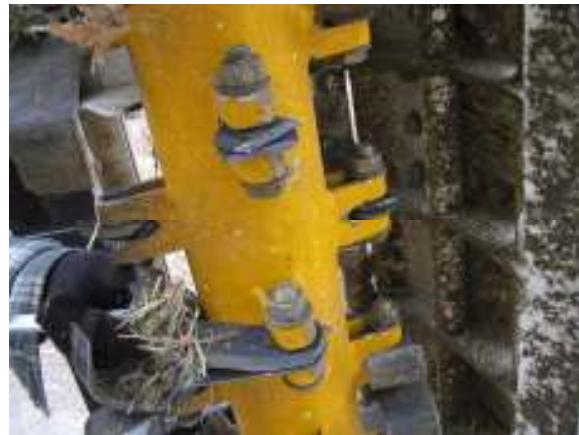
Figure 4: Broken Pre-Test Cutters

- The cutters were notched when they hit the inside bottom edge of the U-shaped cutter mounts. The notch propagated cracks and broke the cutters. The solution was to grind off the sharp shoulder on the U-shaped mount.
- Seven cutters were broken. The time to replace all seven of the cutters was 15 minutes.
- There was a delay between the operator command and the response of the MVC or the cutter. This led to over-control input from the operator. The solution was to adjust the SRCS to shorten the signal-response time.
- The operator had to keep the cutter in the line of sight to know the relation of the cutter to the ground.

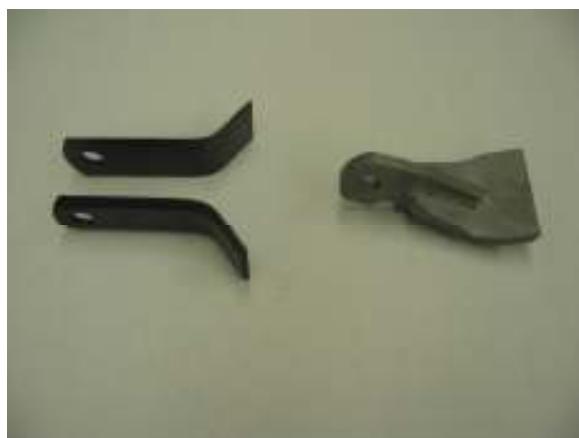
Figure 5: Pre-Test & Operational Evaluation Cutters

operational evaluation test (wt. = 634 grams); and Figure 6 shows the machined cutter (left) and the 4130 heat-treated cast alloy cutter (right) that will be used on future fabricated vegetation cutters (wt. = 756 grams). The weights and materials are shown for each of the cutters as an indicator of each cutter's strength and durability.

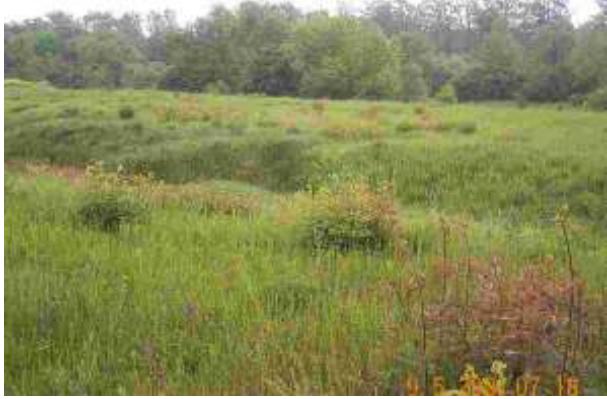
Figure 7: Category 1, Easy

Category 1 (Easy)	Category 2 (Moderate)	Category 3 (Difficult)	Category 4 (Very Difficult)
Light vegetation with minimal saplings up to 3 cm diameter	Moderate vegetation with sparse brush and saplings up to 6 cm diameter	Moderate vegetation with brush, saplings and trees up to 10 cm diameter	Heavy vegetation with dense brush, saplings and trees greater than 10 cm diameter
Fairly level terrain with minimal ruts	Level to light rolling terrain with some ruts	Rolling terrain with lots of ruts	Steep hills with lots of ruts, very rugged terrain
Minimal debris and obstacles	Some debris and obstacles	Moderate debris and obstacles	Heavy debris and obstacles

The operational evaluation test was conducted at a U.S. Army Countermine development test facility located on a military reservation in central Virginia. The development test facility is fully equipped with a heavy equipment maintenance shop, vehicular and light electronic service bays, and office space for the field engineers. Full-time staff consists of mechanics, technicians, explosive ordnance disposal (EOD) and range safety personnel. The terrain is characterized as densely forested rolling hills and plains interspersed with open meadows of heavy, thick field grass and shrubs. Soil is clay and loam. Areas containing the four categories of vegetation described in Table 4 were identified and used to conduct the tests in this report. Pictures representative of each category of vegetation are presented in Figure 7 through Figure 10.

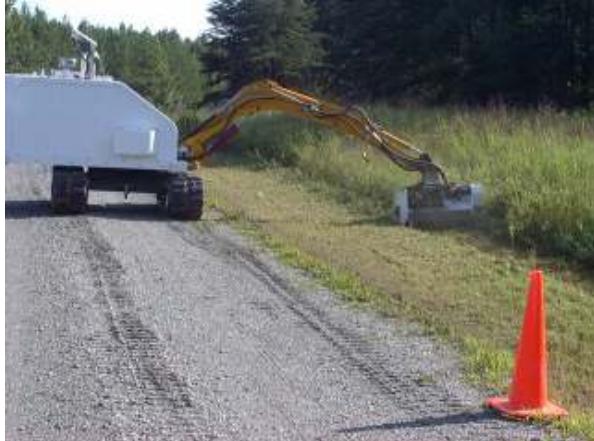
Figure 11: Category 1 Cutting

Two Category 1 vegetation cutting operation assessments were undertaken. The first cutting operation was made to give the system operator an opportunity to gain experience in controlling the Beaver and the attached cutter, to determine the best location from which to observe and control the operation, and to obtain a performance time-measurement data point. The first vegetation-cutting site was on the side of a hill, which allowed for the assessment of system operation on a slope. The area cut measured 25 meters long by 6.3 meters wide. The slope of the cut area was 24.5 degrees on the left side of the cut area, gradually easing to 16.5 degrees at the right end side of the cut area. Cutting was performed across the slope, from left to right, with the Beaver backing up (returning) to the starting point before making each subsequent cut. The control vehicle, the Duck, was located on the road above the hillside so that the operator could observe the position of the cutter head.

The area of the first vegetation cut was 157.5 m^2 and took 41 minutes 47 seconds. This equated to 226 m^2 per hour.

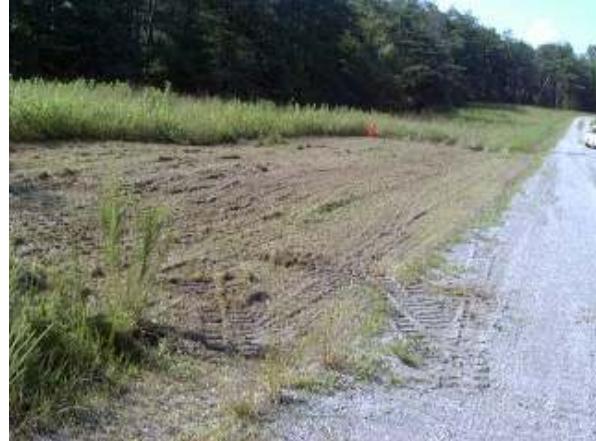
Figure 12: Completed Cutting

The second Category 1 vegetation cut was conducted in a level field bordered by a gravel road. For this cut, the procedure was to cut for 1 hour and then calculate the area that was cut. The cutting front, running parallel to the road, was 25.2 meters long. Cutting started with the Beaver on the road with the boom at 90 degrees to the road. The initial cutting pass was adjacent and parallel to the road, from right to left. At the end of the pass, the Beaver backed up to the starting point on the right hand side and made the second pass. The maximum boom extension allowed for three passes before the Beaver had to be moved into the area just cut. See Figure 11. (In an operational situation, the area cut would be searched for mines before the Beaver would be allowed to continue cutting from the previously cut area.) At the end of the hour, a measurement was taken of the area cut. The length of the area was 25.2 meters. The depth was 7.7 meters on the right side, 8.4 meters on the left side, for an average depth of 8.05 meters. See Figure 12.

The area of the second Category 1 vegetation cut was 202.9 m^2 in 1 hour.

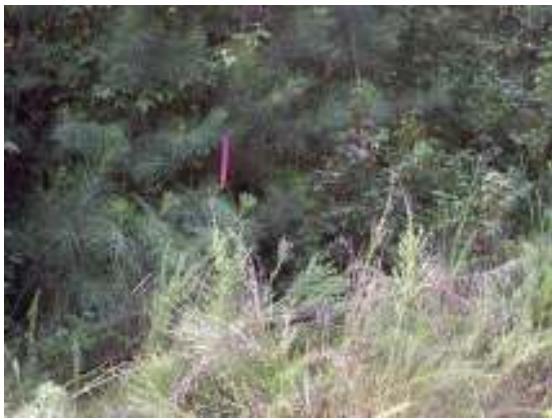
Figure 13: Category 2-3 Vegetation

A timed cut of Category 2 vegetation was made in a 16-meter-long area adjacent to a graded fire road. The first 1.5 to 2 meters in from the road were judged to be Category 1 vegetation (heavy field grass with no brush or saplings). The next 2.5 meters consisted of Category 2 saplings and trees measuring 3 to 10 meters tall, most being up to 6 cm in diameter. The final two trees cut, classified as Category 3, each measured 7.5 cm in diameter.

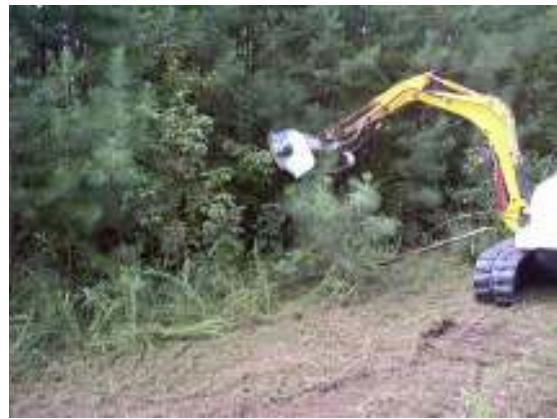
Figure 14: Cutting Procedure

The timed Category 2 cutting test procedure was as follows. The first two passes through the Category 1 vegetation were from right to left, parallel to the road, with the Beaver backing up between passes. A slight drainage ditch along the side of the road required the operator to continually adjust the attitude of the cutter to follow the changing pitch of the ground. Before starting to cut the Category 2 vegetation, the cutter head was rotated 90 degrees so that cutting was accomplished by pushing the cutter on a path that was out away from the vehicle, much in the same way that a push lawnmower might be used to cut grass on a short side slope. After each cut, the operator had to move the Beaver the distance of one cutter width to start the next cut, a process which is much slower than that followed for the Category 1 vegetation cut. When cutting the trees, the technique was to extend the boom and stick, raise the cutter high, and top the trees at some point above the ground. The cutter was then used to chew the standing stumps down to ground level.

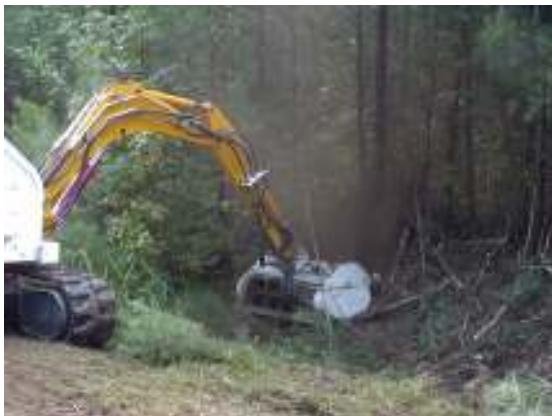
Figure 15: Grinding Stump

Two larger Category 3 size trees, each measuring 7.5 cm in diameter, were removed in the following manner. The cutter was used to put a cut into the front side (side facing road) of the tree trunks at a height of about 3 meters. The cutter was placed behind the trees, above the cut, and used to pull the trees back toward the road, snapping the trees off at the point of the front cut. The cutter was then used to chew the standing stumps down to ground level and to mulch the tops.

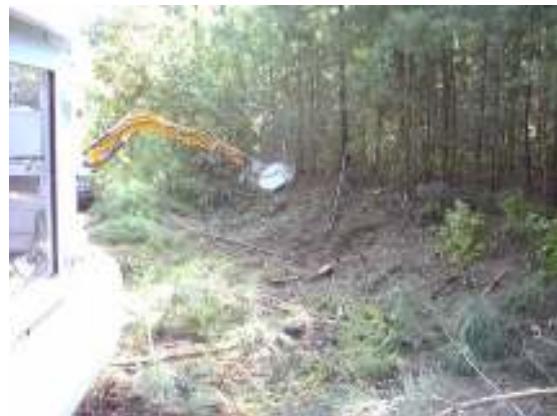
Figure 16: Completed Cutting

The area cut measured 16 meters by 4.5 meters, an area of 72 m^2 cleared in 1 hour.

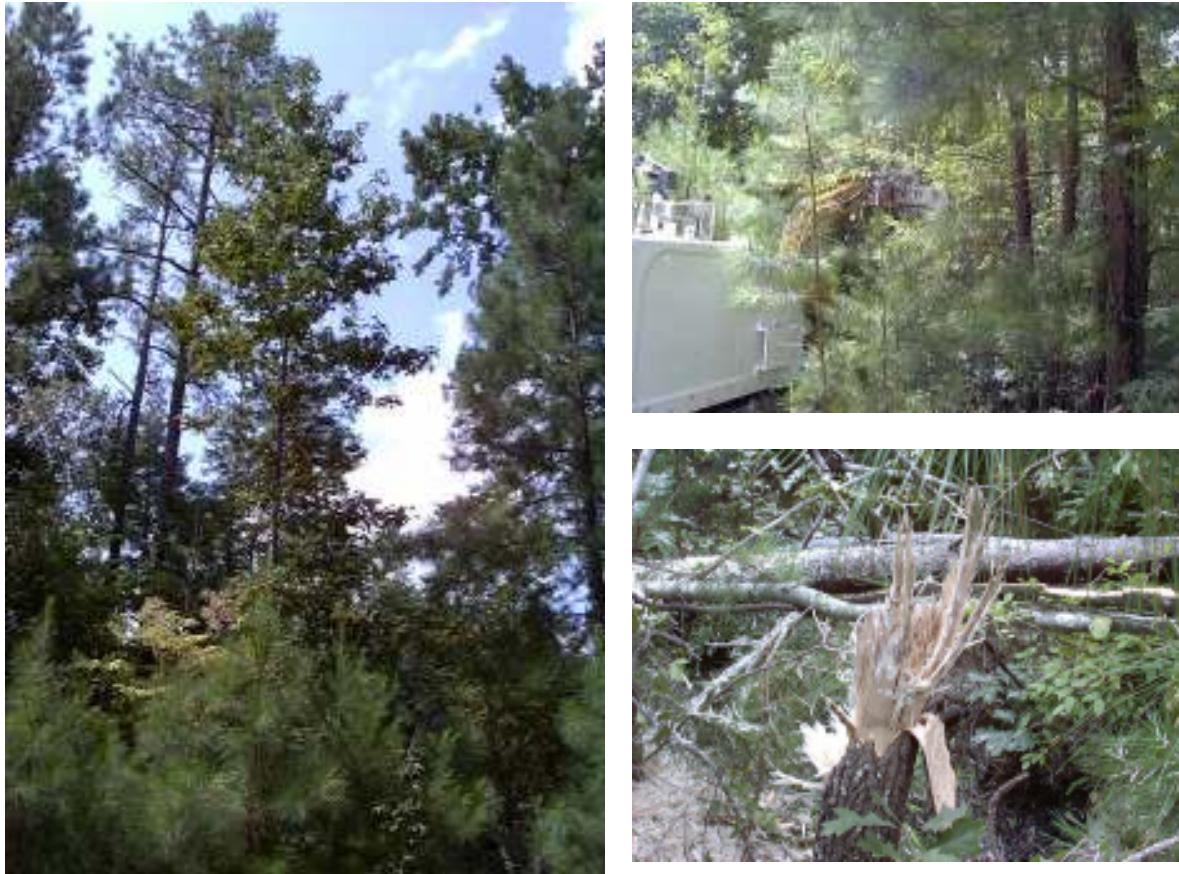
Figure 17: Tree to be Cut (left), Cutting (top right), Stump (bottom right)

A Category 4 deciduous, maple variety tree, 12 to 14 meters high and 15.4 cm in diameter, was selected for the Category 4 cutter operational evaluation test. The procedure followed with this tree was slightly different than followed with the two smaller trees in the Category 2 and 3 test. The tree was topped by cutting through the tree with the cutter at a height of 3–4 meters. The top fell behind the tree and the portion of the trunk left standing was then chewed down to ground level. Total time for this operation was 10 minutes. See Figure 17.

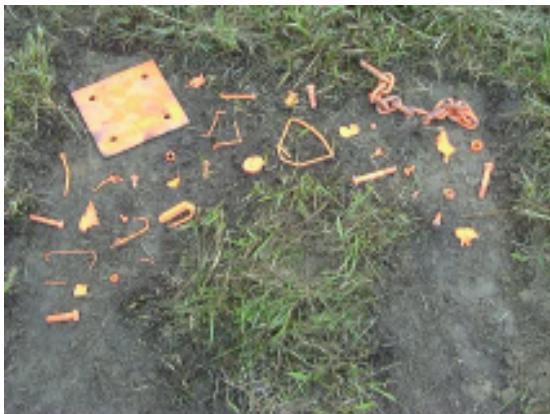
Figure 18: Ferrous Scrap

A Category 1 area, 25 meters by 9 meters, was mowed with the cutter. Thirty-nine pieces of ferrous scrap of various sizes, painted bright orange, were placed randomly throughout the mowed area under the debris from the cutting (see Figure 18). The electromagnet was passed over the area, sweeping the total area in a series of 13 passes. On each pass, the operator kept the magnet as close to the ground as possible without dragging the magnet over the cut vegetation. The magnet was turned off to collect retrieved scrap after every two passes (down and back). A total of 36 pieces of scrap were recovered. A visual search of the area found one more piece. The remaining two pieces were never recovered. However, a metal link from an ammunition belt, not part of the test scrap, was also recovered by the electromagnet. The operator could not guarantee that 100% of the area had been covered since the magnet left no visual tracks of previous passes.

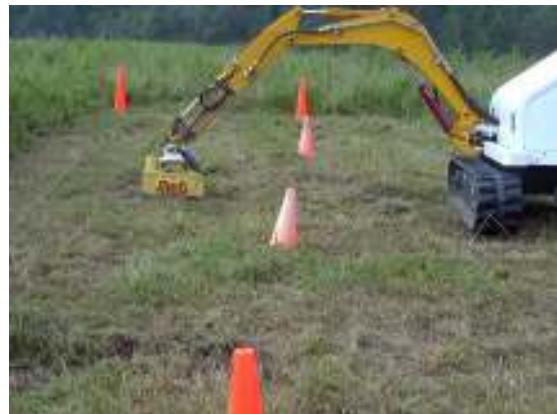
Figure 19: Magnet Sweep

To test the effectiveness of the magnet, seven various pieces of the scrap were selected and placed on a flat area of ground. The magnet was raised above the scrap, turned on, and slowly lowered until the first piece of scrap was picked up. The distance was measured. The lowering of the magnet was continued until all pieces were picked up, with measurements being made as each piece was pulled to the magnet. The test was run twice. The results are presented in Table 6. The difference in pickup height for the same object in the two trials is attributed to the attitude of the electromagnet presenting a changed magnetic field. Figure 19.

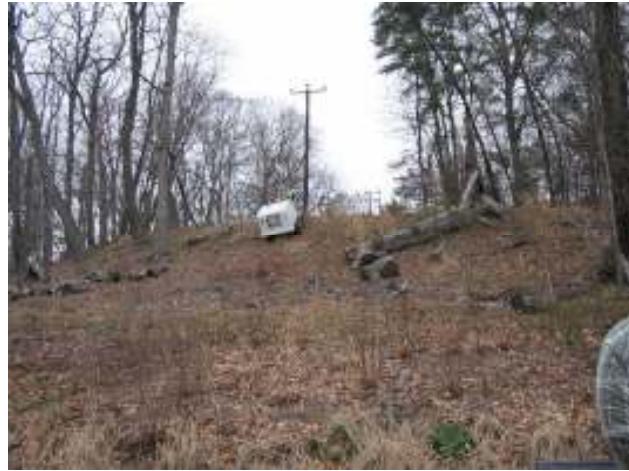
Figure 20: Off-Road Mobility

The off-road mobility test for the Beaver was conducted in three different areas in order to provide a satisfactory range of terrain environments. See Figure 20. One was a watershed track through a hilly, wooded expanse of the military reservation housing the test site. The most critical parts of the test were the ingress and egress. Once into the track, which was rough and gullied from rainwater runoff, neither the Beaver nor the Duck vehicles encountered any operating problems. The maximum slope encountered by the Beaver in entering and departing the run-off gully, which consisted of a mix of raw clay and sand, did not exceed 27 degrees. On a vegetation and mulch-covered slope, the Beaver climbed and descended slopes up to 32.5 degrees. During the vegetation cutting on a hillside, the maximum side slope traversed by the Beaver was 24.5 degrees.

The Duck chose a more gradual slope to follow when entering and departing the run-off track and at no time exceeded a slope of 23 degrees. The maximum tested side slope for the Duck was 17 degrees. The 32.5-degree slope was not used to test the Duck. It is believed that if later models of the Duck were to incorporate a longer track like that of the Beaver, the Duck would have no trouble following any off-road terrain negotiable by the Beaver.

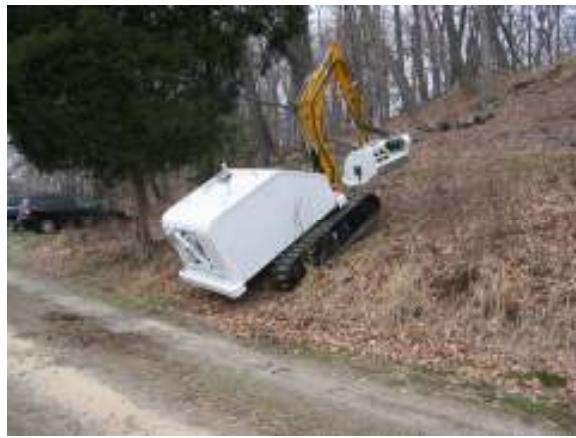
Figure 21: Angle of Approach/Departure

This test was only conducted with the Beaver. The surface cover for the slope climbed was loose soil and gravel intermittently covered with leaf mulch, sparse grass, and low shrubs. The approach and departure angle negotiated, without losing traction, was 32.5 degrees. The Beaver continued to climb the hill, with subsequent grades up to 28 degrees, to a height of about 60 feet without any problems. See Figure 21.

- Hydraulic reservoir filler cap leaked oil in angle of approach and departure test. It is recommended that a redesign be considered.
- The gap at the top of the Duck's front windscreens allows dust to blow in and into the operator's face.

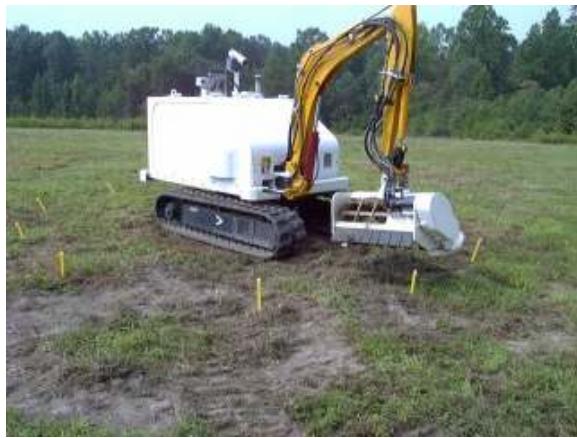
Figure 22: Beaver Turning Radius

Since both vehicles are tracked vehicles, the minimum turning radius will be that achieved by pivoting in a “zero-radius turn,” that is, turning by having one track move forward while the other track moves backwards. By so doing, a tracked vehicle will turn on a point midway between the vehicle’s track system. The minimum turning radius measured for the Beaver was 16.25 feet (4.96 meters) and for the Duck was 8.8 feet (2.69 meters). See Figures 22 and 23.

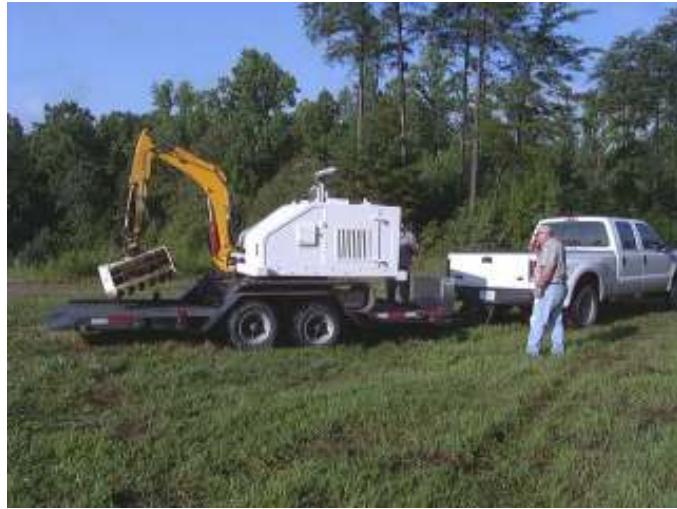
Figure 24: Beaver on Trailer

Local transporting (to and from a staging area) of the Beaver and Duck vehicles, as well as the three attachments (cutter, electromagnet, and bucket shovel), is most easily accomplished with two four-wheel automobile trailers each pulled by a pickup truck. Since the Beaver weighs almost 8,000 pounds (3,629 kg), a heavy truck capable of towing 8,000 pounds will be needed. The Duck, with attachments and tools, weighs about 5,000 pounds (2,268 kg), and may permit the use of a truck with a lower towing capacity. However, if any off-road or unimproved secondary road travel is anticipated, a truck with a towing capacity similar to that used for the Beaver is recommended. Figure 24 is a picture of the Beaver being loaded for movement at the test site.
