Operational Evaluation Test Report on Beaver Micro-Vegetation Cutter

Institute for Defense Analyses
4850 Mark Center Drive
Alexandria, VA 22311-1882

**Operational Evaluation Test Report
on
Micro-Vegetation Cutter**

March 2005

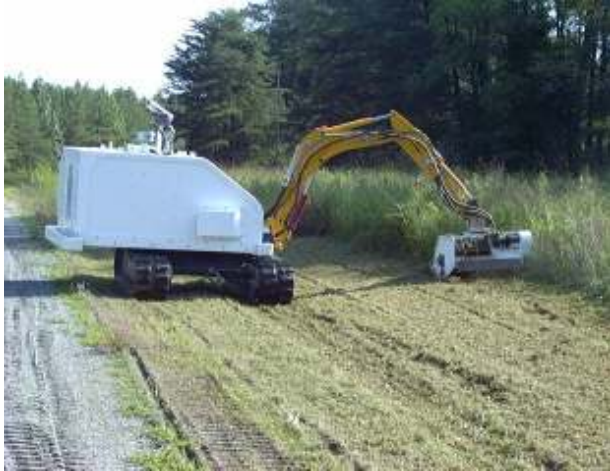
Figure 1: MVC Beaver

Pictures of the Beaver and the Duck are shown in Figures 1 and 2.

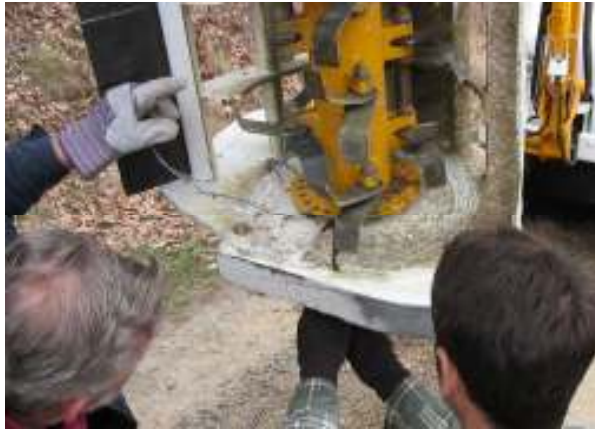
Figure 3: Pre-Test Cutters

- **Vegetation Cutter:** The vegetation cutter was designed and fabricated in the Humanitarian Demining Program’s fabrication shop at Ft. Belvoir. A second hydraulic pump is mounted in the Beaver to power the cutter. As a result of the high failure rate of the commercially procured cutting blades used during the pre-evaluation test, new cutters were designed and manufactured in the fabrication shop and used throughout the operational evaluation test. Figures 3 and 4 show the damage sustained by the two-piece cutters used during the pre-evaluation test (wt. = 434 grams); Figure 5 shows the pre-test cutters (left) and the T-1 steel machined cutter (right) used during the

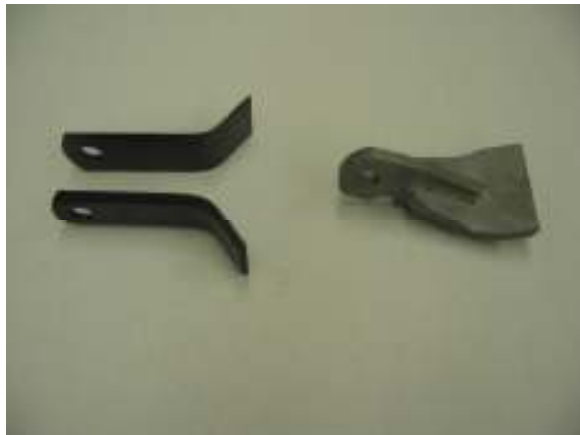
Figure 5: Pre-Test & Operational Evaluation Cutters

operational evaluation test (wt. = 634 grams); and Figure 6 shows the machined cutter (left) and the 4130 heat-treated cast alloy cutter (right) that will be used on future fabricated vegetation cutters (wt. = 756 grams). The weights and materials are shown for each of the cutters as an indicator of each cutter's strength and durability.

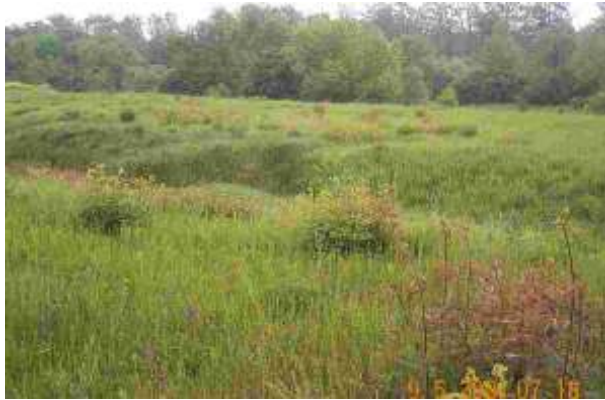
Figure 7: Category 1, Easy

The operational evaluation test was conducted at a U.S. Army Countermine development test facility located on a military reservation in central Virginia. The development test facility is fully equipped with a heavy equipment maintenance shop, vehicular and light electronic service bays, and office space for the field engineers. Full-time staff consists of mechanics, technicians, explosive ordnance disposal (EOD) and range safety personnel. The terrain is characterized as densely forested rolling hills and plains interspersed with open meadows of heavy, thick field grass and shrubs. Soil is clay and loam. Areas containing the four categories of vegetation described in Table 4 were identified and used to conduct the tests in this report. Pictures representative of each category of vegetation are presented in Figure 7 through Figure 10.

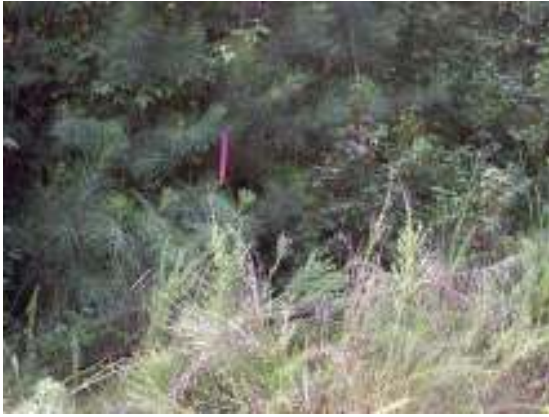
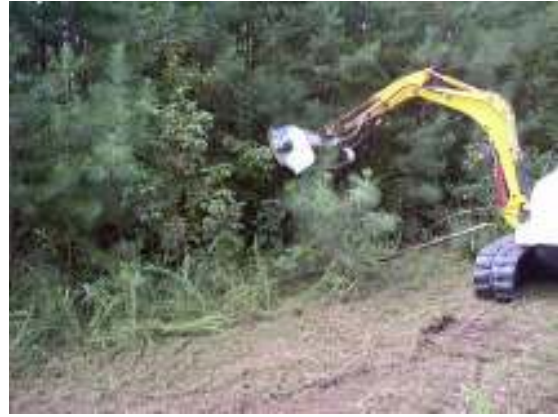
A timed cut of Category 2 vegetation was made in a 16-meter-long area adjacent to a graded fire road. The first 1.5 to 2 meters in from the road were judged to be Category 1 vegetation (heavy field grass with no brush or saplings). The next 2.5 meters consisted of Category 2 saplings and trees measuring 3 to 10 meters tall, most being up to 6 cm in diameter. The final two trees cut, classified as Category 3, each measured 7.5 cm in diameter.

The timed Category 2 cutting test procedure was as follows. The first two passes through the Category 1 vegetation were from right to left, parallel to the road, with the Beaver backing up between passes. A slight drainage ditch along the side of the road required the operator to continually adjust the attitude of the cutter to follow the changing pitch of the ground. Before starting to cut the Category 2 vegetation, the cutter head was rotated 90 degrees so that cutting was accomplished by pushing the cutter on a path that was out away from the vehicle, much in the same way that a push lawnmower might be used to cut grass on a short side slope. After each cut, the operator had to move the Beaver the distance of one cutter width to start the next cut, a process which is much slower than that followed for the Category 1 vegetation cut. When cutting the trees, the technique was to extend the boom and stick, raise the cutter high, and top the trees at some point above the ground. The cutter was then used to chew the standing stumps down to ground level.

Two larger Category 3 size trees, each measuring 7.5 cm in diameter, were removed in the following manner. The cutter was used to put a cut into the front side (side facing road) of the tree trunks at a height of about 3 meters. The cutter was placed behind the trees, above the cut, and used to pull the trees back toward the road, snapping the trees off at the point of the front cut. The cutter was then used to chew the standing stumps down to ground level and to mulch the tops.

The area cut measured 16 meters by 4.5 meters, an area of 72 m² cleared in 1 hour.

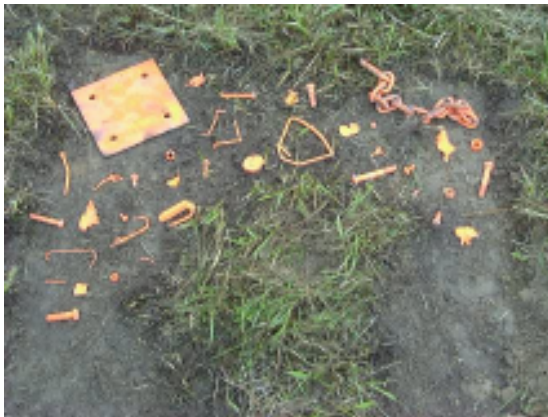
A Category 1 area, 25 meters by 9 meters, was mowed with the cutter. Thirty-nine pieces of ferrous scrap of various sizes, painted bright orange, were placed randomly throughout the mowed area under the debris from the cutting (see Figure 18). The electromagnet was passed over the area, sweeping the total area in a series of 13 passes. On each pass, the operator kept the magnet as close to the ground as possible without dragging the magnet over the cut vegetation. The magnet was turned off to collect retrieved scrap after every two passes (down and back). A total of 36 pieces of scrap were recovered. A visual search of the area found one more piece. The remaining two pieces were never recovered. However, a metal link from an ammunition belt, not part of the test scrap, was also recovered by the electromagnet. The operator could not guarantee that 100% of the area had been covered since the magnet left no visual tracks of previous passes.

To test the effectiveness of the magnet, seven various pieces of the scrap were selected and placed on a flat area of ground. The magnet was raised above the scrap, turned on, and slowly lowered until the first piece of scrap was picked up. The distance was measured. The lowering of the magnet was continued until all pieces were picked up, with measurements being made as each piece was pulled to the magnet. The test was run twice. The results are presented in Table 6. The difference in pickup height for the same object in the two trials is attributed to the attitude of the electromagnet presenting a changed magnetic field. Figure 19.

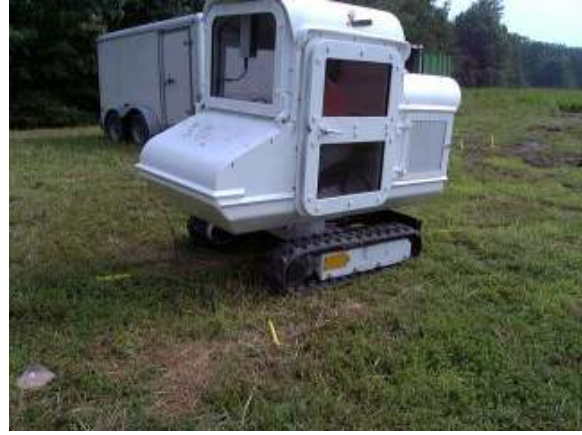
Since both vehicles are tracked vehicles, the minimum turning radius will be that achieved by pivoting in a “zero-radius turn,” that is, turning by having one track move forward while the other track moves backwards. By so doing, a tracked vehicle will turn on a point midway between the vehicle’s track system. The minimum turning radius measured for the Beaver was 16.25 feet (4.96 meters) and for the Duck was 8.8 feet (2.69 meters). See Figures 22 and 23.
