Proof of Performance Test Report

MANTIS

April 2005

**Proof of Performance Test Report
on
Mine Clearing/Survivable Vehicle
(Mantis)**

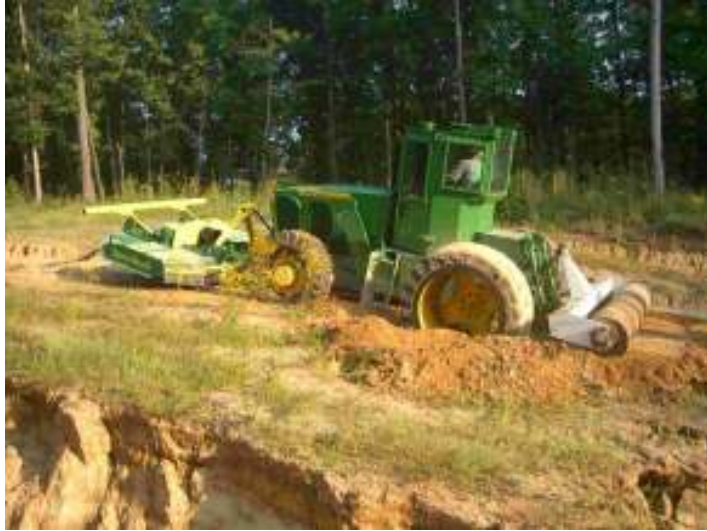
The MCSV, with SETCO tires and the rotary mower and area reduction roller mounted, got stuck on a section of the cross-country track that approximated a 20-degree slope in soft, damp sand. Getting stuck appeared to be caused by a combination of the rigidity of the solid tires and the molded traction cleats in the rear tires, which are close together, becoming packed solid with soil. This resulted in the rear, heavily cleated tires taking on the characteristics of “slick” tires, with no flexibility to self-clean (see Figure 19). The tractor was able to back out of the ruts, created in its attempt to go forward, after sections of logs were placed into the ruts behind the four driving wheels. A dozer was brought in to repair the damage done to the dirt road over the length of the hill

Figure 19: MCSV Stuck in Damp Sand Hill

Two days later, after the soil had a chance to drain, the run was made again with SETCO tires and the counterweight and area reduction roller attached. There were no problems and not a single hesitation or wheel spin when the MCSV climbed the portion of the hill where it had previously gotten stuck. The run was completed at an average speed of 8.97 mph (14.5 kph).

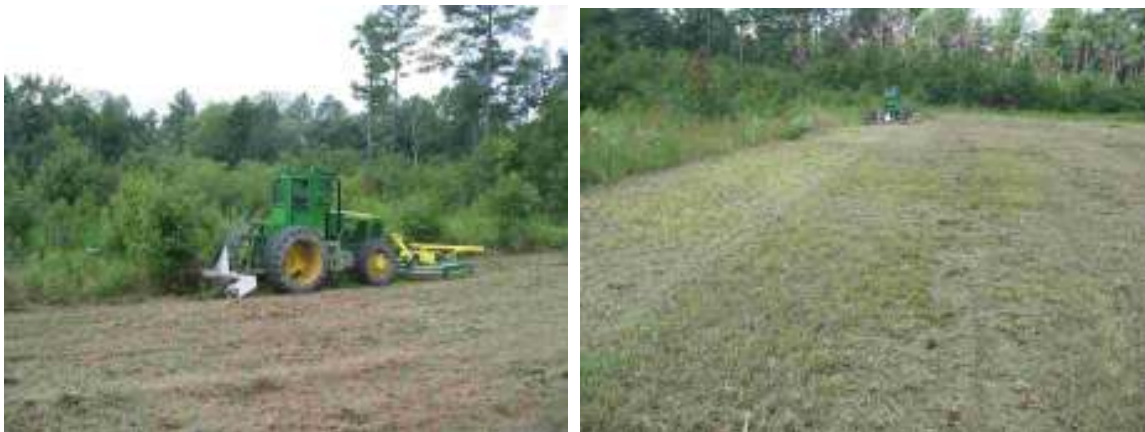
Figures 20 and 21 show the results of mowing with the use of the roller, and of the sheared universal joint (drive shaft yoke).

Figure 20: Area Reduction Roller and Mower Results

To demonstrate using the mower in an AP mined area, and to eliminate clutch disengagements in heavy Category 2 vegetation, the mower was used in tandem with the area reduction roller. On the first pass through a Category 2 vegetation area, the roller was pushed through the vegetation (cab facing to the rear and roller mounted on the rear), with the mower following and raised about 6 to 12 inches (15 to 30 cm) off the ground. At the end of the pass, the MCSV operator rotated the cab, dropped the mower to ground level, and retraced the path he had just taken, this time with the mower leading and the roller following. While this double-pass operation increased the mowing time, it resulted in a closer cut area and minimized the chance of the mower deck being caught on dirt or shrub growth, causing shaft damage as described above.

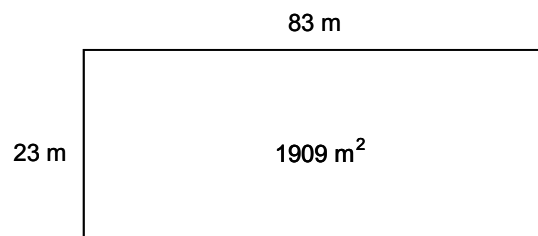
Two timed mowing tests were conducted to provide planning factors for field operations of the rotary mower. The first test was with the mower only on an area where the vegetation progressed from a heavy Category 1 to a mix of Categories 1 and 2. The area mowed was 1,909 m², the time required was 62 minutes. This equates to approximately 1,850 m² per hour. Figure 22 is a diagram of the mowed area.

Figure 22: Mowed Area (1900 m²/h), Mower Only, Single Pass

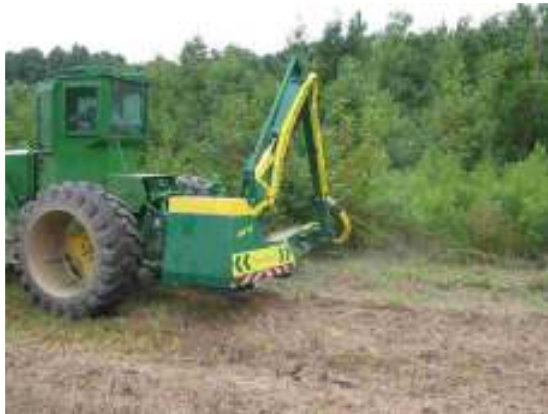
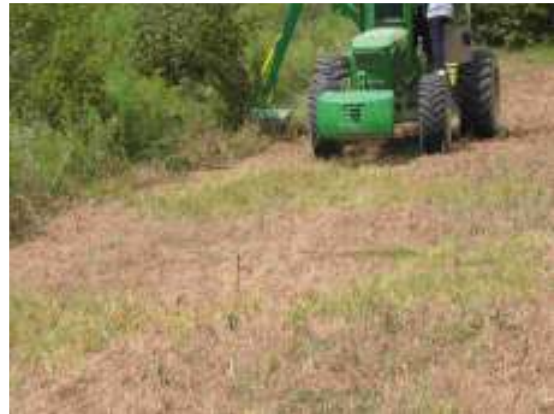
The Hedge Trimmer, designed to be mounted on the rear 3-point hitch of the tractor, is powered by the rear PTO. The PTO drives an on-board hydraulic system that controls the movement of the boom and powers the cutter head. The boom allows the hedge cutter to operate over an intervening guard rail or other similar obstacle and cut the vegetation beyond

the obstacle. The cutter is powerful, quiet, with very minimal vibration, indicating excellent balance of the cutting rotor. The cutting rotor has a double row of cutters with 14 cutters per row. The cutting swath is 1 meter. With the boom fully extended, and with no intervening obstacle, the cutting head is able to reach out 13.33 ft (4 m). The Hedge Cutter had no problem cutting Category 1 and 2 vegetation. On Category 3 vegetation, the cutter was able to cut the vegetation down to ground level only by cutting the vegetation in stages, beginning at the top, and working down. The Hedge Cutter was not designed to be operated in this fashion; however, it can be done, albeit awkwardly. The Hedge Cutter appears to be sufficiently robust to operate for extended periods of time against Categories 1 and 2 vegetation. No trials of area versus time were made. No mechanical problems were encountered.

Figure 25: Brush Cutter Operations

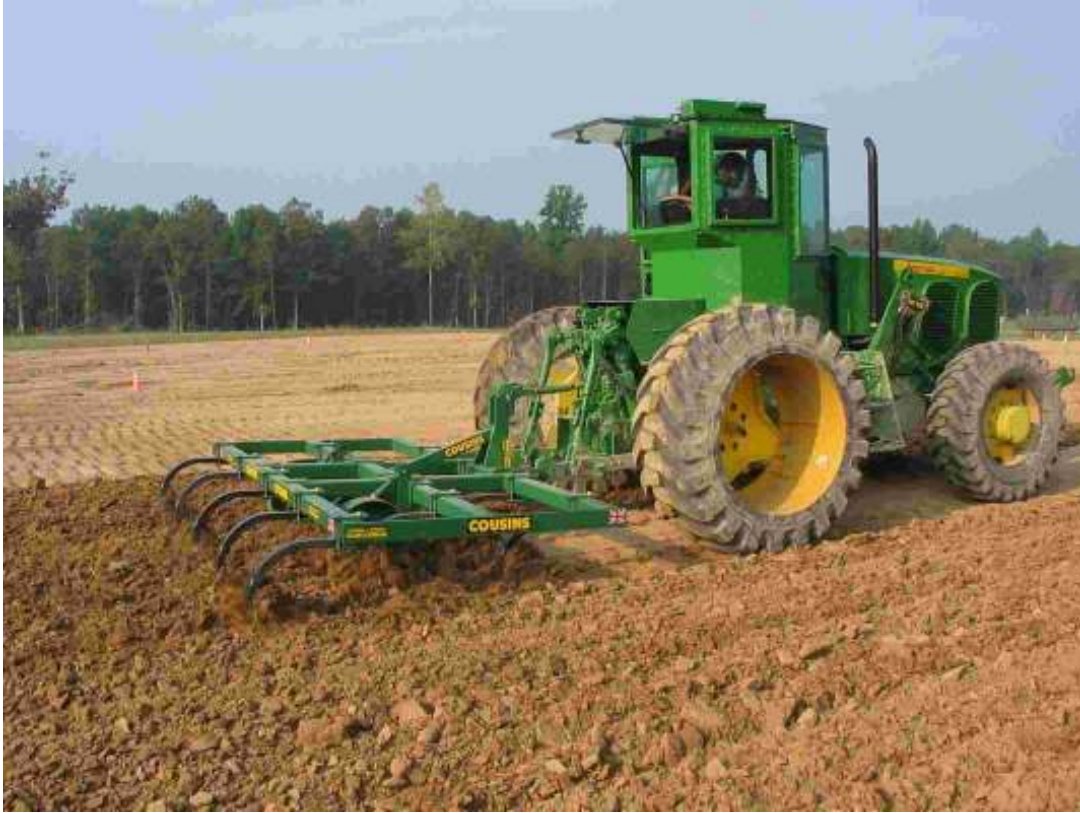
The Spring Tine Cultivator, a commercial farming tool, was mounted on the MCSV with SETCO tires. The test area was hard-packed sandy clay soil. At the start of the test, when the MCSV operator tried to control the tractor throttle and depth of the cultivator manually, the cultivator operating depth varied as the surface of the field rose and fell, and the MCSV was brought to a complete standstill at low tractor speeds by the drag of the cultivator. However, when the tractor was put into Economy Drive (similar to cruise control), the cultivator allowed to ride on the depth-control wheels installed on the cultivator, and the desired tractor speed set, the MCSV fuel-control system and engine computer automatically adjusted the fuel flow to keep the tractor moving as the cultivator load on the tractor varied. When driven using Economy Drive, the tractor was able to cultivate the soil to a depth of 6 inches (15.25 cm) on all three rows of tines. No time trial measurements against area cultivated were made.

Figure 26: Spring Tine Cultivator Demonstration

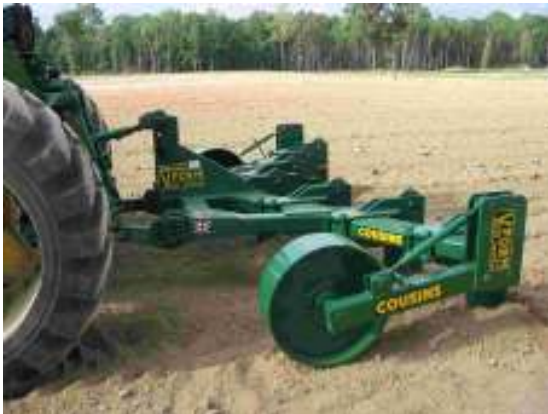
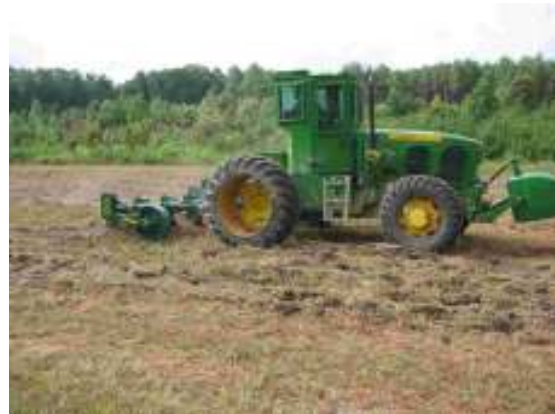
Based on the experience with the Spring Tine Cultivator, the performance test of the Soil Loosener made use of the installed depth-control wheels to control the tool's operating depth, and the Economy Drive system was engaged. Trials were conducted in dry, compacted sandy clay soil with no vegetation and in an area where Category 1 vegetation had been cut with the rotary mower. At both sites, the MCSV had no trouble pulling the Soil Loosener at an operating depth of approximately ½ meter.

Figure 27: Soil Loosener in Packed Clay and Heavy Sod

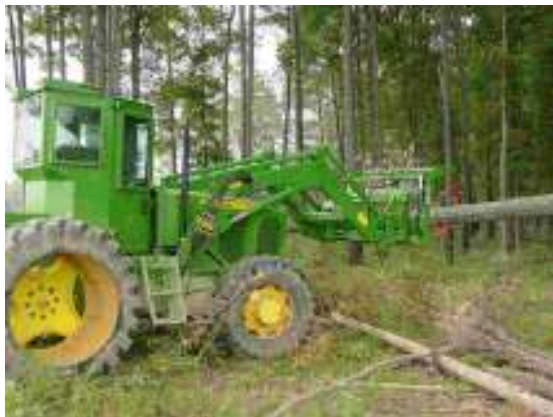
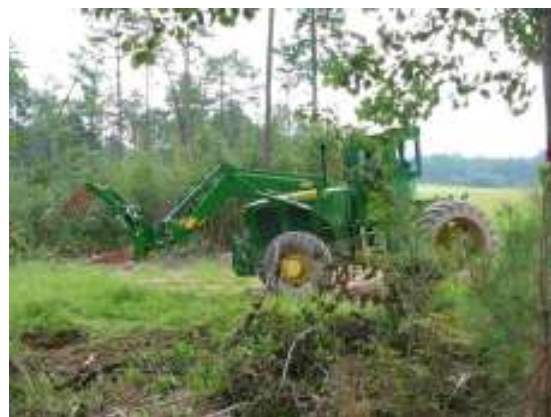
The Grab, designed to pick up cut brush, debris from forestry operations, or any loose material resulting from a vegetation-clearing project, is mounted to the tractor using the Universal Mount. Although operator visibility of the tool is limited when the tool is on the ground, with a minimal amount of experience the operator is able to use the tool with no trouble. As can be seen, lifting capacity, by weight, is sufficient to handle large debris-clearing jobs. No tests, other than the demonstration shown, were conducted.

Figure 29: MCSV with Grab

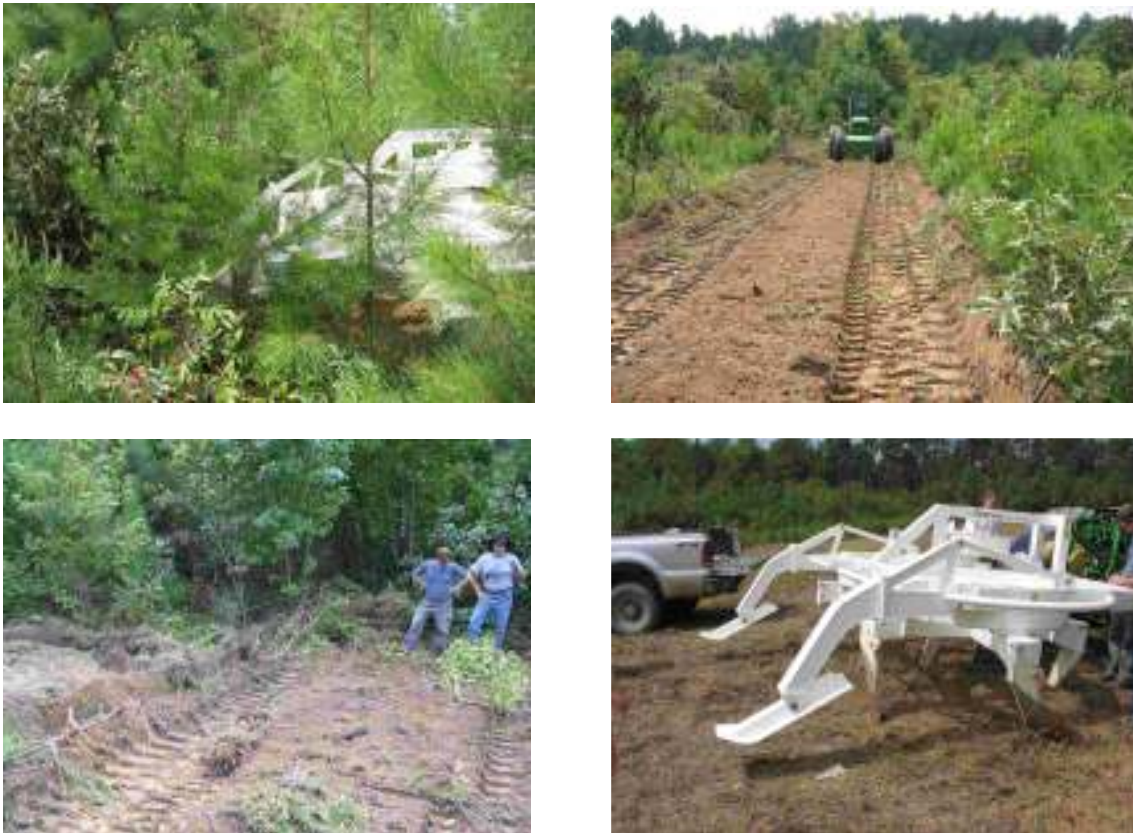
The Rotary Mine Comb, designed and built by Pearson Engineering, Ltd., is an adaptation of an old idea for a garden tiller. The two sets of counter-rotating tillers, canted slightly outward, bring mines to the surface and then slowly, and gently, move the mines to the sides of the tiller and deposits them in windrows. Throughout the demonstration, the Rotary Mine Comb handled all vegetation conditions, ranging from dense Category 1 to very heavy Category 3, with ease. The 40 cm operating depth of the cultivating tines removed not only the above ground vegetation, including 15 to 20 ft (4.6 to 6.1 meter) tall trees up to 3 inches (7.6 cm) in diameter, but also dug up the trees' root systems. This tool, without exception, was the best area-proofing and mine-removal tool tested during the MCSV proof of performance. Pictures showing the Rotary Mine Comb in action and the results of its operation are shown in Figure 30.

Figure 30: Rotary Mine Comb Demonstration

During the performance demonstration in heavy Category 2 and Category 3 vegetation, the operator had trouble steering in a straight line with the mine comb pulling the tractor on a gentle curve to the left. If the ground is not level, the Rotary Mine Comb digs more deeply on the low side. This in turn exerts a pull to that side causing the tractor to

An operational transit problem presented itself and a workable solution was devised. In the full-up position with the Rotary Mine Comb out of the ground and the PTO shaft connected to the Rotary Mine Comb, the Rotary Mine Comb clears the ground by scant inches. When moving from a staging area to a work site over anything other than a flat, smooth surface, the Rotary Mine Comb digs into the ground as the MCSV pitches and sways over the uneven surface. Since the PTO shaft is the limiting link in determining ground clearance in the all-up position, it is recommended that the PTO shaft not be connected until the Rotary Mine Comb is at the work site. This allows additional ground clearance when in the all-up position. When departing a work site, the PTO shaft should be disconnected.

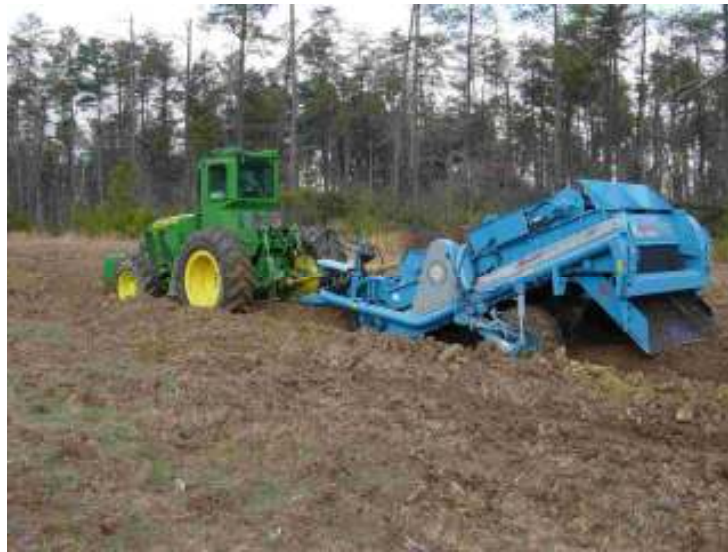
Before using the sifter, the soil was broken up by the MCSV pulling the Soil Loosener. After breaking up the soil, the soil-breaking wedges were removed from the Soil Loosener frame, and two bed-forming v-shaped plow implements attached. The area to be sifted was formed into windrows using the bed-forming v-shaped plows. The design and spacing of the plow attachments allow the wheels of the MCSV and the sifter to ride in the troughs between the windrows, sifting one windrow at a time. The sifter can be set to sift to a maximum depth of 14 inches (35.6 cm). The pros and cons of using this attachment are discussed below.

at the rear of the sifter. Experience showed that the sifter was much more efficient when operated at the lower of the PTO speeds (540 rpm vs. 1000 rpm). At a forward speed of 1 mph (1.61 kph), the sifter is capable of sifting 3,033 square yards per hour (2,773 square meters per hour).

Figure 31: Mine Sifter in Operation

There are four drawbacks to using this attachment, one potentially serious, three easily correctable. The serious drawback is that the MCSV would have to drive over a mined area to prepare the soil with the Soil Loosener and Bed Formers prior to using the Mine Sifter. The second drawback involves the rear-facing chute. Because of its width, mines can be deposited in the trough between the sifted windrows and might be covered with a thin layer of soil that slides down the sides of the sifted windrows. This can pose a hazard to deminers who would walk in the troughs looking to recover sifted mines. An easy correction to keep the mines on top of the sifted windrow is to install a choke in the discharge chute, ensuring that the mines are deposited in the center portion of the windrows. The third drawback is that the MCSV operator cannot see what is being deposited by the rear facing discharge chute, and therefore alert waiting deminers of a sifted AP mine. It is thought that an observer using binoculars should be able to spot sifted mines. Finally, SETCO tires with standard hubs, and not the blast-off hubs, have to be used to match the tire track width of the sifter.

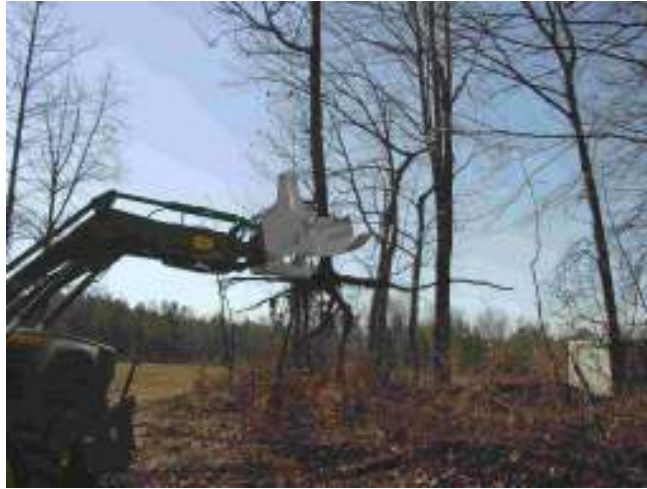
The Tree Picker, also supplied by Pearson Engineering, Ltd., is a hydraulically actuated attachment that mounts to the MCSV using the standard 3-point hitch on the front of the vehicle. The picker is actuated by two electronically controlled hydraulic feed lines off the MCSV's hydraulic system, mounted one on each side of the 3-point hitch. These operate the left and right power outriggers on the picker as well as the central tree-grabbing mechanism. Limited training on and use of, the tree picker occurred during the assessment. However, the demonstration did include the removal of a 12 inch (30.5 cm) diameter tree well in excess of 60 feet tall.

Figure 32: Tree Picker in Operation

Two operational issues were noticed during the demonstration assessment, which included using pneumatic tires on the MCSV. The first is that the pressure placed on the front tires during the tree extraction process and later by the weight of the extracted tree was sufficient to almost totally collapse the front tires. Therefore, it is recommended that the tree picker be used with the SETCO tires installed on the MCSV. The second is that forward moment caused by the weight of the extracted tree made the MCSV very light on its rear tires. Therefore, any extracted tree should be lifted slowly to make sure that the weight of the tree does not cause the rear wheels to lift off of the ground.

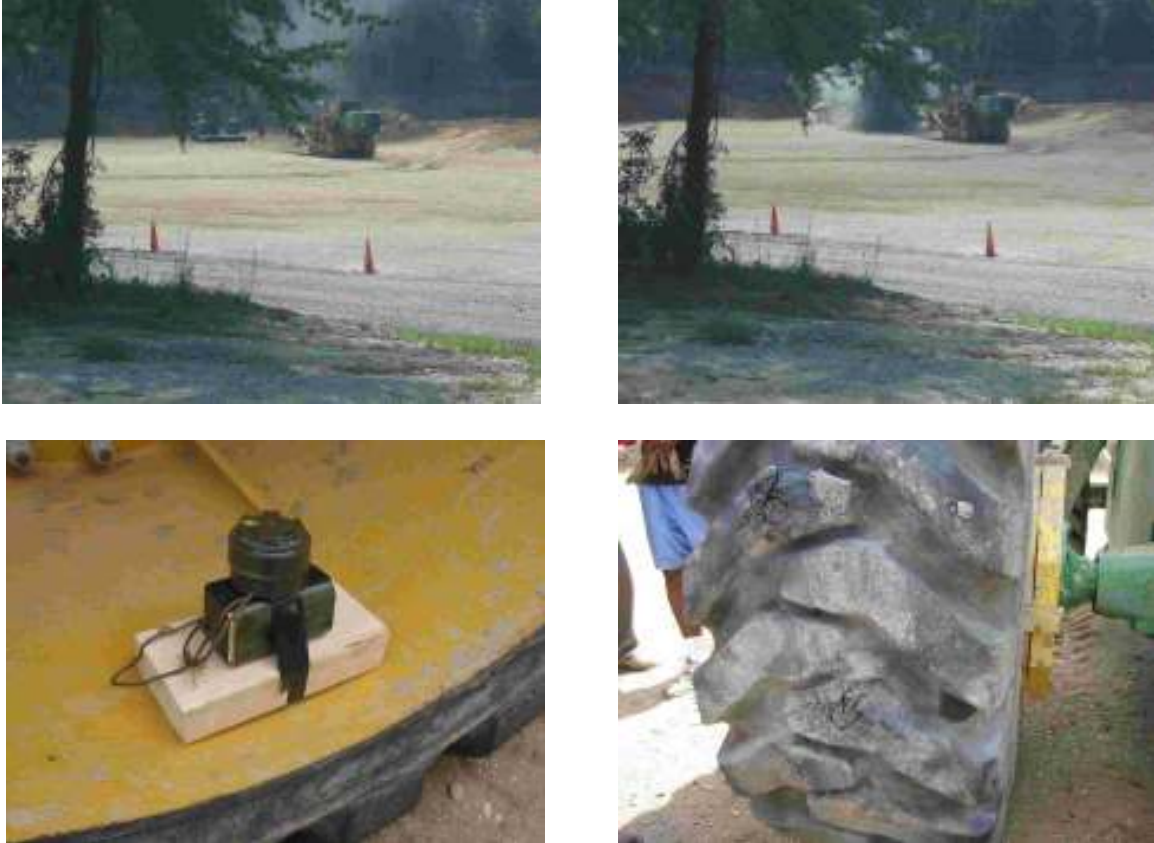
Two blast tests were conducted against the left rear SETCO tire. The two explosive charges used were (1) $\frac{1}{4}$ pound TNT initiated by a small U.S. AP mine, and (2) $\frac{1}{2}$ pound TNT initiated by a small US AP mine. The explosives were buried with the AP mine pressure plate at ground level. The SETCO tires sustained some surface scuffing and localized charring from the blasts. While there was more surface scuffing caused by the $\frac{1}{2}$ pound explosive charge, neither blast area showed significant damage. Given the size and the surface area of the tires, each tire could probably sustain hundreds of such blasts before consideration might be give to changing them.

Figure 33: Blast Test, SETCO Tires

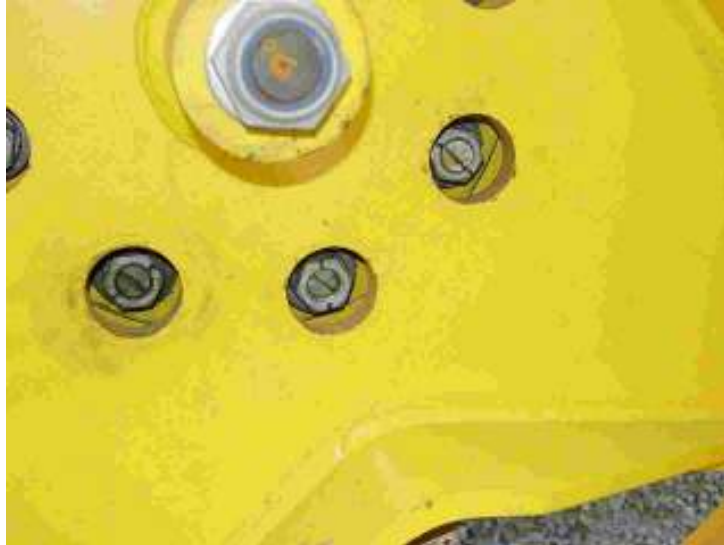
- g. Lapsed time for the repair was 8 hours, with one to three people working at all times.
9. It was noticed during the inspection of the MCSV, after the on- and off-road mobility trials, that the wheel lugs on the rear SETCO tires had worked loose. The lugs nuts were tightened and the trials made with the heavy cultivator. Inspection of the lug nuts showed that they had again become loose, some as many as three and four complete turns of the nut. The nuts were again tightened, using a large breaker bar with a 4-foot extension pipe. The lug bolts were marked and checked three to four times a day for the remainder of the demonstration. There was no further loosening of the lug nuts. See Figure 34. The offset of the black lines on the stud and lug nut indicates a loose lug nut. As can be seen, the bottom lug nut has backed-off at least three full turns.

Figure 34: Loosening Lug Nuts

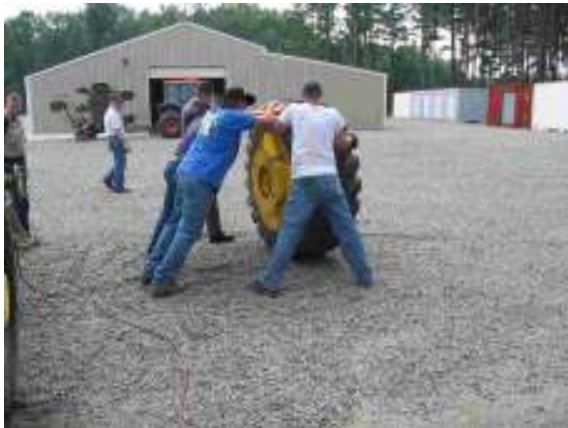
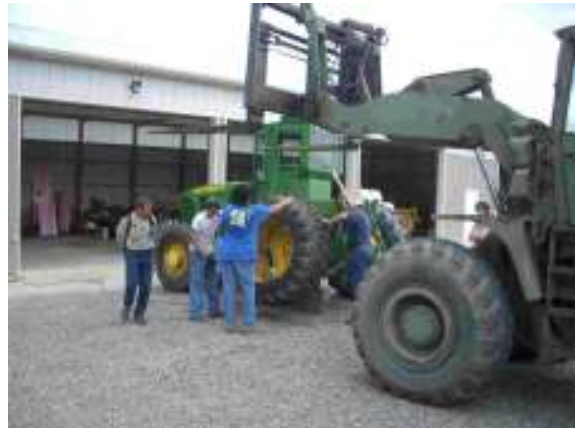
Changing of the rear SETCO tires requires some means of lifting the tires and two to three strong men to position them on the axle. During the proof of performance demonstration, a forklift was used to lift the tire into position. See Figure 35.

Figure 35: Mounting SETCO Rear Tires

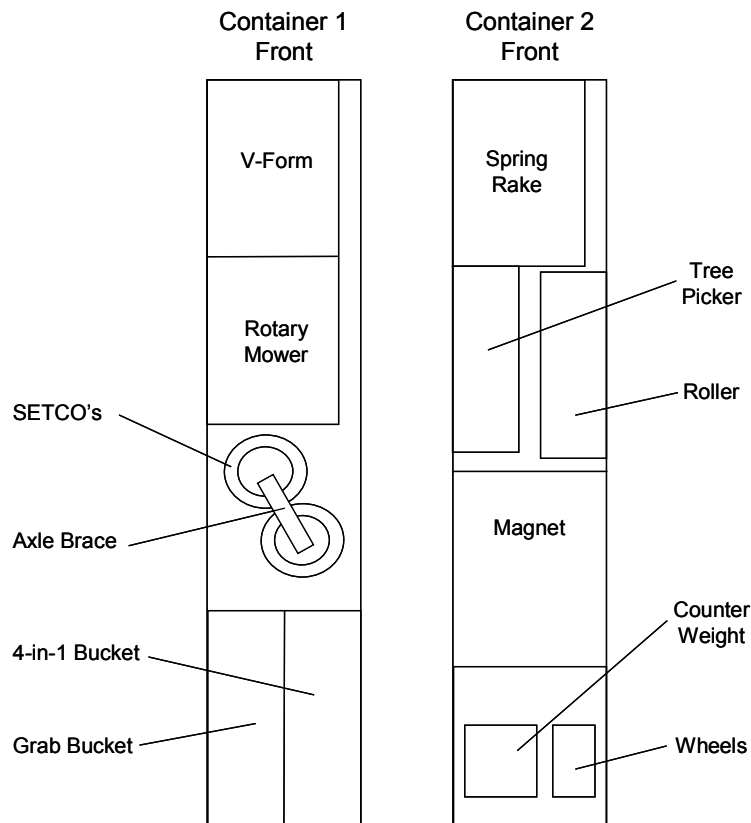
For overseas or long-distance in-country shipment, the MCSV tools and attachments will be loaded into two, 40 foot long CONEX containers according to the loading plan shown in Figure 36. The tractor will be driven into or onto a ship, flatbed rail car, or flatbed trailer and chained in place for shipment.

Figure 36: MCSV Load Plan: Two 40-foot Containers
