Operational Evaluation Test of Mine Clearing Cultivator and Mine Clearing Sifter

January 2005

Institute for Defense Analyses
4850 Mark Center Drive
Alexandria, VA 22311-1882

**Humanitarian Demining Research
and Development Program**
Night Vision and Electronic Sensors Directorate
10221 Burbeck Road, Suite 430
Fort Belvoir, VA 22060

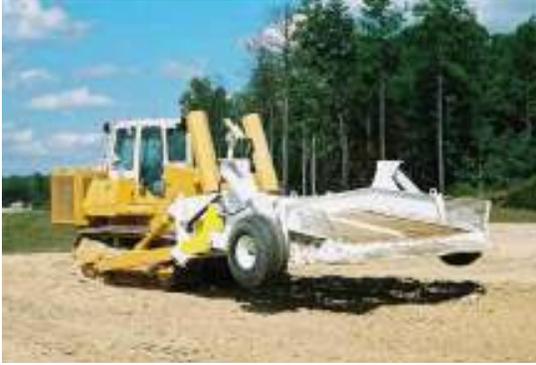
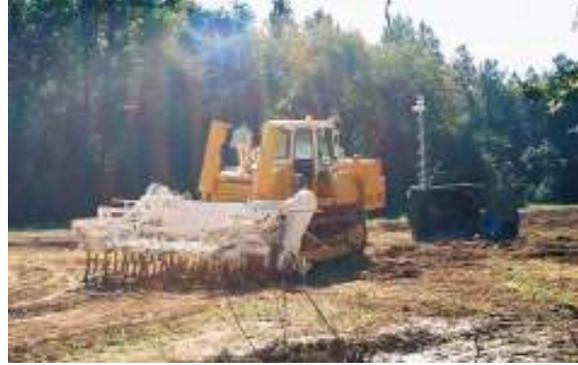
Figure 1: MCC/MCS and Control Vehicle

The Mine Clearing Cultivator/Mine Clearing Sifter (MCC/MCS) consists of the following: the prime mover, the cultivator, the sifter, the Standardized Remote Control System (SRCS) and a hydraulic power unit (HPU). The prime mover for both the cultivator and the sifter is a Liebherr Crawler Tractor, Model No. PR742B, with a rear-mounted HPU. The HPU supplies power to both the cultivator and the sifter. The Mine Clearing Cultivator was designed and built by the Modeling and Mechanical Fabrication Shop of NVESD at Ft. Belvoir, Virginia, as was the Standardized Remote Control System for remote operation of the prime mover, cultivator and sifter. Support equipment includes a separate vehicle to house the remote operators' control station and a portable generator unit. The Reliance Corporation built the sifter.

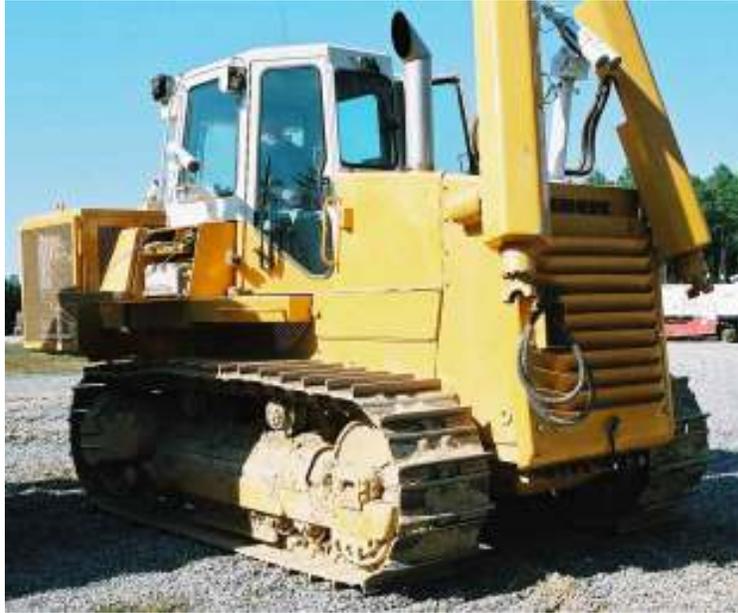
Figure 2: Liebherr Tractor with Modifications

The prime mover for the MCC/MCS is a Liebherr Crawler Tractor, Model PR742B Litronic, manufactured by Liebherr-Werk-Telfs GmbH, Telft, Austria. The Liebherr has a hydrostatic transmission system, which allows continuous and total control of the power to the tracks. This feature gives the operator the ability to adjust the power setting necessary to maintain a set speed for the prime mover as resistance to forward movement varies, a desired capability when operating the MCC/MCS.

allow driving of the tractor and operation of the MCC and MCS from a remote command vehicle.

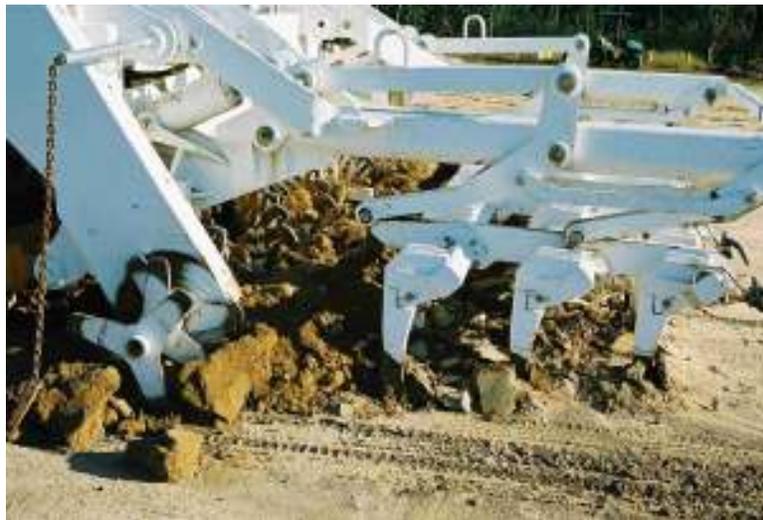
Figure 4: Mine Clearing Cultivator

The MCC was designed and built by the Modeling and Mechanical Fabrication Shop of the Night Vision and Electronic Sensors Directorate (NVESD), Ft. Belvoir, Virginia. The cultivator tines are designed to break up the soil and bring dislodged mines to the surface. The spacing of the cultivator tines allows a mine to move through the cultivator to a horizontal auger whose purpose is to move the mines out of the cultivator and deposit the mines in a berm to either the left or right of the cultivator and tractor.

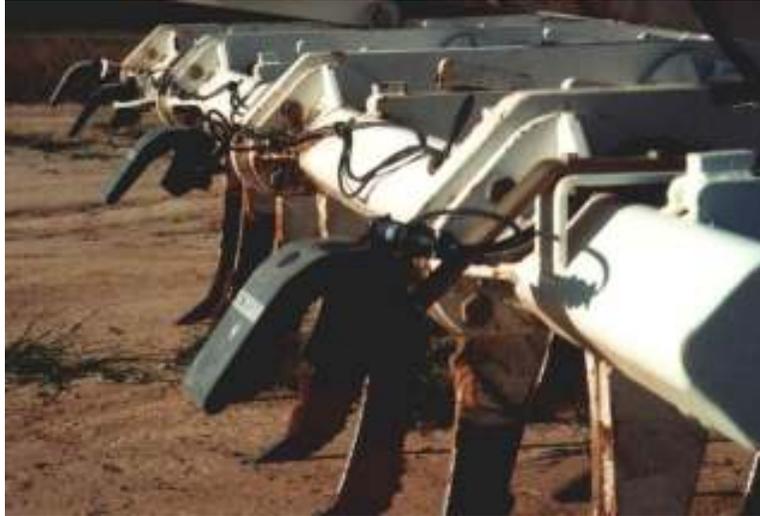
Figure 7: Depth Sensors

Figure 7 shows the depth sensors mounted on the front edge of the cultivator. Their purpose is to automatically control the operating depth of the cultivator tines by maintaining a constant distance above the ground.

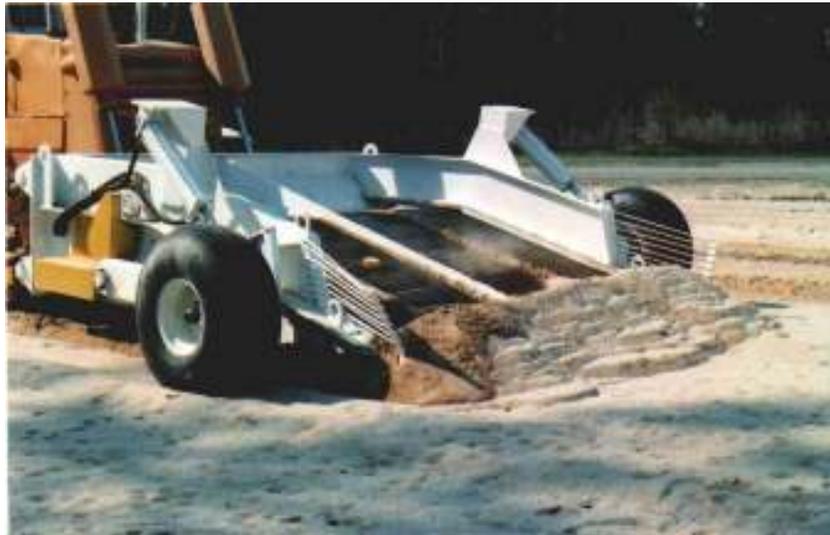
Figure 8: Mine Clearing Sifter

The Mine Clearing Sifter (MCS), manufactured by the Reliance Corporation, is identical to the Heartlands Sifter tested by NVESD in 2002. (The report on the 2002 test of the Sifter is presented in Appendix A). The sifter, an off-the-shelf agricultural machine, is used to remove land mines from the soil by the sifting action of two steel-bar conveyor belts and a discharge conveyor belt that deposits the mines in windrows off to the side of the sifter and prime mover. The discharge belt drive mechanism allows selecting the side of discharge.

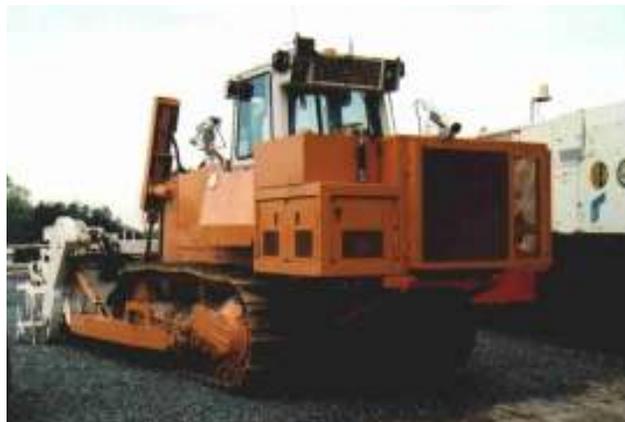
Figure 11: Hydraulic Power Unit (HPU)

Due to the hydraulic power requirements of the cultivator and sifter, an auxiliary, diesel-driven HPU was mounted just aft of the cab on the Liebherr crawler tractor. The HPU, powered by a 177 HP, Deutz diesel engine, is capable of providing 80 gpm of hydraulic fluid at a pressure of 3000 psi.

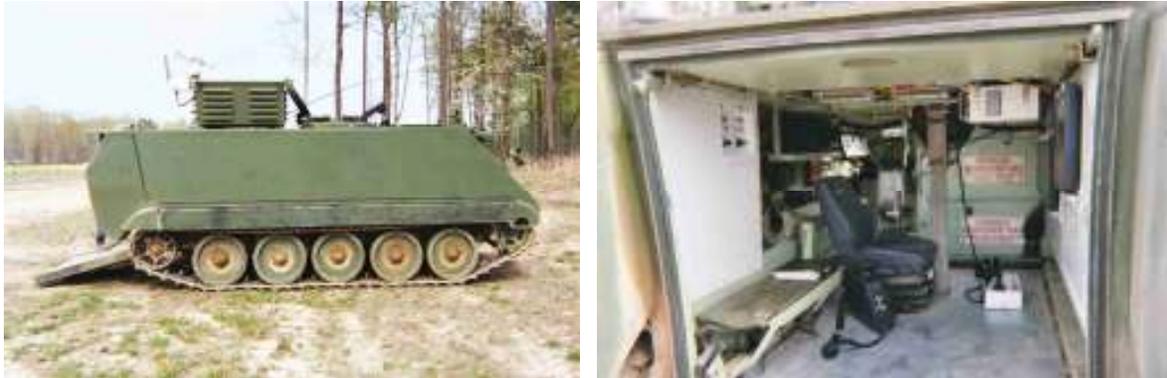
Figure 12: Remote Command Vehicle (exterior and interior)

The SRCS is a stand-alone system that can be mounted in any van-like vehicle (or large SUV) or a small portable room. The volume needed must accommodate the vehicle and mast-mounted camera operators and have wall space for five flat-panel displays measuring 18×24 inches each. For this test, an M113 armored personnel carrier was used as the Remote Command Vehicle (RCV). In other tests using the SRCS, SUV-like vehicles have been used as the RCV. The portable generator for the SRCS and a commercial air conditioner were mounted on the roof of the M113.

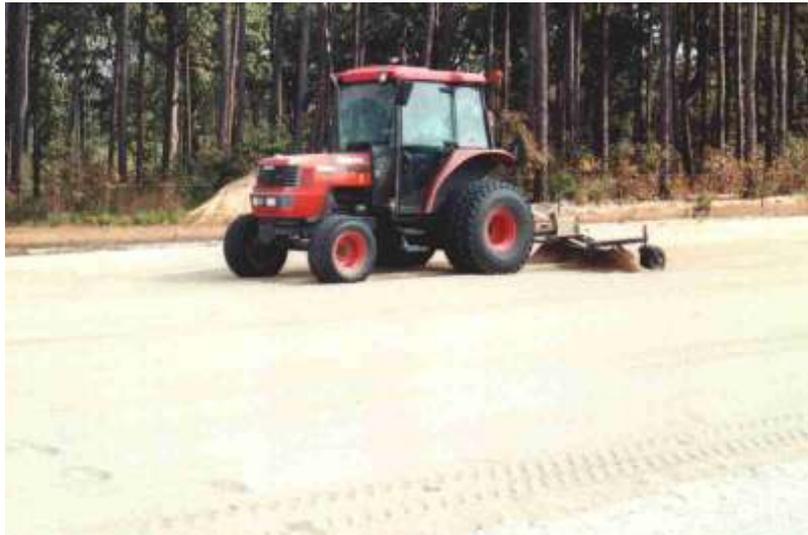
Figure 19: Raking of Sand at Test Site 3

Prior to the start of each test, the location of each mine (x, y, and z coordinates) was recorded and stored in the VLPS. Cultivation with the MCC started 15 meters before the start of the test lanes, allowing the cultivator operator sufficient distance to position the cultivator tines at the appropriate operating depth, to adjust the camera apertures to allow for ambient lighting, and to insure proper alignment with the center of the lane. As each mine was brought to the surface by the MCC, note was made of whether it was seen by both the system operator and ground observers. The MCC proceeded to the end of each lane, at which time the cultivator was extracted from the soil. The final location of each mine was measured with the VLPS, exposed mines were removed from the test lane, and the MCC prime mover was backed up to its starting point. At Test Site 1, the procedure was conducted twice. The first time in uncut, sod-covered soil, the second time in soil stripped of sod that had been previously cultivated during the sod test. At Test Site 3, the three lanes of testing were conducted in a single lane that was raked (see Figure 19 below) and replanted with mines between each single-lane run.

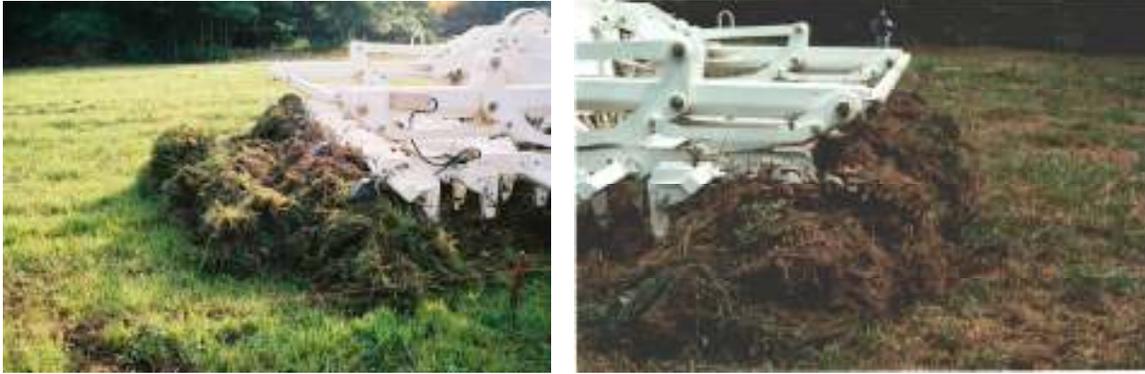
Figure 22: Sod Build-up In Front and Within the Cultivator's Tines

It was during this test that the problem with sod build-up in the cultivator was encountered. As the tines of the cultivator went through the soil, they picked up the grass including the topsoil and the root system underneath. In addition, the moist soil tended to clump and bind with the sod. This sod and soil build-up within the tines prevented the mines from passing between the tines and reaching the auger. At a couple of points during the test, the build-up became so great that the prime mover lost traction and could no longer make forward progress with the cultivator. The cultivator then had to be lifted out of the ground, sod and dirt removed from the tines, the tractor backed up at least 5 meters, and the cultivator reinserted into the soil to continue the operation. It was during the reinsertion of the cultivator into a lane that some mines were stabbed or activated. The sod build-up also resulted in a very large end-berm that had to be cleared of mines by hand after scanning with a metal detector.

The expectations for this test were reduced after the results of the standardized testing of the cultivator in sod-covered soil. The test was started but it was found that the soil and sod build-up in the cultivator was so extensive that it adversely affected the operational usefulness of the equipment. The problem was the combination of long grass, its soil-holding root system, and soil moisture content which caused a heavy build-up of soil and sod both in front of and within the tines of the cultivator (see Figure 22). The build-up in front of the cultivator negated the functioning of the depth sensors to maintain the cultivator's operating depth. The weight and volume of the sod and soil build-up in front and within the cultivator became so great that, at times, the tractor was not able to move. The test was stopped after one and a half passes into the minefield. While some performance data was recorded, it was not statistically significant and no valid quantitative conclusions could be drawn. This portion of the test was halted and the mines removed from the minefield.

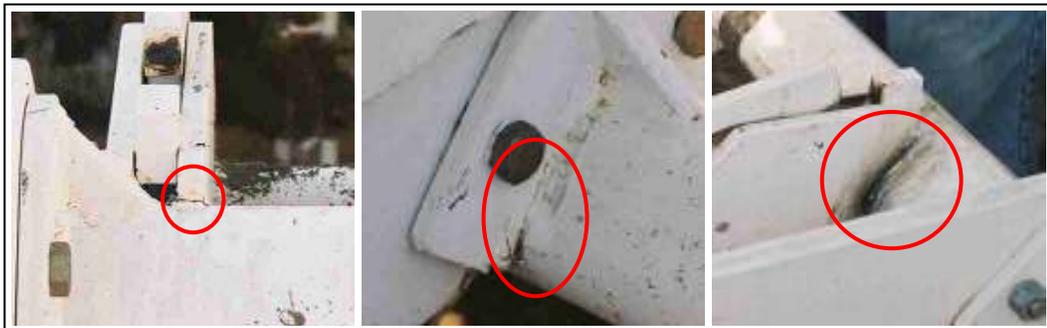
Figure 23: Cracks Found on the MCC

1. During a routine inspection of the tines of the MCC after the trials at Test Site 1, cracks were found along the welds between the connecting bar and the tines (see Figure 23). A welding unit was brought in and the cracks were fixed within an hour. The remainder of the test was completed with no new cracks developing.

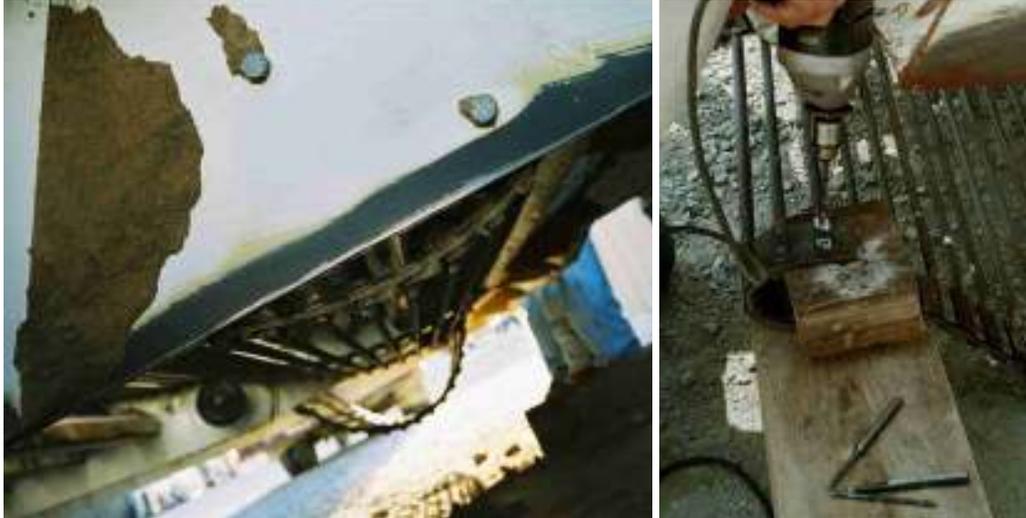
Figure 24: Loose MCS Belt Repair

2. A major concern was the main conveyor belts on the MCS. In previous tests, it was found that operating the sifter with heavy loads (very moist or rocky soil) could cause the main sifting belt to stretch, causing it to override the drive sprockets. While care was taken to prevent this from happening during this test, a belt was found to have stretched excessively from the limited work done at Test Site 1 (in soil with 25% to 30% moisture levels at 8 inches depth). The main sifting belt was opened at the closing (master) link, unfastened from the MCS and tightened by shortening the belt by removing one bar and its webbing.

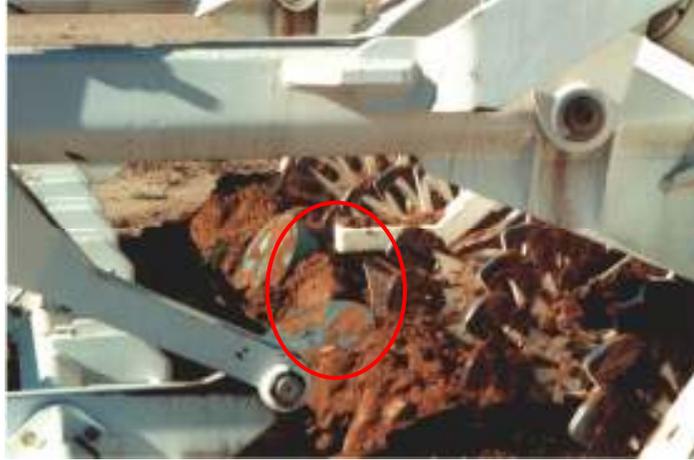
Figure 25: Mine Caught Under Center Bar

- Center fingers in the middle of the auger combined with the presence of the center structural bar (see Figure 25 below) tend to roll mines forward instead of to the side and out the auger. Redesign of the center left and right auger fingers and the structural center bar should induce a mine coming into the very center of the auger to move to one of the sides.

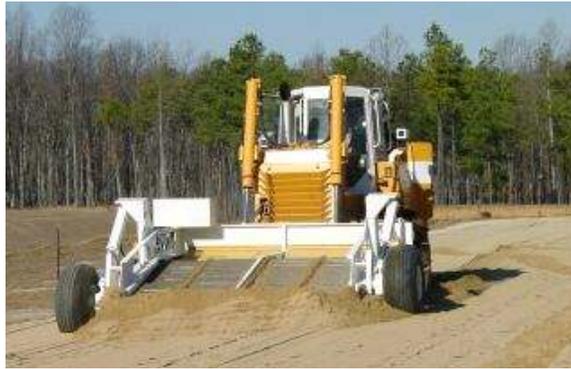
Figure A-1: Heartlands Sifter

operations. Using customized mounting hardware, the HLS can be mated to various construction vehicles which function as the prime mover. The prime mover selected for this test was the Liebherr 742 crawler tractor with a four-point, C-frame hook-up. The Modeling and Mechanical Fabrication Shop of the U.S. Army Communications Command, Night Vision and Electronic Sensors Directorate (NVESD) Fort Belvoir, Virginia, integrated the HLS with the Liebherr tractor.

The COTS HLS consists of everything forward of the Liebherr tractor (i.e., the sifting web, cross sifting web, and the tires) (see Figure A-1). An auxiliary hydraulic unit driven by a 175 HP diesel engine, mounted on the rear of the tractor, drives the sifter. The dimensions of the sifter are provided below in Table A-1 and depicted in Figure A-2.

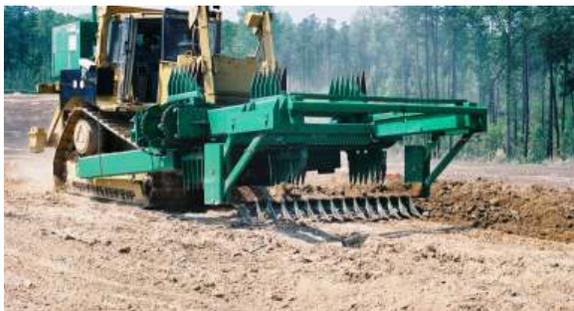
Figure A-3: Floating Mine Blade (out of ground)

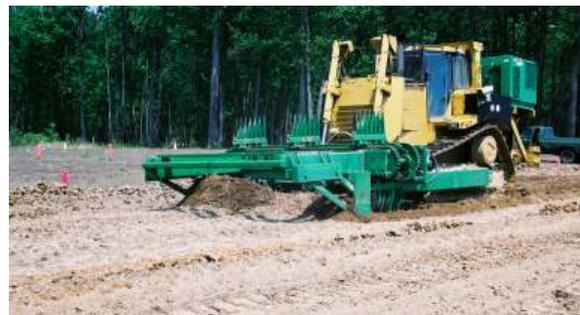
Figure A-4: Floating Mine Blade (in ground)

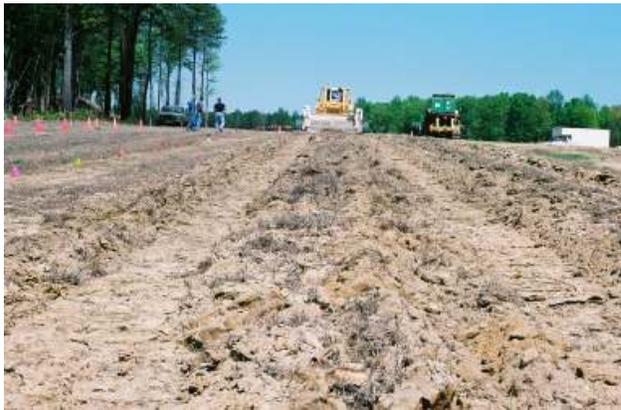
Figure A-7:
Cultivated Test Lane

The HLS was evaluated during four runs in cultivated heavy clay soil, covering 900m² of area in 43.7 minutes (1235 m²/hr.). The ground was damp (average of 10.3% moisture content) and consisted of thick, tightly packed clay. The soil tended to clump together even after being broken up by the FMB tines during soil preparation. The HLS dug as deep as 30cm into the cultivated ground, sifted the soil, and then deposited the larger debris (rocks and sod) along with large clumps of soil on the windrow. The windrow berms created by the HLS were as large as 60 cm tall and 100 cm wide.

Soil built up on the HLS front digging blade over the course of each run, requiring that the blade be cleaned off after each lane run.

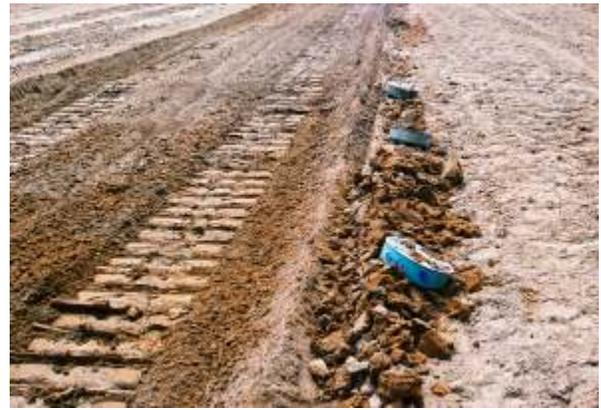
Figure A-8:
Sifted Test Lane and Berm

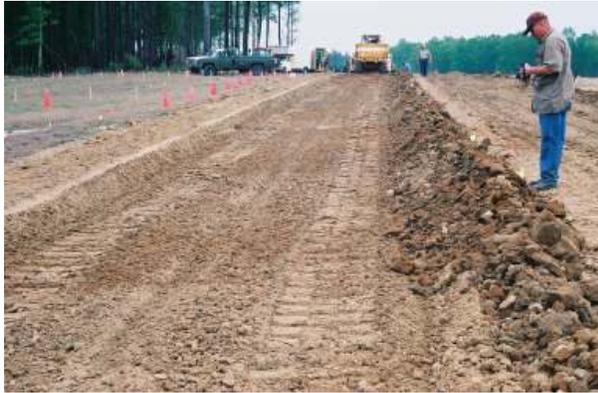
**Figure A-9:
Sifted, Cultivated Lane**

The HLS was evaluated over four runs in the cultivated and sifted heavy clay and covered 900 m² of area in 32.5 minutes (1660 m²/hr). The average soil moisture content was 11.9%. The soil was prepared using the FMB and the HLS. The evaluation was conducted as the HLS processed the soil for the second time. The only significant difference in processing between the cultivated heavy clay and the cultivated and sifted heavy clay was the amount of time the HLS took to process the soils. The HLS processed the sifted soil 11.2 minutes faster than the unsifted heavy clay soil. The HLS dug as deep as 30 cm, lifting uncultivated and unsifted soil as well as sifted soil from the previous run, which resulted in large berms of dirt clumps and debris along the windrow.

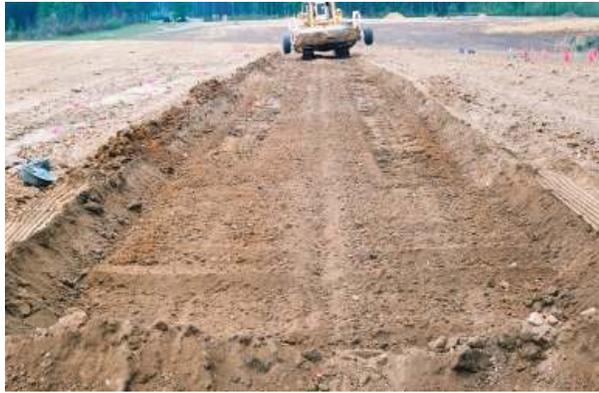
**Figure A-10:
Sifted, Cultivated and Sifted Lane**

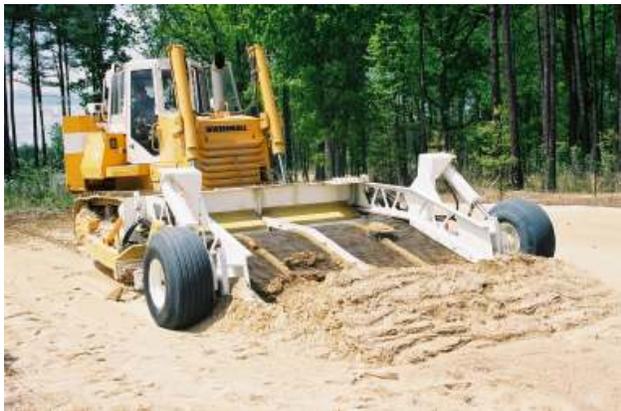
**Figure A-11:
HLS Operating in Sand**

The HLS was evaluated during six runs in the sandy soil, covering 1350 m² of ground in 64 minutes (1265 m²/hr). The sandy soil was loose and damp with an average soil moisture content of 17.2%. The HLS was able to dig as deep as 40 cm. This depth is 10 cm more than the manufacturer's recommended maximum depth for the system. Soil preparation was not needed for the HLS to operate effectively in the sand. However, after each run, the rake mounted on the back of the tractor was used to level out the end-berm left by the HLS.

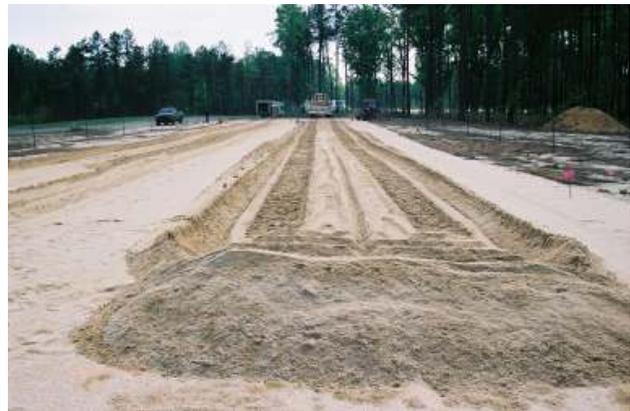
**Figure A-12:
Sifted Sand Lane with End-Berm**

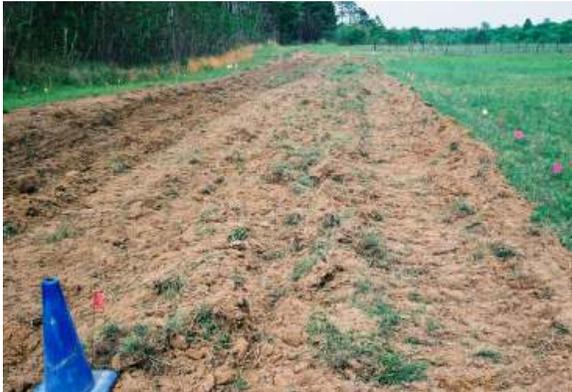
**Figure A-13:
Cultivate Light Clay with Sod**

The HLS was evaluated during four runs in cultivated light clay soil (covered with sod), covering 900 m² of area in 43.3 minutes (1247 m²/hr). The average soil moisture content was 17%. The soil was prepared using the FMB. The HLS dug as deep as 30 cm. In a few places along the run, the HLS dug deeper than the FMB had during soil preparation. In these cases, the HLS blade dug up large clumps of uncultivated soil. Since the ground was covered with sod, the sod root structure tended to hold the soil in clumps. The HLS sifted the soil then

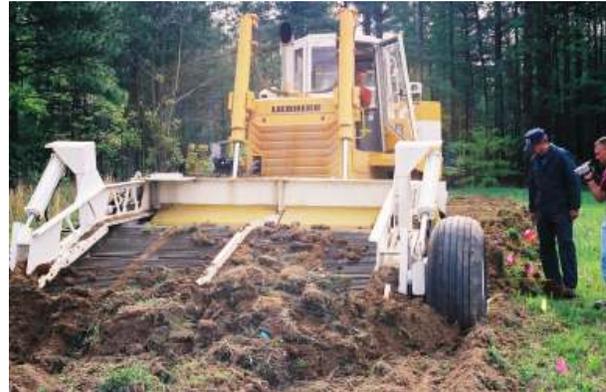
**Figure A-14:
HLS Sifting Light Clay and Sod**

deposited the remaining dirt and sod clumps in the windrow creating berms as large as 75 cm in height and 95 cm wide.

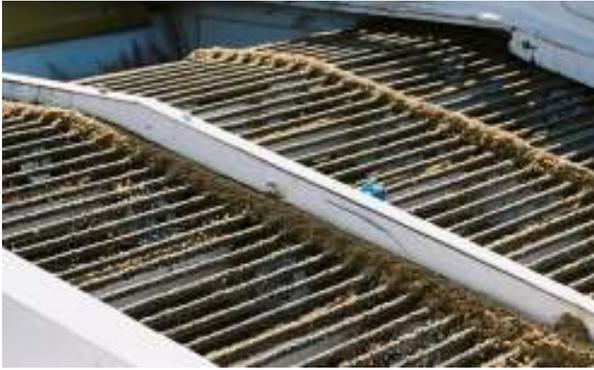
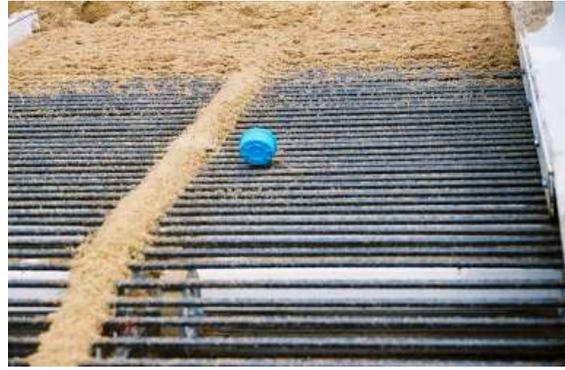
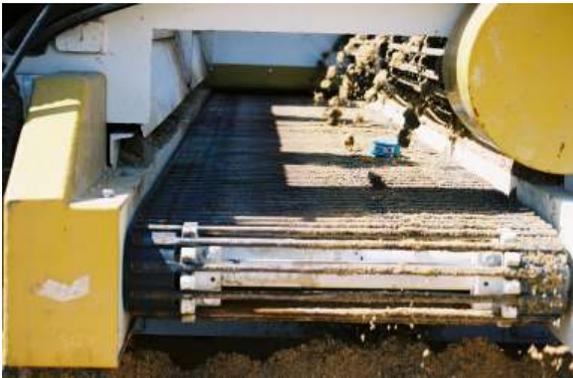
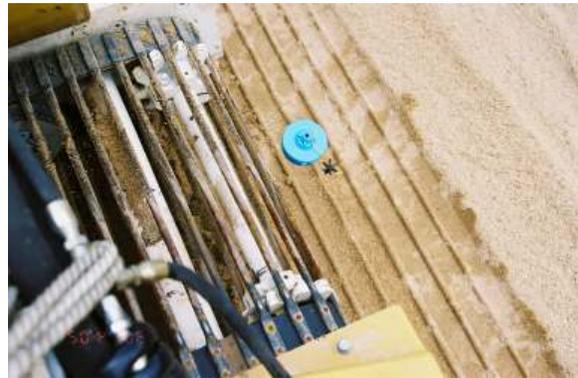
In four instances, the smaller targets (one PMN, two MK2, and one Type 72) slipped between the main sifting web and the cross conveyor. These targets were either caught underneath the main web or fell back onto the sifted ground underneath the HLS. If these were live mines, additional problems could have occurred. First, the sifted soil could have contained live mines. Second, the probability of some mines detonating could be increased due to the mines being battered as they continued to bounce in the sifting web instead of clearing the sifter.

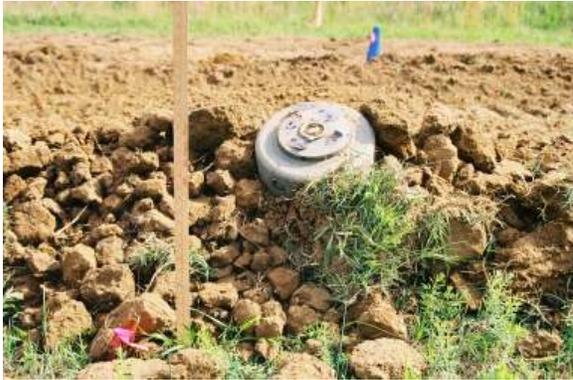
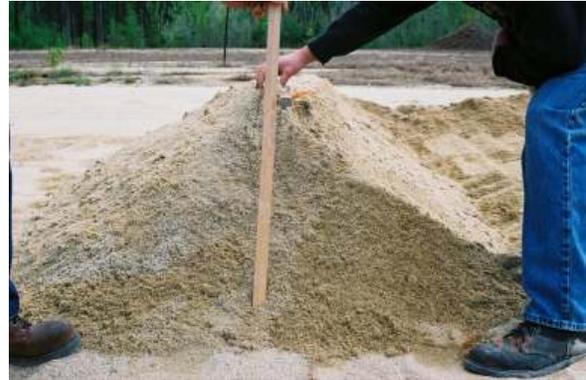
In both heavy and light clay soils, the HLS left large windrows, where the targets were either partially or totally reburied under the clumps of soil. For actual demining operations, another mechanical system or deminers with metal detectors will have to follow the HLS to find and remove these reburied targets from the berms. In all soil conditions, a soil bow wave formed on the front scoop during operations through which mines entering the sifter had to pass. When the dirt bow wave was removed from the sifter at the end of each lane, an end-berm was formed. Since the end berm could also contain mines, it also must be treated mechanically or by deminers with metal detectors to removes any remaining mines.

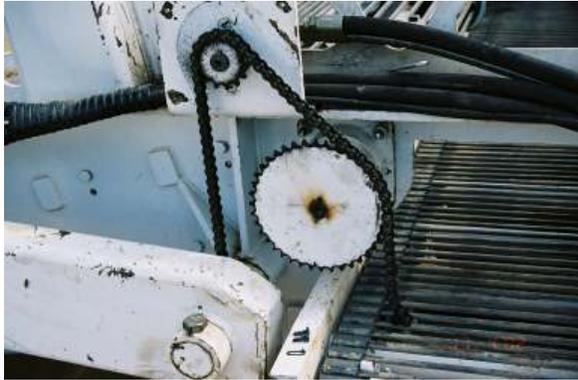
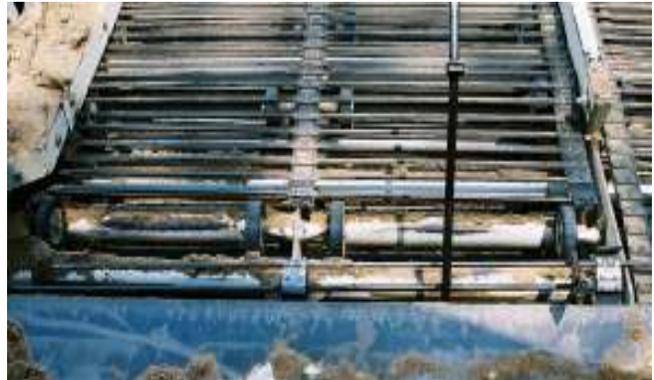
The only damage to the HLS that required major repair occurred at the beginning of the test period, during the start of the second run. The left sprocket chain and the right main sifting web broke. The repair took about half a day once the parts arrived. The HLS performed well for the rest of the testing period.
