# Performance Evaluation Test of the Nemesis M3

**September 2008**

Prepared by  
Institute for Defense Analyses  
4850 Mark Center Drive  
Alexandria, VA 22311-1882

**Humanitarian Demining Program**  
Night Vision and Electronic Sensors Directorate  
Attn: AMSRD-CER-NV-CM-HD  
10221 Burbeck Road  
Fort Belvoir, VA 22060

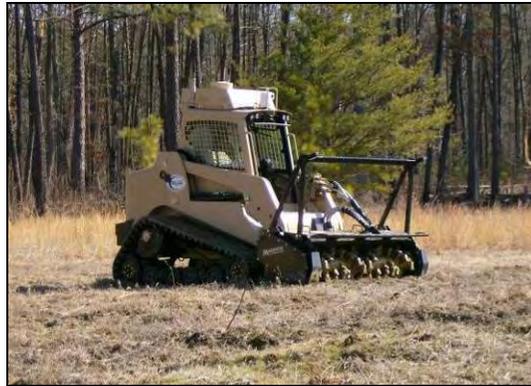
The Nemesis tracked vehicle (Figure 1) was assembled by Applied Research Associates, Inc., on an ASV SR-80 vehicle. It can operate a suite of area-preparation tools. The Nemesis hydraulic track-laying drive system gives the operator the ability to maneuver in all types of terrain, as well as perform 180-degree turns within its own length. Table 1 lists the Nemesis specifications.

Figure 1: Nemesis with Vegetation Cutter Attachment

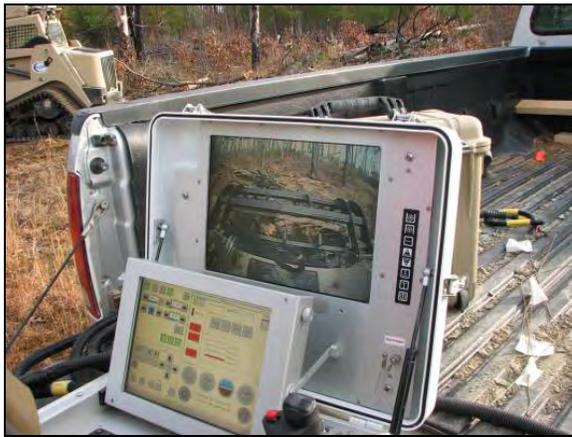
The Nemesis, which can also be controlled by an on-board operator, is fitted with the Modular Robotic Control System (MRCs), a remote-control system manufactured by Applied Research Associates, Inc. This system can provide up to 1.5 km line-of-sight control with video and up to 2.4 km without video. The remote system consists of a receiver antenna, a remote operator control unit, a battery, and the transmit antennas and cameras mounted on the Nemesis vehicle. The operator control unit gives remote operators the ability to fix vehicle speed, maneuver and perform operations with attachments, and view operations from a selection of four cameras (to include a pan/tilt camera that can be slewed by the operator to any desired forward-looking location) through the use of touch-screen and joystick controls (expandable up to eight cameras). In addition, the remote system is equipped with Global Positioning System (GPS) receiver to provide tracking, track mapping, and a record of the vehicle's current location. Figures 2–5 give images of the remote system components, and Table 2 lists specifications of the radio control system.

**Figure 2: Remote Operator Control Unit with Battery Box**

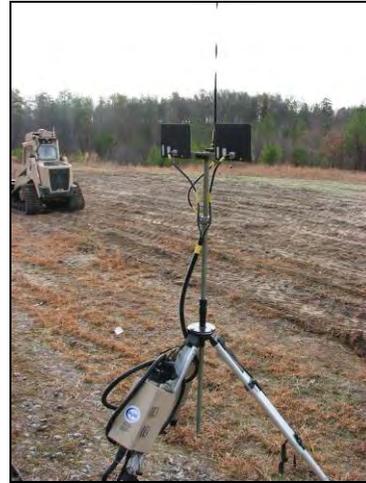
**Figure 3: Remote Transmit/Receiver Antenna**

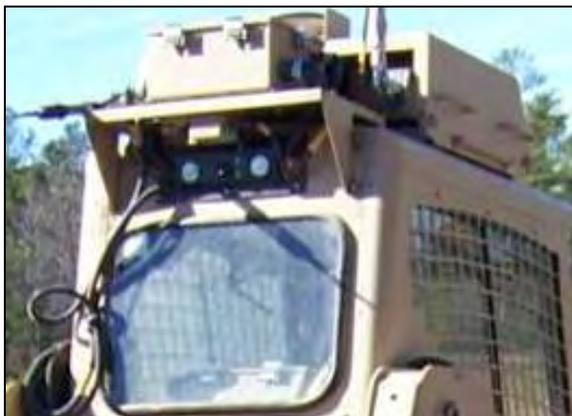
**Figure 4: Vehicle-Mounted Remote Transmit/Receive Antennas and Electronics Box**

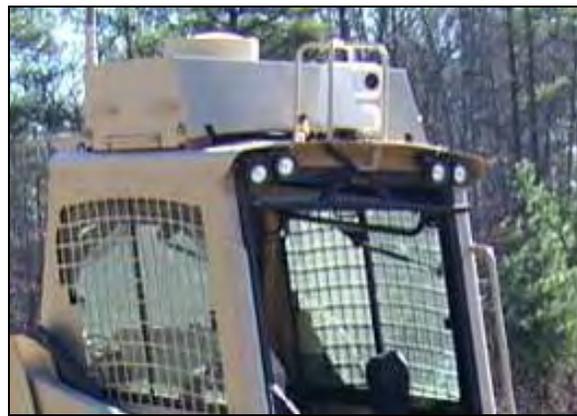
**Figure 5: Vehicle-Mounted Pan/Tilt Camera**

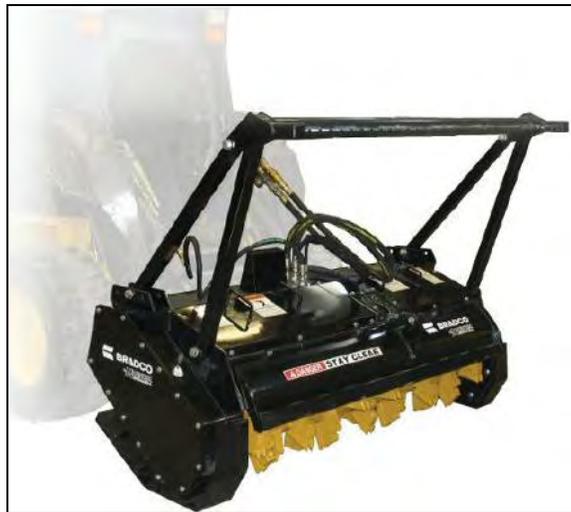
The set of attachments for Nemesis currently contains four skid-steer tools: a mulcher, grapple bucket, 4-in-1 bucket, and a cold asphalt planer. The primary tool is the heavy-duty Bradco Mini-Mag Mulcher brush cutter, capable of cutting heavy undergrowth and trees up to 20 cm (8 inches) in diameter. Figure 6 shows the mulcher, with specifications given in Table 3.

**Figure 6: Bradco Mini-Mag Mulcher XL 165-6**

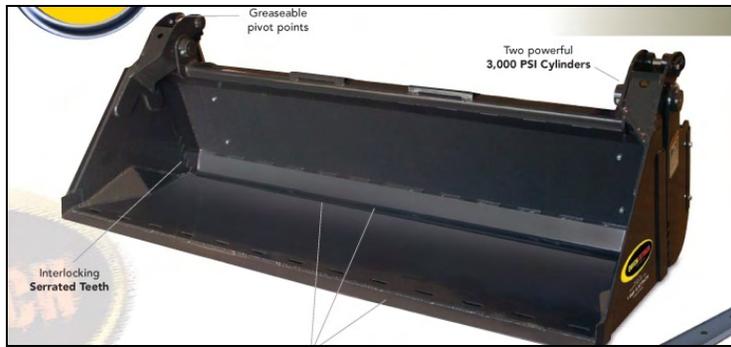
The 4-in-1 bucket (the Quick Combo Bucket; see Figure 7) and the Eagle Talon grapple (see Figure 8), both built by Quick Attach Attachments, Inc., are used to clear areas where vegetation has been cut or stockpiled. The 4-in-1 bucket can be used as a shovel or scoop to pick up and move debris or as a plow/light grapple to push debris into berms for later disposal. The grapple is ideal for lifting large, heavy items (rocks, logs, etc.) and moving them to nearby locations. Specifications for both attachments can be found in Tables 4 and 5.

**Figure 7: Quick Combo, 4-in-1 Bucket**

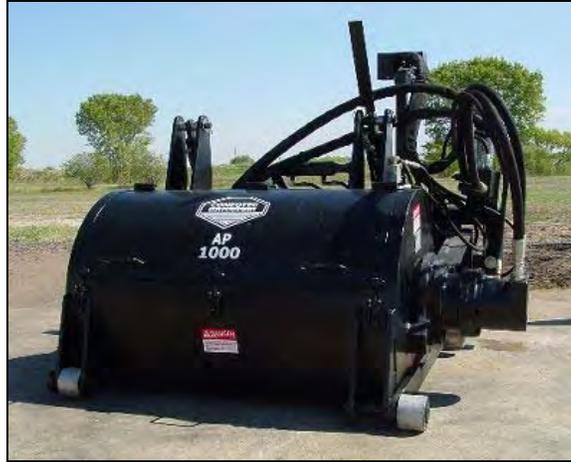
Adding the Coneqtec Corp. pavement planer to the Nemesis attachments tool box gave another dimension to the test program; namely, the ability to remotely control the tool versus the performance of the tool. In normal pavement planer operations, the cold planer is able to remove pavement to a depth of 15 cm (6 in.). Given this and the design of the planer, which is not unlike that of a very robust tiller, it was considered an ideal off-the-shelf tool for removal (including neutralization) of antipersonnel land mines and possibly for quality-assurance operations. Figure 9 shows the pavement planer, and specifications are given in Table 6.

**Figure 9: Cold Planer**

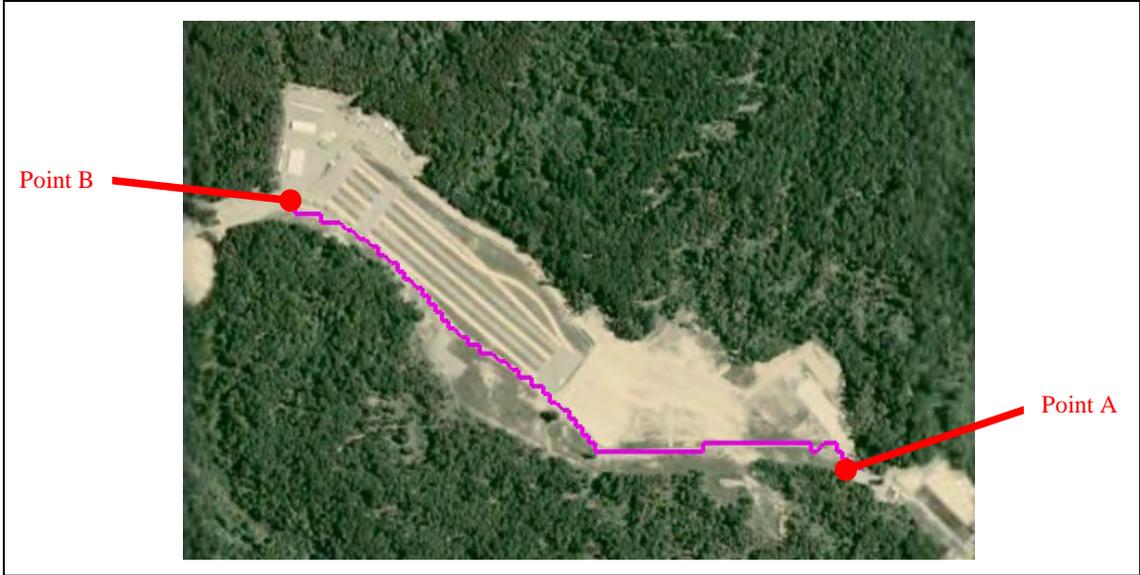
Test Site A contains well-maintained gravel roads that were used to determine operational distances achieved by the remotely operated Nemesis in clear, line-of-sight and obstructed, non-line-of-sight situations. For non-line-of-sight testing, obstructions included hills, trees, and other vegetation. Figures 10 and 11 show aerial images of the gravel roads (with the roads highlighted in yellow).

Figure 10: Test Site A, Line-of-Site Test Road

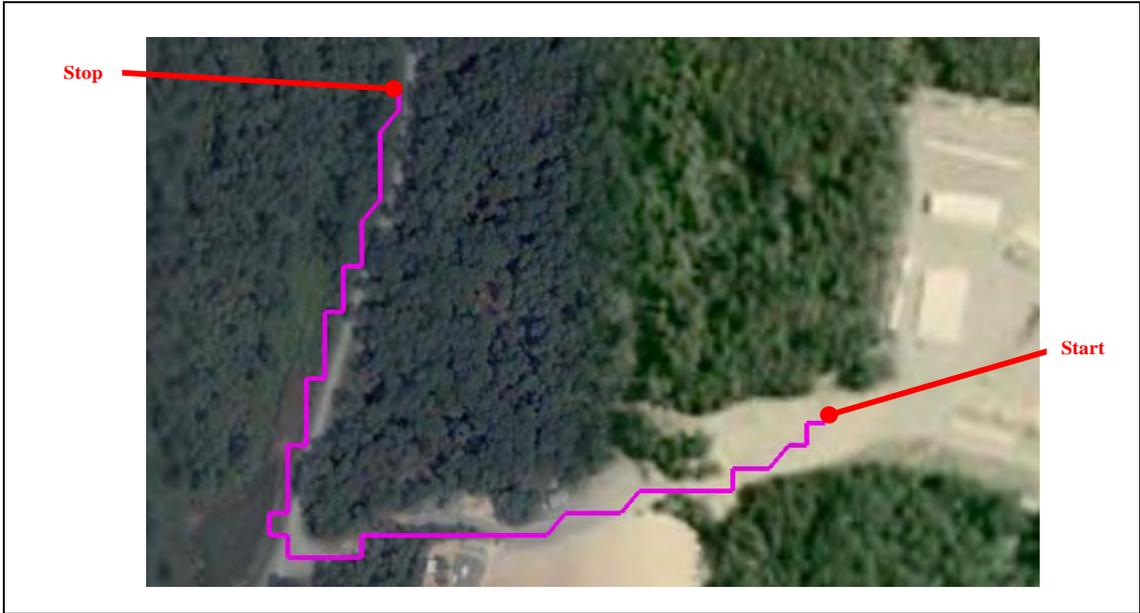
Figure 11: Test Site A, Non-Line-of-Site Test Road

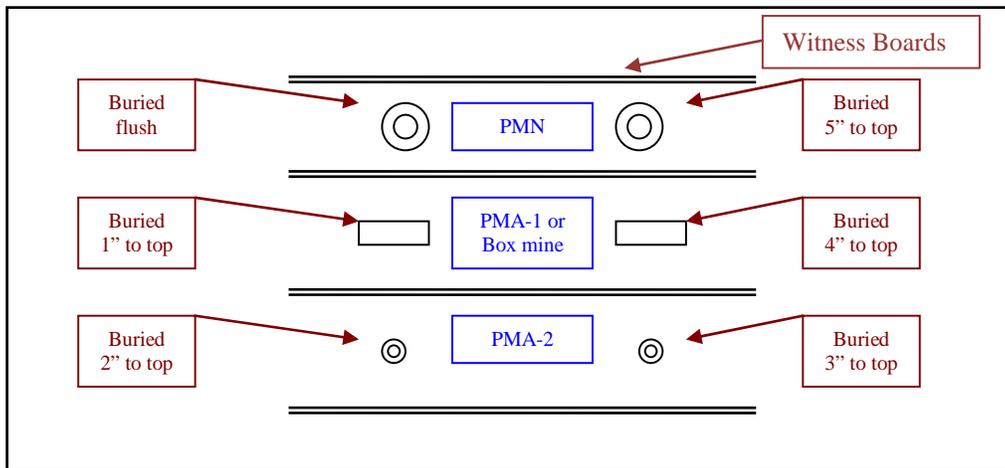
Figure 16 shows Test Site C, an area of little to no vegetation consisting of a clay and loam mix soil. Due to rain in the weeks prior to testing, the ground was relatively soft. Because this area was designated for planer testing, six antipersonnel mine simulants were buried at various depths, together with four 8 ft (length) × 1 ft (width) fiber witness boards. Figure 17 is a plan view of the layout. Use of the mines and boards during testing will be described in Section 5.6.

**Figure 17: Test Site C, Mine Simulant and Witness Board Layout, Plan View**

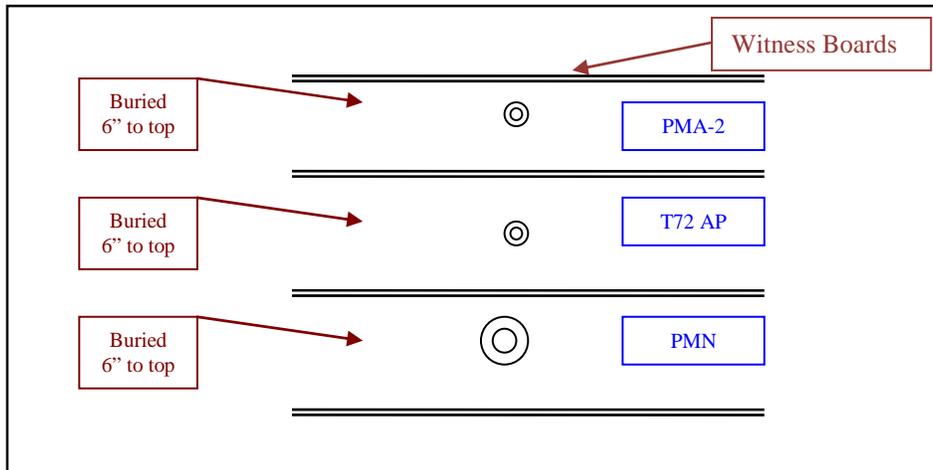
Test Site D was used for additional testing of the cold planer. The soil in Test Site D is a sandy loam consisting of a low, thick, grass-like vegetation with a heavy root system (see Figure 18). Like Test Site C, mine simulants and fiber boards were buried within the test area for the cold planer testing. Figure 19 is a plan view of the mine and board layout.

**Figure 19: Test Site D, Mine Simulant and Witness Board Layout, Plan View**

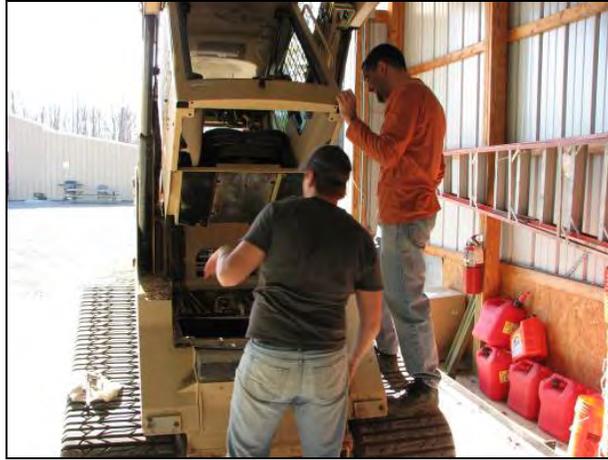
All maintenance and inspections, except those items requiring under-the-cab investigation, can be performed by a single trained person in less than 2 hours. For under-the-cab inspections, three persons are recommended to lift and lock the cab in its raised position (see Figure 21). Tools needed to perform maintenance inspections will be provided with the Nemesis.

**Figure 21: Cab Raised for Maintenance Inspection**

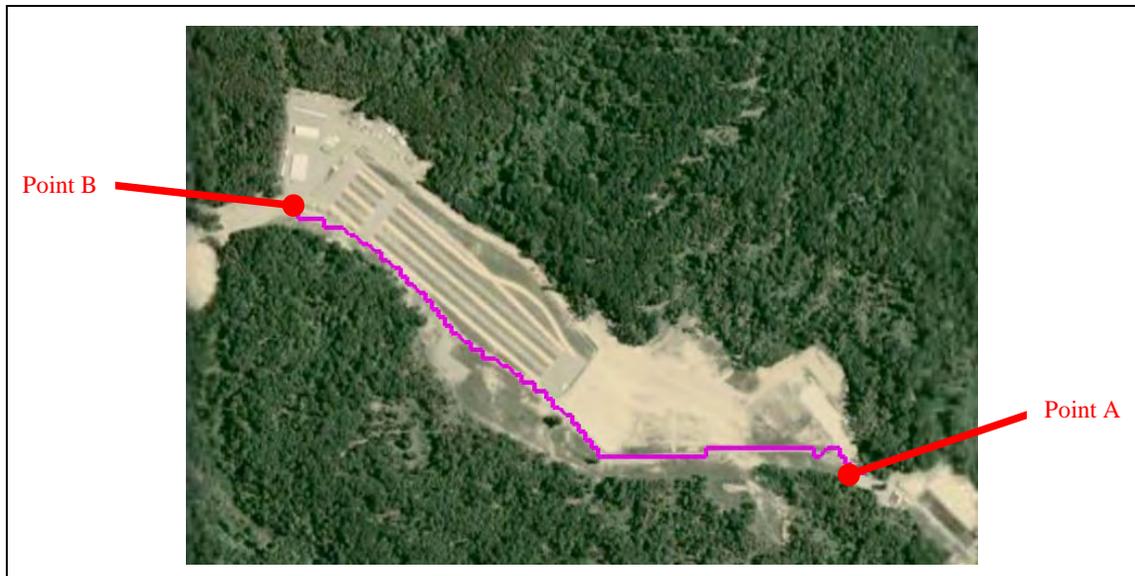
During the line-of-site test, the Nemesis passed by three GPS monuments located within the test site compound. Since a mapping of the vehicle's path and its current GPS locations are viewable on the operator control unit, the GPS monuments located within the test site were used to verify the accuracy of the system's GPS (latitude-longitude in degrees, elevation in meters). For each monument within the test site, the operator stopped the vehicle next to the monument location and the corresponding GPS coordinates were compared. In each case, the GPS coordinates of the remote guidance unit were identical to those of the GPS monuments.

Figure 22: Line-of-Site Test Route

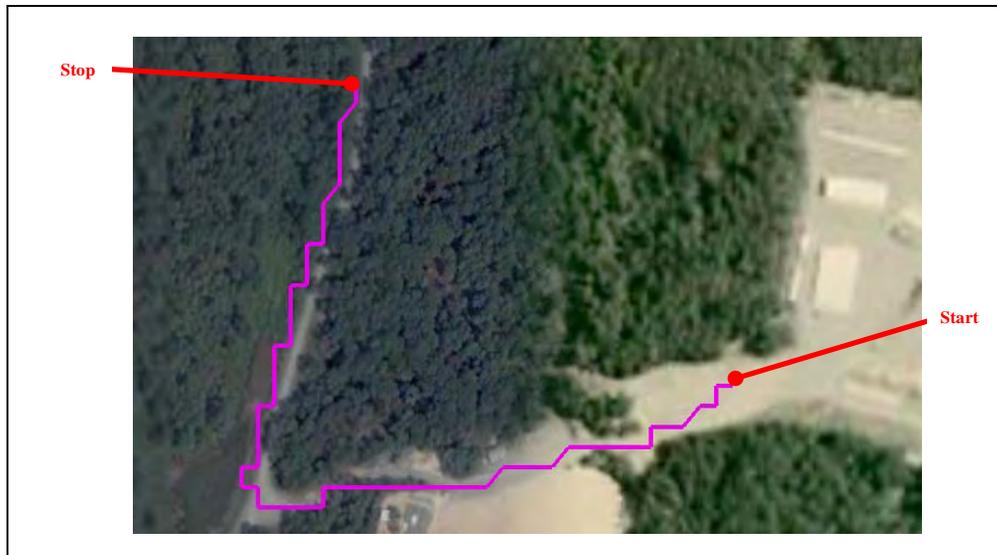
The test was conducted in an area with hills, trees, and other vegetation acting as line-of-sight obstructions. The remote operator maintained complete control of the Nemesis for a travel path of approximately 0.45 km, at which time the video feed began to skip and delay. The operator continued movement along the road until a total loss of video feed occurred. Although the video transmission ceased, the operator maintained control of the vehicle. (Nevertheless, in any situations in which the vehicle is beyond the operator's line of sight, it is recommended that operations stop once video feedback is lost.) The total path traversed was approximately 0.55 km, a straight-line distance of approximately 0.25 km. Figure 23 shows the non-line-of-site path.

Figure 23: Non-Line-of-Site Test Route

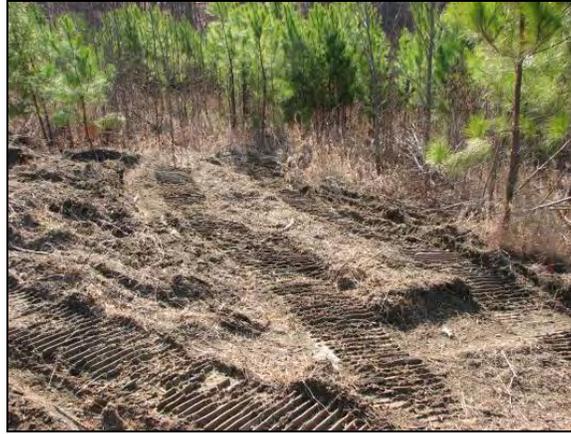
Remote vegetation-cutting operations were performed using the Mini-Mag Mulcher attached to the Nemesis front arms. The test began with Category 1 vegetation cutting in Test Site B. The Category 1 vegetation test area covered, on average, a 7-degree slope, with slopes reaching 12.8 degrees at one end of the test area. When cutting on a slope, it was observed that the cutter tended to cut into the soil since it was not able to remain perfectly parallel to the ground (see Figure 24). On a few occasions, the tilled dirt formed mounds that were high enough to slow the Nemesis's forward movement. In one instance, the flat underbelly of the Nemesis plowed enough soft dirt and cut vegetation under the vehicle to lift the tracks off the ground and stop its motion. The vehicle had to be backed off the dirt and vegetation mound, and the mound had to be further mulched by the cutter to sufficiently level the ground for forward movement. These mounds, and the effects they had on vehicle travel, were not always visible with the onboard camera system. In those cases, the remote operator had to reposition himself to get a line-of-sight view of the Nemesis to determine what was slowing the vehicle.

**Figure 24: Vegetation/Dirt Mounds Created During Mulching Operations**

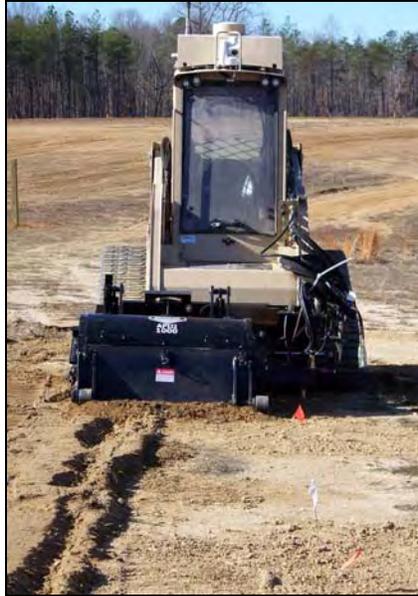
The cold planer is a 101.6 cm wide off-the-shelf asphalt planer that has potential for the removal or neutralization of small antipersonnel mines. Because the cutting width of the planer is less than the width of the Nemesis, the planer’s attached position relative to the vehicle will be offset to the right to cover the path of the right track (see Figure 39). This will ensure that the planer will engage threats before that side’s track overpasses them. The exposed left track will always operate in an area already cleared of mines to maintain its safety.

**Figure 39: Cold Planer Attached to Nemesis**

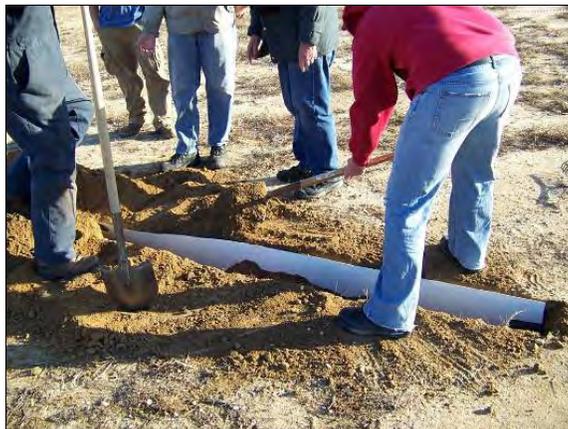
The cold planer was tested in Test Site C and Test Site D. For both tests, antipersonnel mine simulants were buried at various depths to assess the planer's ability to remove and possibly neutralize small mine threats. In addition, at each site, four 8 ft × 1 ft fiber boards were buried on edge, flush to the surface, at a distance of 5 m apart, to determine the depth reached by the planer during normal operations (see Figure 40). (See Figures 17 and 19 for images of the surrogate mine and fiber board layout.)

**Figure 40: Fiber Board Emplacement, Test Site C**

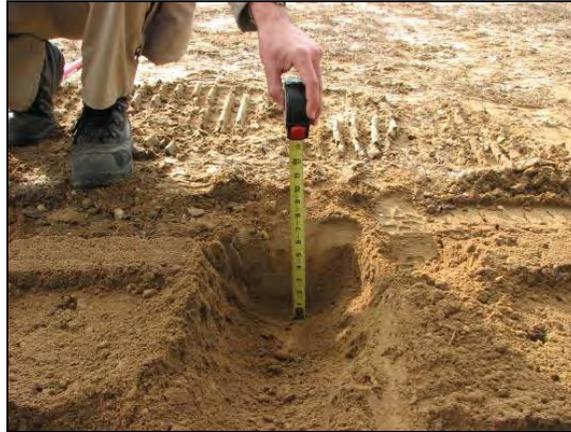
Before remote operations, the planer was manually operated within Test Site C. The purpose of this manual operation was to determine the ground-to-planer height that should be maintained for planing operations. During this test, it was observed that the weight of the planer caused the vehicle to rock while operating, stop abruptly when attempting to brake, and tilt forward when the planer was lifted off the ground. Also, due to the skewed location of the planer in relation to the Nemesis, the vehicle tended to drift to the right when forward operations straight ahead were attempted. The planer was able to penetrate 6 inches into the ground (see Figure 41), although buildup inside and in front

**Figure 41: Penetration Depth of Planer in Manual Operations**

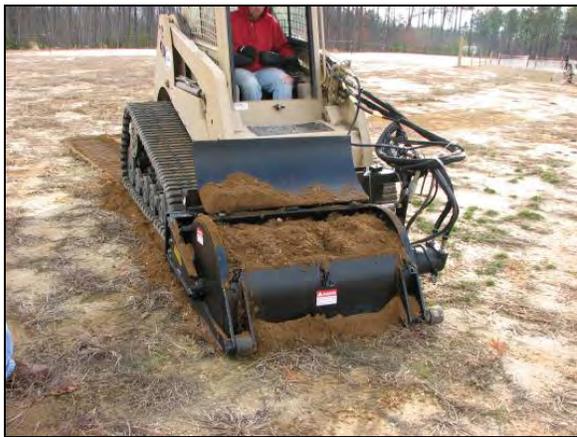
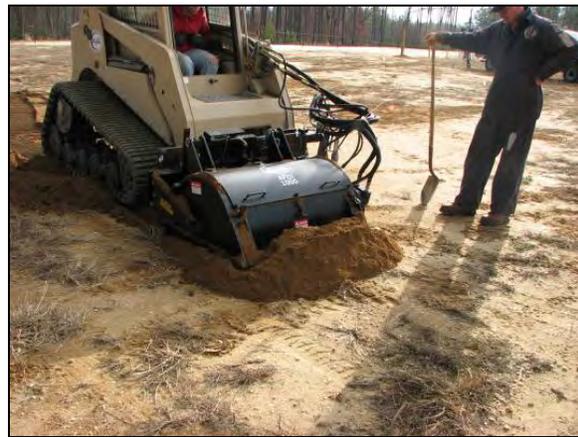
of the planer caused the vehicle's forward movement to slow or stop on many occasions. Figures 42 and 43 show dirt buildup inside and in front of the planer.

**Figure 42: Dirt Buildup Inside Planer**

**Figure 43: Dirt Buildup in front of Planer**

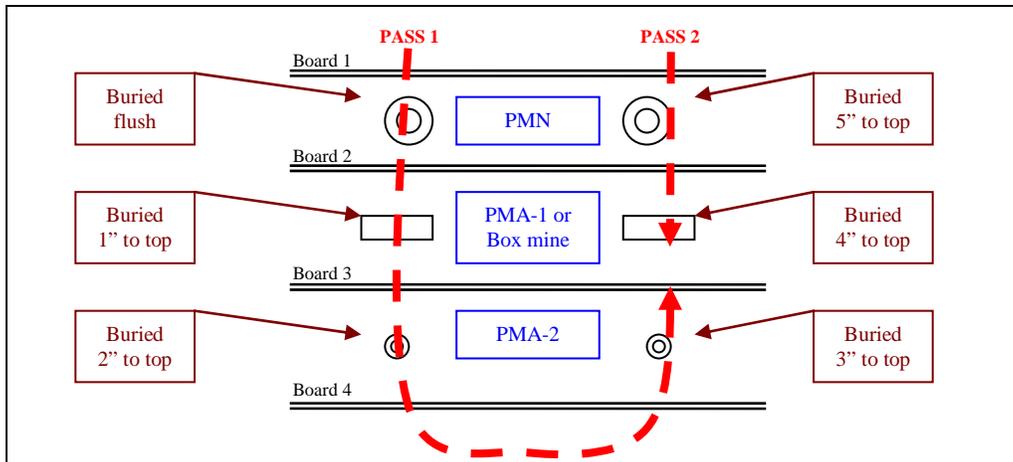
The first remote operation performance test of the Planer occurred at Test Site C. As described in Section 3.3, Test Site C consists of flat ground with clay and loam mixed soil and spotty amounts of low vegetation (e.g., grass, shallow roots). Simulated mines and 8 ft × 1 ft fiber witness boards were buried according to the layout in Figure 44. The dotted line represents the path forward by the Nemesis.

**Figure 44: Test Site C, Vehicle Path**

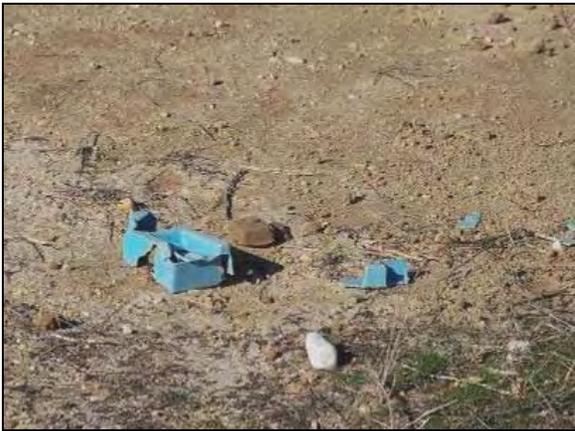
**Figure 45: Box Mine Broken in Pieces by Planer, Test Site C (Pieces Recovered by Test Personnel)**

<b>Simulated Mine Description</b>	<b>Outcome</b>
PMN, buried flush to surface	Planer flipped mine over, but mine remained intact
Box mine, buried 1 in. to the top of the mine	Mine broken into pieces by the planer
PMA-2, buried 2 in. to the top of the mine	Mine broken into pieces by the planer
PMA-2, buried 3 in. to the top of the mine	Mine broken into pieces by the planer
Box mine, buried 4 in. to the top of the mine	Mine untouched
PMN, buried 5 in. to the top of the mine	Mine untouched

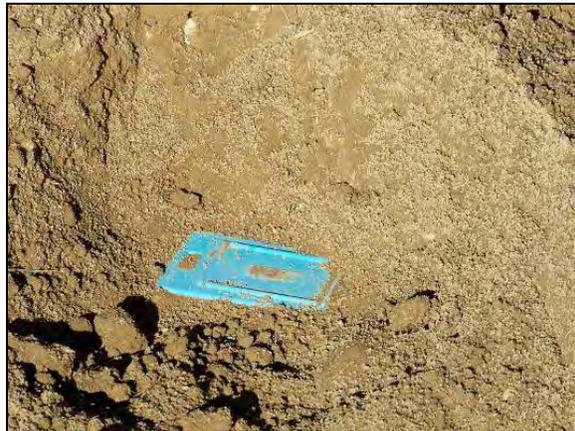
**Figure 46: Box Mine Untouched by Planer, Test Site C (Uncovered by Personnel for Photo)**

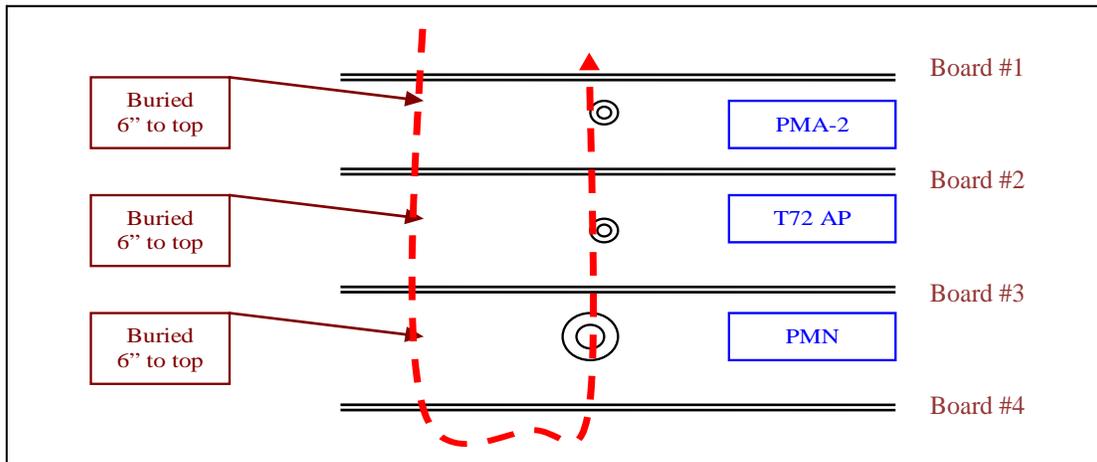
The second performance evaluation for the remotely operated planer occurred at Test Site D. As mentioned earlier, surrogate mines and fiber boards were buried there. Figure 51 shows the vehicle's path. The major difference between this planer test and the previous test is the abundance of low vegetation and the density of the root systems present in Test Site D (see Figure 52).

**Figure 51: Test Site D, Vehicle Path**

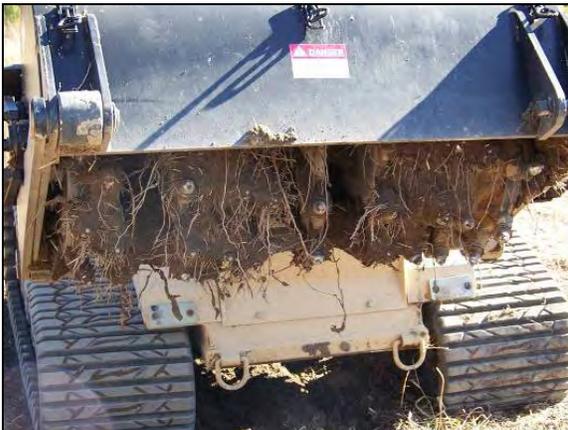
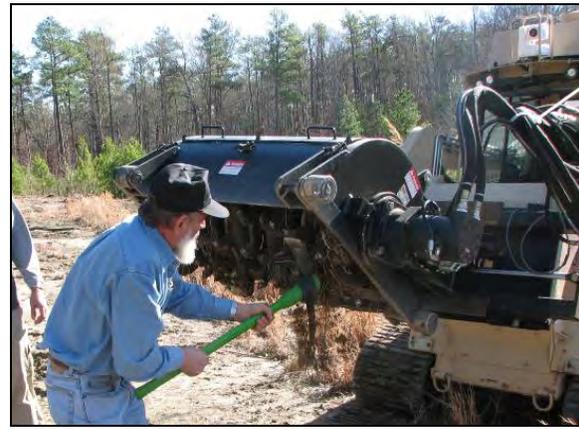
The vegetation present in Test Site D posed new challenges for the planer. Whereas in Test Site C the dirt accumulated within and in front of the planer, at Test Site D the density of the root systems and the moisture retained in the soil by the vegetation caused the dirt to pack in between the planer cutting tillers. Compounding this, the cutting tiller disks are canted to the mounting shaft to provide maximum coverage of the cutting teeth, but the variable separation between the tiller disks became traps for the roots and soil. This collection of dirt and roots was hard enough to require the use of picks and shovels for removal (see Figures 53 and 54).

**Figure 53: Dirt and Vegetation Accumulation Inside Planer**

**Figure 54: Removal of Dirt and Vegetation Accumulation**

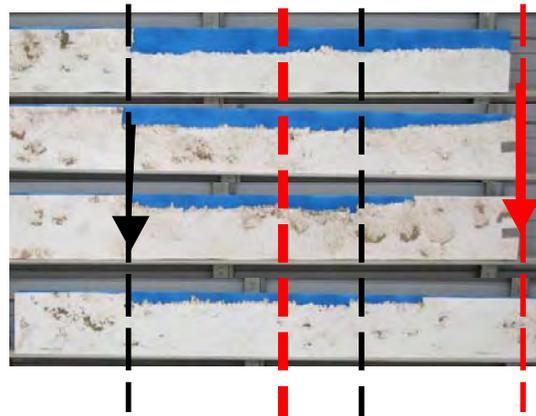
Fiber Board Description	Outcome
Board #1	4.5 in. depth cut by planer
Board #2	3.5 in. depth cut by planer
Board #3	1.5 in. – 2.75 in. bowed cut by planer
Board #4	1.75 in. depth cut by planer

**Figure 55: Witness Boards Test Site D**

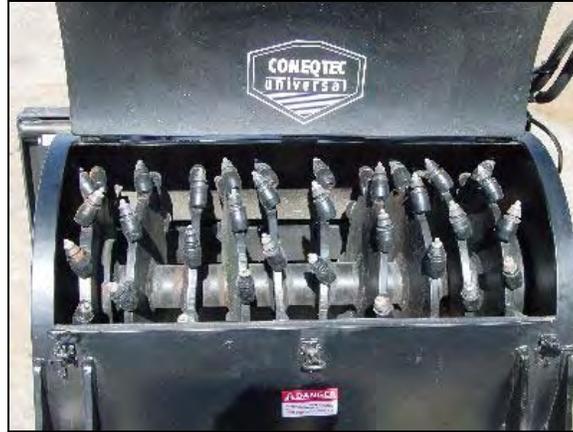
Although the planer was clogged with soil at both test sites, it was slowed less while remotely operated than while manually operated. The remote system allows the Nemesis to maintain a constant forward speed and a maximum speed limit. For example, in “slow-ops” mode, a forward speed down to 0.3 kph can be maintained. During this test, the optimum speed for the cold planer was 0.4 kph. In Test Site D, where more vegetation and root systems were present, the clogging problems limited the use of the planer. A manufacturer’s representative recommended that the cold planer be reengineered to incorporate straight-mounted tiller disks, as opposed to the canted disk installation (see Figure 56), to eliminate some of the dirt collection problems faced during operation. This dirt and vegetation accumulation not only slows operations, but could potentially present a danger to personnel clearing the dirt out of the tiller head if a mine became lodged inside the clogged dirt.

**Figure 56: Angled Digging Tooth Plates in Planer**

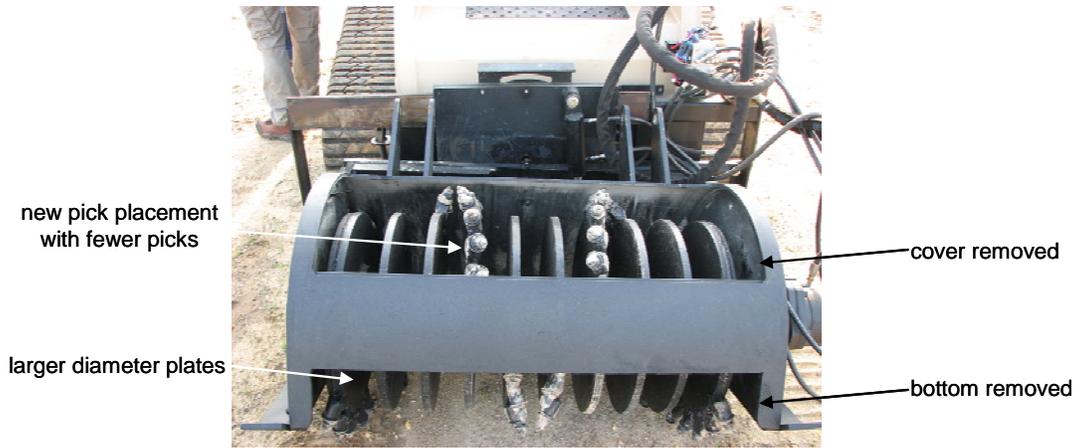
The new perpendicular plate orientation and the removal of the cover and front and rear shield help reduce the dirt buildup in the drum and the clogging of material between the plates. However, the drum will have to be returned to its original “undercut” direction in order to help maintain a consistent depth into the ground. The motor will have to be replaced again with one that can provide a higher RPM in order to create a consistent cut and facilitate destruction of mines, preventing them from potentially being

**Figure 57: Test 2 Configuration, Cover Removed, Planer Disks Perpendicular to Shaft**

The modifications made to the cold planer helped reduce the amount of dirt buildup in the drum and behind the attach plate. However, the performance overall decreased as can be seen on the witness boards. The cuts made were not as clean as before and they are still not consistent across the boards. The change from an undercut to an overcut resulted in the planer stalling frequently and bouncing off of the ground. The undercut configuration helped keep the planer in contact with the ground, where the overcut caused the planer to jump off of the ground when the teeth first try to cut into the surface. The new motor spun the drum at a slower RPM causing the planer to push mines rather than destroy them. This can also be seen on the witness boards and explain why the cuts were not as clean. When the picks contacted the witness boards at the slower RPM, the tendency was to push on the board until it cracked rather than cleanly cut through them.

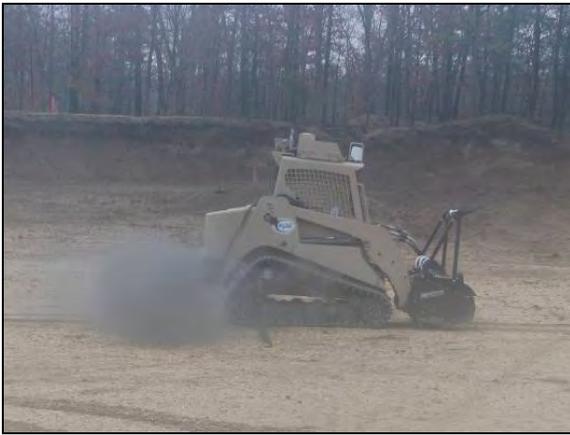
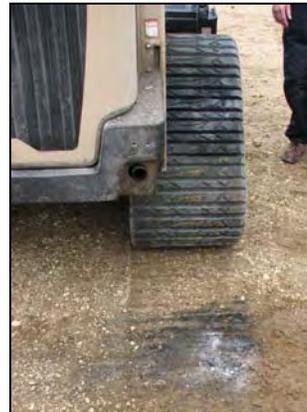
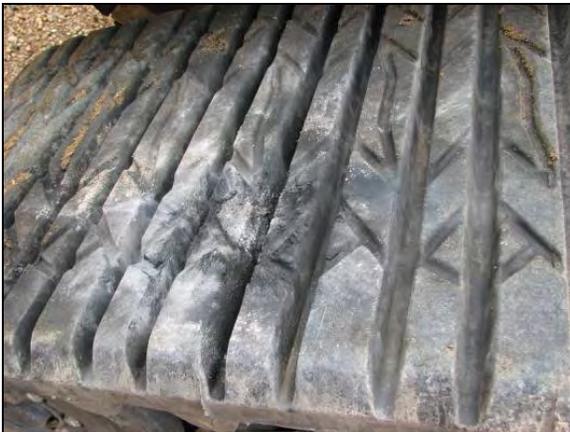
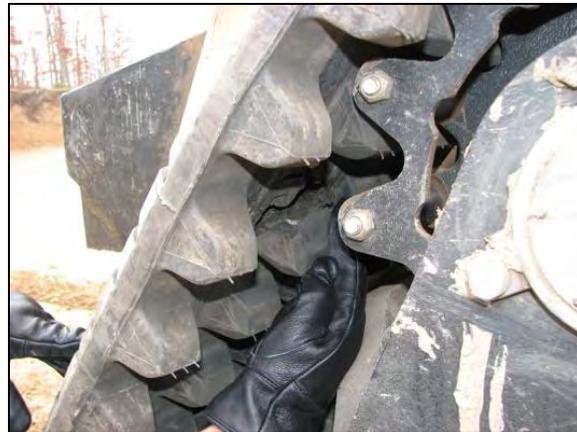
The first mine to be used for testing was Mine A, a small, round antipersonnel mine. Inspection of the vehicle after the blast showed damage to both the exterior and interior of the rubber track (see Figures 62–65). Exterior damage was limited to surface scarring, whereas interior damage resulted in a deep crack in one of the belt’s drive cogs. In addition to the track damage, the drive system encoder, which is located at the rear inside the loop of the track, sustained some damage. As a result of the damage, the vehicle veered slightly left during straight drives.

**Figure 62: Mine A Blast**

**Figure 63: Vehicle after Mine A Blast**

**Figure 64: Damage to Track Exterior, Mine A**

**Figure 65: Damage to Track Interior, Mine A**

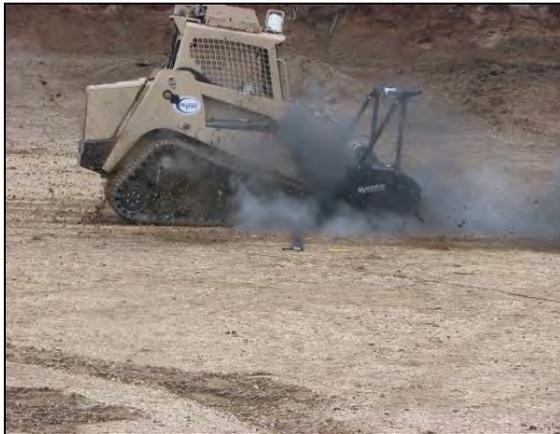
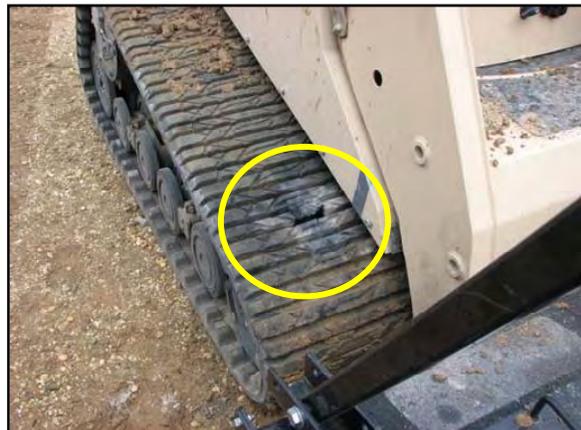
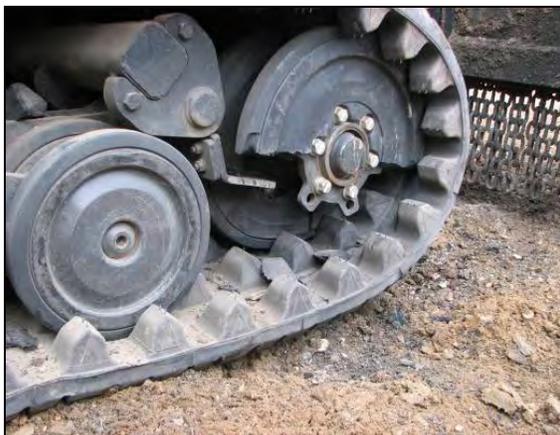
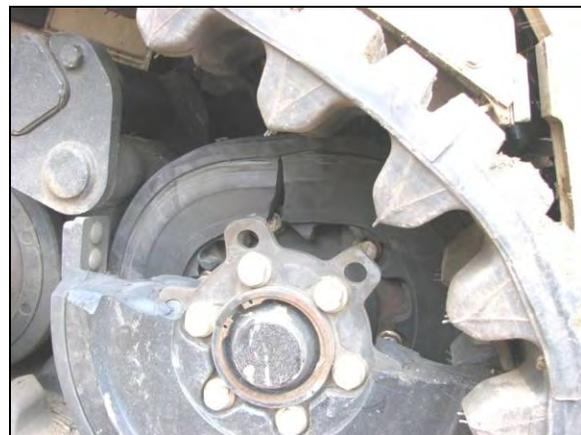
The last mine tested, Mine C, had the largest explosive (TNT) content of the three mines tested. The blast from this mine damaged both the exterior and interior of the rubber track, as well as two of the graphite composite wheels inside the track. Although the damage was more severe than the damage sustained from Mine A, the vehicle was still able to function and could safely move both forward and backward after the blast. In fact, the Nemesis traveled approximately 200 m from the blast test site to a maintenance garage. Figures 66–69 are images of the blast and damage incurred from Mine C.

**Figure 66: Mine C Blast**

**Figure 67: Damage to Track Exterior, Mine C**

**Figure 68: Damage to Outer Wheel, Mine C**

**Figure 69: Damage to Outer and Inner Wheel, Mine C**

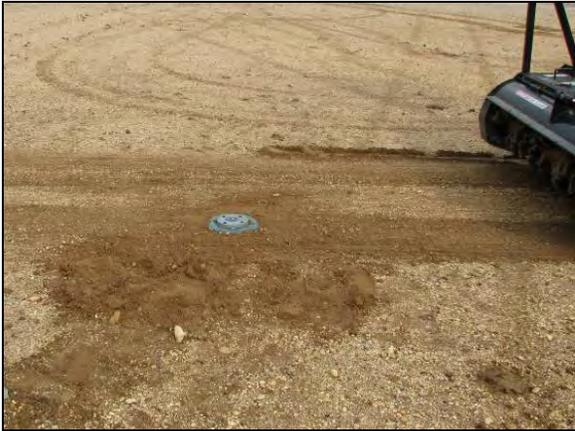
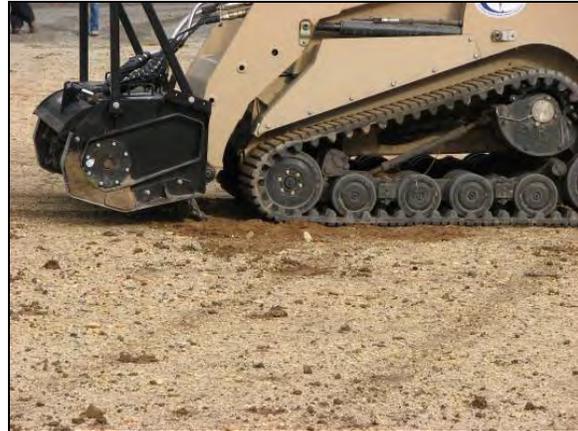
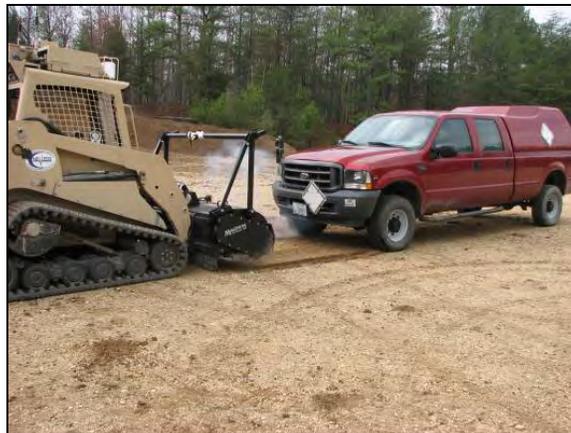
To perform the test, the smoke-fused antitank mine was buried flush to the ground's surface, as shown in Figure 69. The Nemesis was remotely driven over the mine without activating the fuse (Figure 70). The Nemesis then backed over the mine, again without setting the mine off. The mine was lifted and reburied with the fuse at one inch above the ground. The Nemesis again drove over the mine without detonating the fuse. To ensure the fuse was functioning properly and that the Nemesis had indeed demonstrated an overpass capability, test personnel drove a pickup truck over the mine. This set off the smoke fuse (see Figure 71), thus verifying that the Nemesis has a potential antitank mine overpass capability.

**Figure 70: Emplaced Smoke-Fused Antitank Mine**

**Figure 71: Nemesis, Driving Over Smoke-Fused Antitank Mine**

**Figure 72: Pickup Truck Detonating Smoke-Fused Mine**
