Performance Evaluation Test of the Peco Tracked Brush Blazer

January 2008

Prepared by
Institute for Defense Analyses
4850 Mark Center Drive
Alexandria, VA 22311-1882

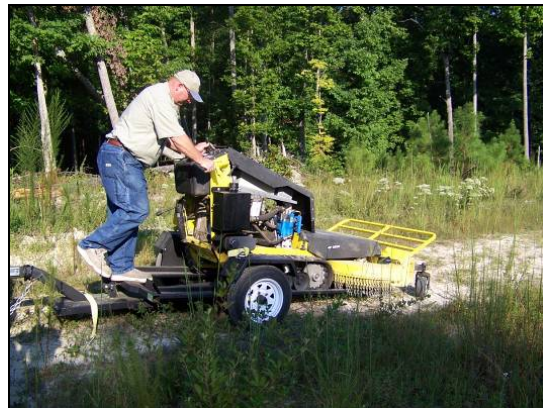
Manual operation of the Peco Cutter is necessary when loading and off-loading it from its travel trailer, as shown in Figure 15 and 16. Modifications to the Peco Cutter’s manual driving mechanism include the addition of a driving joystick to make it possible for any operator to control movement of the Peco Cutter. Throughout the test, manual operators were able to successfully load (and off-load) the Peco Cutter in less than 1 minute.

Figure 15: Off-Loading Peco Cutter

Figure 16: Loading Peco Cutter onto Trailer

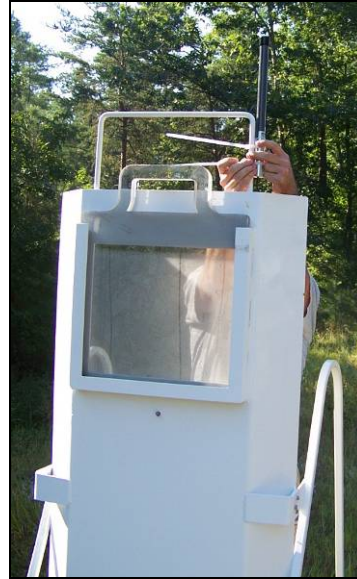
Figure 25: Mounting Remote Antenna to Operator Shield

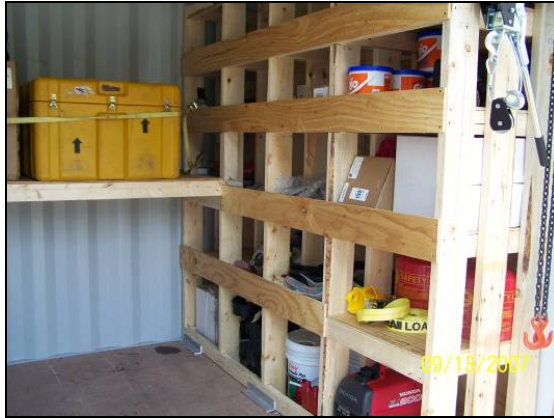
Spare parts are placed in bins within the container (Figure 35). The bins are labeled to assist operators and other personnel. Spare parts include tools, belts, tracks, circuit boards, electronic interfaces, cutting blades, and many other items necessary to

Figure 35: View of Inside Shipping Container
