# **TEST REPORT ROTARY MINE COMB**

**Christopher Wanner  
March 2005**

This report documents the field testing of two vehicle-based, mineclearing systems both of which are based on the use of the Rotary Mine Combing Tool (RMCT). The test was designed to expand upon the body of knowledge developed by the maker of the RMCT as well as incorporate performance data related to the implementation of the tool in the two vehicles chosen to host the systems and elements of an operational concept for employment of the systems.

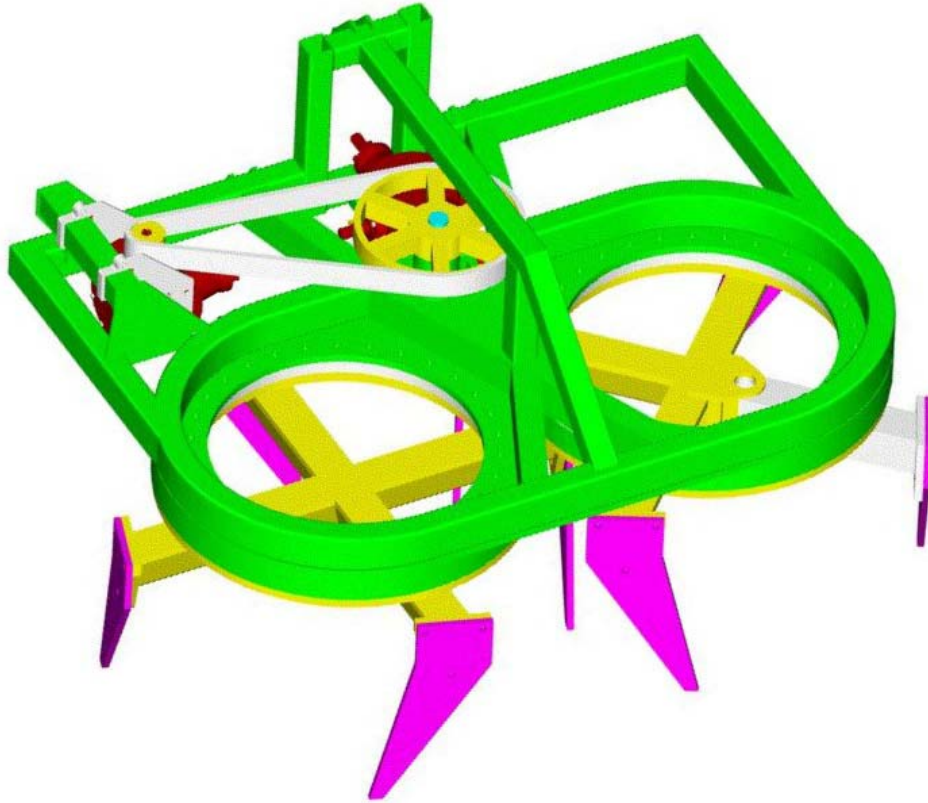
The Rotary Mine Comb is an innovative tool capable of gently extricating buried objects from the soil and pushing them to the side of the path of the host vehicle. The RMCT's two rotors, each containing four soil-engaging tines, intermesh and counter-rotate about the vertical axes as the vehicle travels forward. The tines lift and continuously nudge objects (including mines) above a minimum size from the center line of the host vehicle path to the outside edge. A given object will be nudged dozens of times in small increments as it is worked to the surface and off to the edge of the path. This action clears a mine free path in front of the vehicle without creating a large berm or soil heap. Previous testing has shown that the comb has a remarkable ability to cut through hard packed soils, clay, rocky and vegetated soils.

**Figure 1. Rotary Mine Combing Tool**

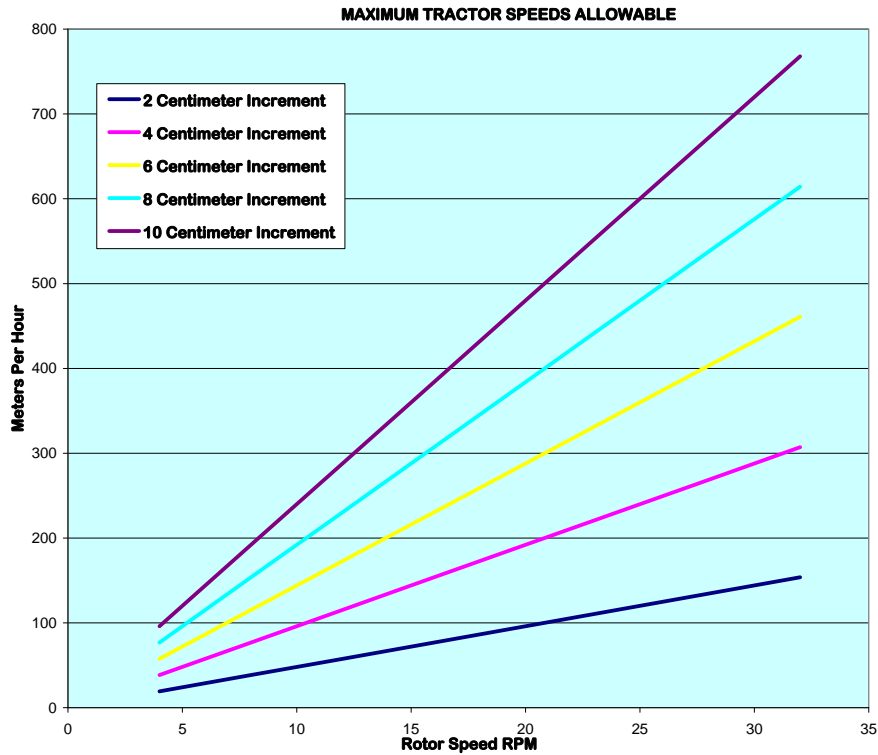
A key parameter in the performance of the tool is the “tine increment”, which is the distance the vehicle travels forward between any two successive passes of the tines. Generally this must be kept small enough to avoid allowing the smallest objects desired to be excavated from slipping through the space between the pass of one tooth and the pass of the next one. As a practical matter it is speculated that keeping the tine increment smaller than  $1/3$  the diameter of the mines being cleared will permit the tines to always engage the mines from the rear. Figure 2 shows the vehicle speed as a function of the chosen rotor speed and chosen tine increment. Because the RMCT requires a reasonably large target to engage as the combing action occurs, it is intended for use in clearing antitank mines and not antipersonnel mines. The weight of the RMCT is 3160 KG, and the combing width is 3.5 meters.

Figure 2. Tractor Speed vs. Rotor Speed at Selected Tine Increments

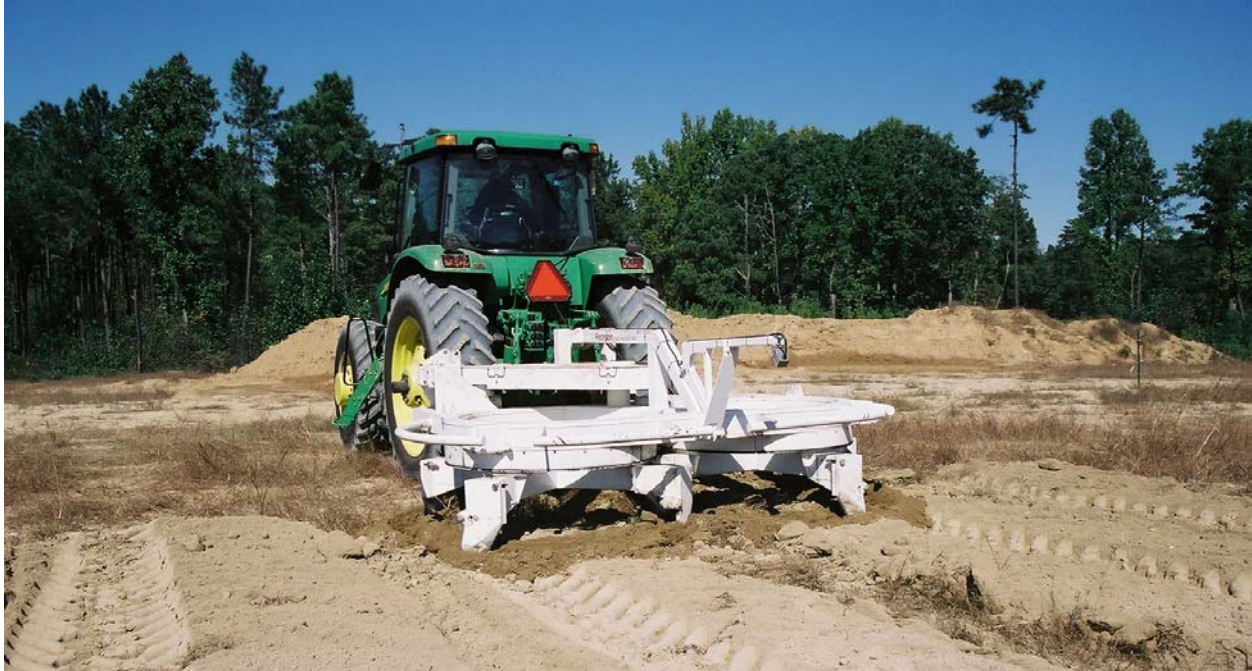
The first vehicle configured is the 115 kW, John Deere 7820 farm tractor. The comb attaches to the standard three point hitch on the rear of the tractor, and no special interface is required. The comb is driven from the standard PTO shaft available on the tractor. The mechanical drive internal to the comb includes both gears and chain drives in series. Two different sized chain drive sprockets and two gear box ratios are provided, which along with the tractor selectable 540 RPM and 1000 RPM PTO drive speeds gives 8 different, full power rotor speeds ranging from 9 to 34 RPM.

**Figure 3. RMCT On Farm Tractor**

The tractor is driven backwards when combing in order to clear the vehicle path. The tractor is equipped with a regulated and infinitely variable mechanical transmission which allows precise setting and control of the vehicle speed independent from the setting and control of the engine speed. This allows the engine to supply high power to the comb drive through the PTO while traveling slowly as required by the “tine increment” considerations. The range of tractor speeds required can be bounded by considering a conservative minimum of one quarter of the diameter of the smallest toe popper mine being combed at the lowest rotor speed available (1.5 cm and 9 RPM respectively). These requirements result in a vehicle speed of 32 meters/hour. The upper bound can be established by considering a risky maximum of one half of the diameter of the largest AT blast mine being combed at the highest rotor speed (16 cm and 34 RPM respectively). These requirements result in a vehicle speed of 1305 meters/hour. Practical considerations and experience with the RMC tool has more narrowly focused vehicle operations in the range from 100 meters/hour to a high of 380 meters/hour for most mines and clearing situations of interest.

Although the comb weight is well within the 6500 KG limit for the three point hitch, its front-to-back length of 2.5 meters places a heavy cantilevered load on the tractor. The manufacturer of the RMCT has equipped the system with skid shoes to provide depth control and lateral stability, and to support the implement weight when combing. The skids however are vulnerable to mine blast and part of the objective of the test was to document how well the operator and system can control the comb without using the skid shoes. As is common in three point hitch configurations, the raising of the hitch is hydraulically driven; however the lowering is driven solely by gravity. Further, the angle the hitch and comb make with respect to the plane of vehicle travel is mechanically fixed. It can be adjusted between passes, but during a combing run, the RMCT

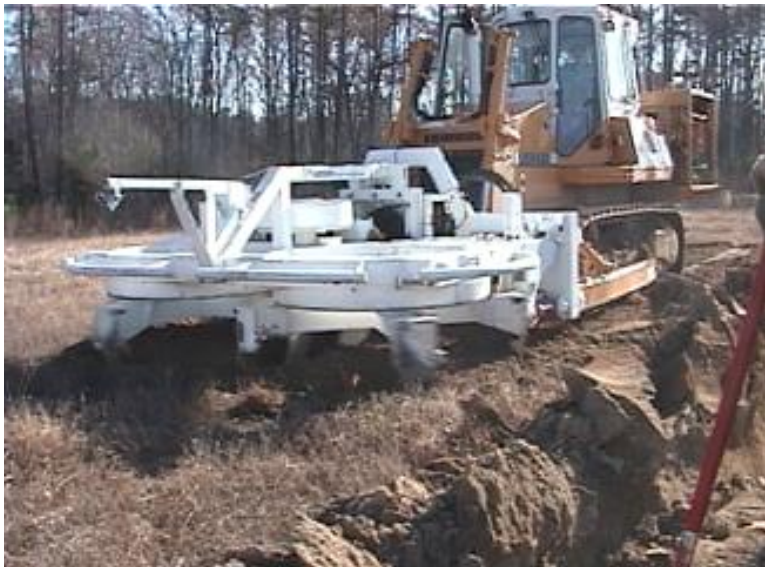
The second vehicle configured is the 77 kW, Liebherr 712 tracked, crawler tractor. The comb attaches to a special mounting built to interface with the standard front dozer blade lifting arrangement. The comb is driven from a hydraulic motor built into the interface. Power for the hydraulic motor is supplied from an 80 kW hydraulic system with a separate diesel engine mounted on the rear of the tractor. Both the hydraulic motor and the supply pump have electrically controlled, continuously variable displacements, giving rotor speed control beyond the ranges of interest discussed above in the farm tractor description. The tractor is equipped with a hydrostatic drive system. This gives the vehicle unregulated but continuously variable speed control, set independently from the vehicle engine throttle. Because the speed is not regulated or monitored, operation at the very low speeds required by the comb does require the constant attention of the operator to keep motion going and controlled. Having the capability to “set and forget” the vehicle speed is a desirable yet unavailable feature of the Liebherr vehicle.

**Figure 4. RMCT on Construction Dozer**

In contrast to the Deere implementation in which the comb floats on the three point hitch, the mechanical interface rigidly fixes the comb to the tractor. The comb is both lifted and driven into the ground hydraulically. In addition, the pitch of the comb relative to the plane of travel is controllable and adjustable by the operator “on the fly”.

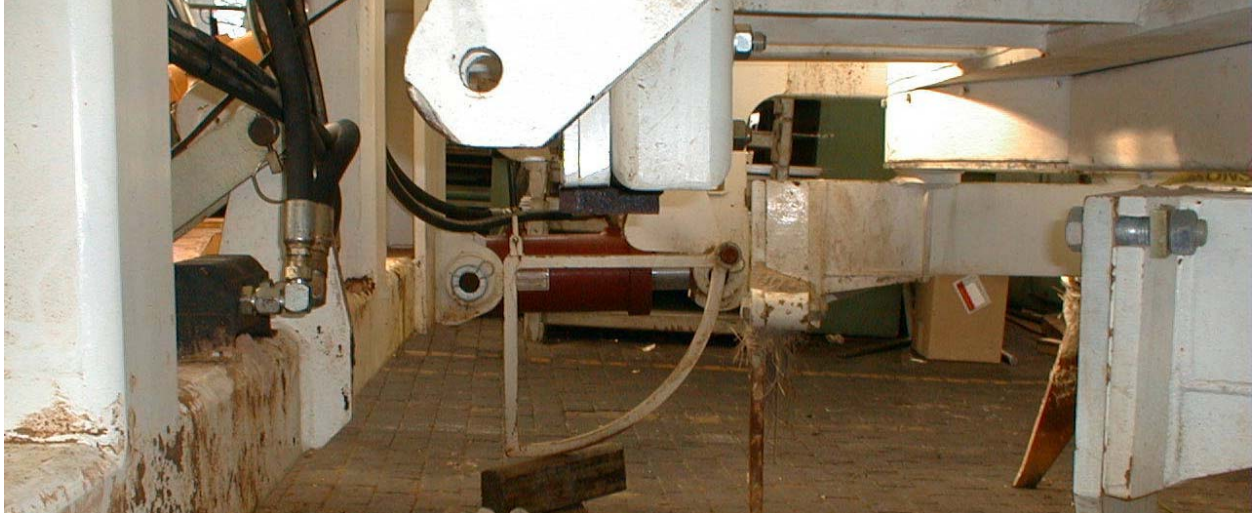
The skid shoes which the RMCT manufacturer supplies for depth control are weight bearing devices located in front of the comb. The shoes' ground pressure over uncombed soil makes them vulnerable to mine detonation. Both of the vehicles on which these tests were conducted are larger, more stable platforms than the New Holland 160/90 tractor on which the original RMCT development and testing was conducted. These tests were conducted with the operator exercising control over the combing depth on the basis of feedback from a depth-indicating shoe tracking the ground surface behind the combs.

**Figure 5. Hinged Depth Shoe.**

This change in depth control was designed to allow the forward mounted, weight bearing skid shoes to be eliminated from the system. Placing the indicator behind the comb removes the threat of mine damage and vegetation interference with the operation of the shoe. However, the comb's shearing of the soil into a more fluid medium, and its creation of large clods or sod chunks provides a less readable surface to sense. The shoe implemented for these tests is intended to provide moderate ground pressure which sinks the shoe 0-5 centimeters into the sheared soil under most conditions, but allows it to cut through soft discontinuities. The shoe is attached to a depth indicating rod which has alternately white and black bands which can be calibrated to give a rough indication of current combing depth. The task of the operator with respect to controlling the depth amounted to keeping the indicating rod within one of these 5 centimeter black or white bands.

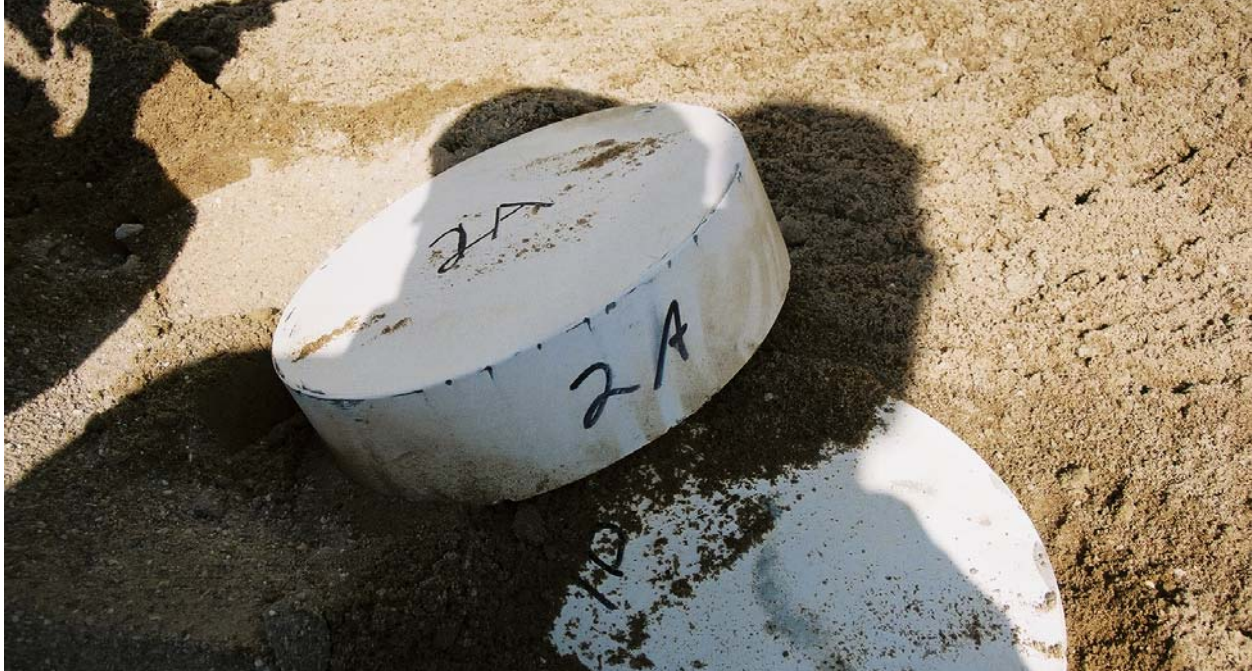
**Figure 7. Mine Surrogate**

The surrogate mine bodies are constructed from sand filled, 20 gauge, low carbon steel shells, generically representing large antitank landmines. The test lanes were prepared as diagrammed in figure 8.

A key defining parameter in the operation of the Rotary Mine Comb is the maximum rotational speed allowable. As tine speed is increased, so is the potential for structural damage to mines encountered, and quite probably the risk of mine detonation. Properly assessing the maximum allowable rotor speed is important for both managing the risk of detonating AT mines and for defining the overall clearance rate with the comb. AT mine detonation risk as a function of rotor speed was not directly measured; however, observations were made of structural damage to mine AT bodies at varying rotor speeds. These tests were conducted using surrogate AT mine bodies (see Fig. 7) buried in both sand and unvegetated clay.

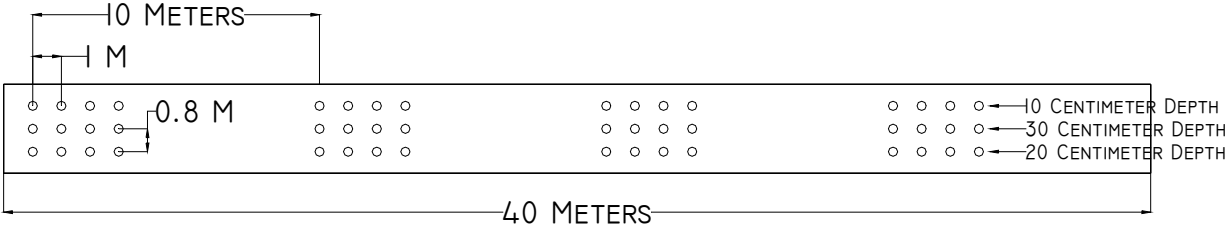
**Figure 8 Test Lane for Rotor Speed Trials**

Each test lane was combed using a fixed tine increment of 4 centimeters. One of 4 different rotor speeds was used for each group of 12 mine surrogates shown in figure 8. Thus both rotor speed and vehicle speed increased with each group of 12 surrogates encountered. The test rotor speeds used were 12.1, 18.5, 25.7, and 34.3 rpm, which correspond to four of the eight available full power PTO speeds from the farm tractor.

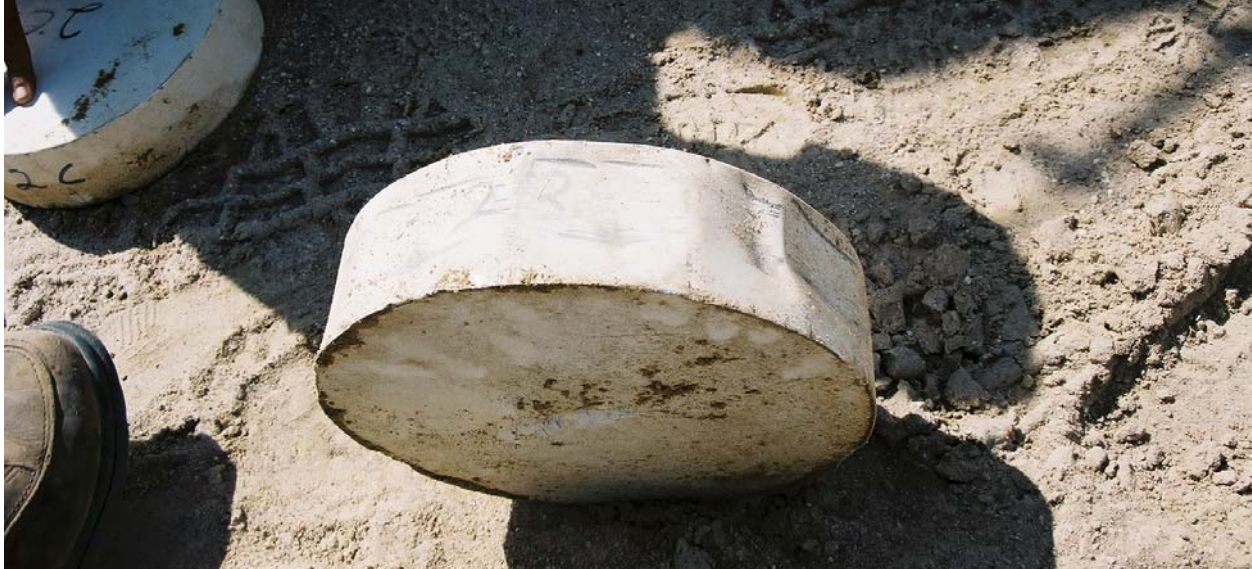
In contrast, the clay soil results reflect a much tougher challenge. The surrogates were buried as prescribed and the test lane was compacted with a vibratory roller to produce a very hard, unyielding medium. The farm tractor used for these tests did have some difficulty in achieving and maintaining the desired combing depth. This is reflected in the results at 30 centimeters burial depth where many of the test objects were speared by the tines rather than being lifted to the surface. With no apriori knowledge of detonation risk, subsequent test expectations place a conservative lower limit of risk at the level of stress producing minor dents and slight case buckling. An upper limite of risk was established at conditions producing moderate dents and moderate case buckling.

**Figure 9. Example of Surrogate with Moderate Dent and Slight Case Buckling**

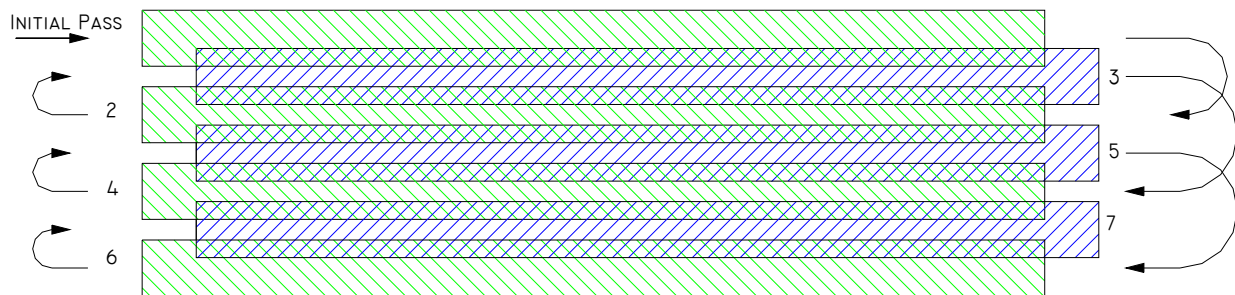
The development of an effective pattern for combing an area is a necessary requirement. Prior testing had led to the conclusion that a path as diagrammed in figure 10 is required to keep balanced draft and side shifting forces on the comb. As diagrammed the comb is always either engaging a full width cut of bank condition soil or a center “slice” of bank soil with equal strips of previously tilled soil at the edges of the cut.

**Figure 10. Alternating Combing Pattern**

Without this method, experience has shown the comb will wander inexorably to the softer soils in the previously tilled area despite the operator’s best efforts to the contrary. Planning for proper overlap from pass to pass required consideration of the effective lane width as measured in the previous test. In addition consideration must be made of the placement of the wheels or tracks of the host vehicles with respect to previous passes with the comb. Figure 11 diagrams the various widths associated with the tractor as it makes a combing pass. The center line spacing from adjacent passes must be less than the effective lane width if all mines are to be made visible. The uncombed gap left between alternating lanes which is combed last must either be wider than the outer track width, or must be narrower than the inner track width in order to keep both tracks either both on combed soil or both on uncombed soil. Leaving a pass-to-pass gap wide enough for the outer track width will result in lane spacings of 293 centimeters which is too wide for the effective lane width consideration. Leaving a pass-to-pass gap narrow enough for

the inner track width to straddle will result in permitted lane spacings of less than 232 centimeters. 210 centimeter lane spacings were chosen for the simulated minefield clearance tests. This spacing left gaps of 70 centimeters which were taken out on the odd numbered passes as diagrammed in figure 10.

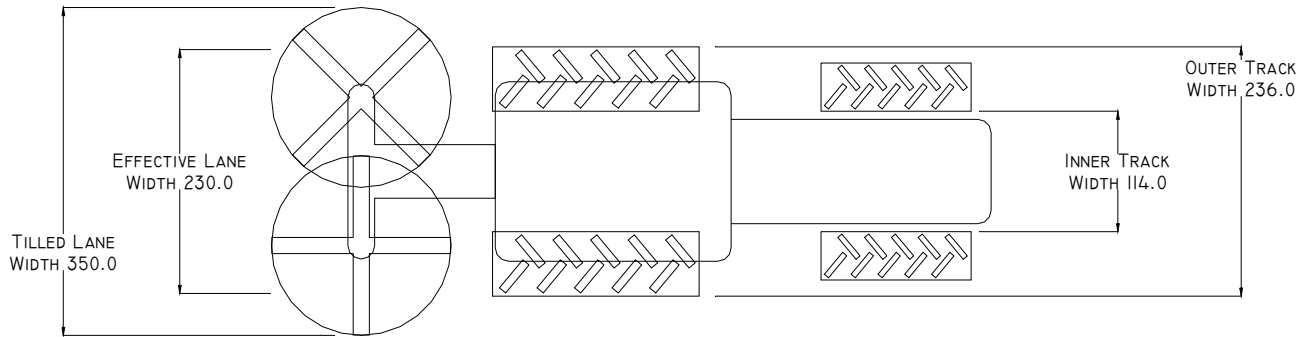
**Figure 11. Lane Widths Associated with Tractor and Comb**

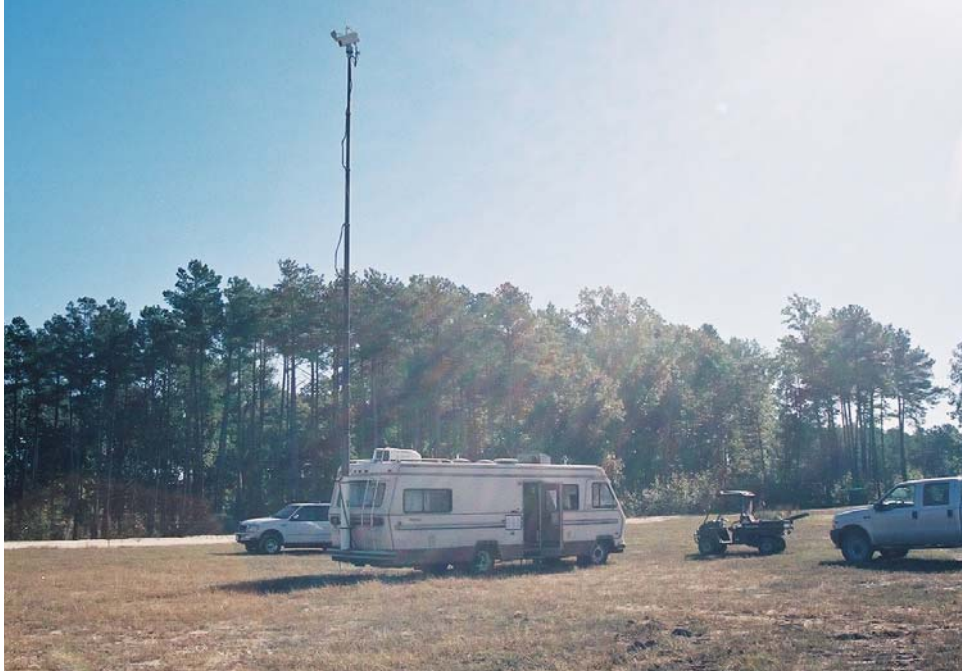
An external monitoring station was placed 15 meters beyond the end of the minefield border. The monitoring station was equipped with a mast mounted pan and tilt camera and receivers/monitors to allow observers to watch the comb-mounted cameras.

**Figure 12. External Monitoring Station**

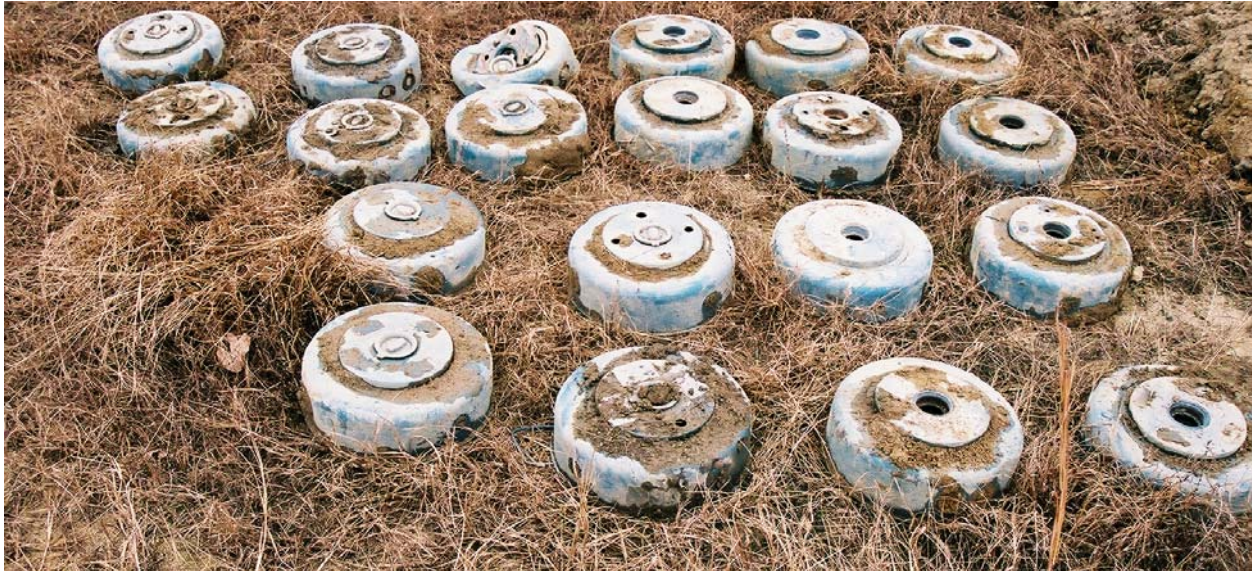
**Figure 13. AT Test Mines Recovered from 10 cm Burial**

The dependence of the fuze triggering on the depth of burial in table 6 is not surprising. The increasing damage observed in the surrogates reported in the investigation of rotor speed with increased depth is consistent with these results; see figures 13-15.

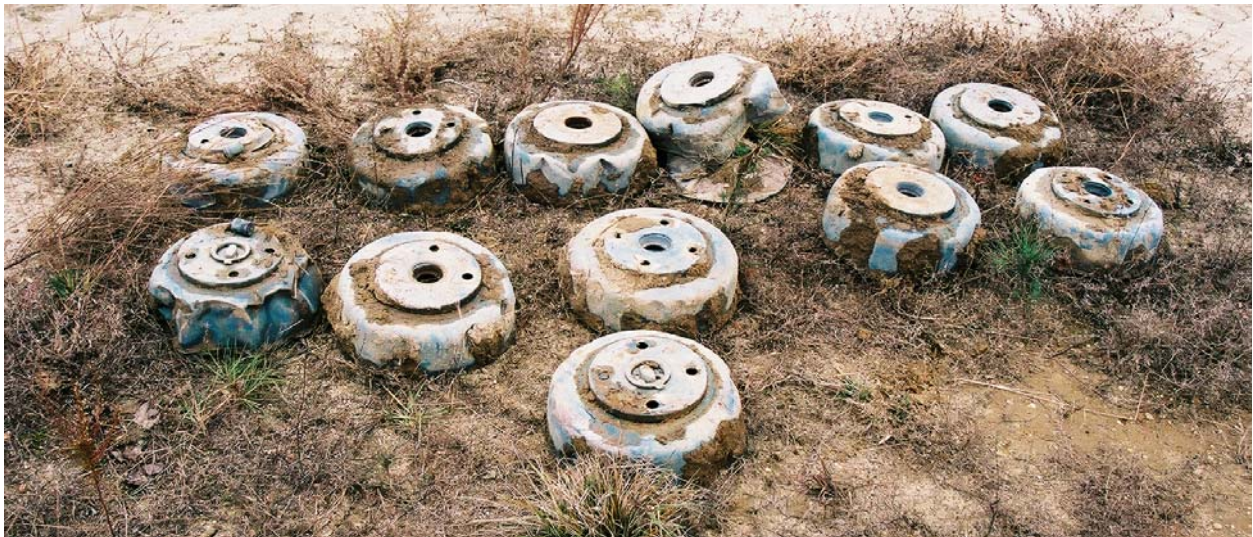
**Figure 14. AT Test Mines Recovered from 20 cm Burial**

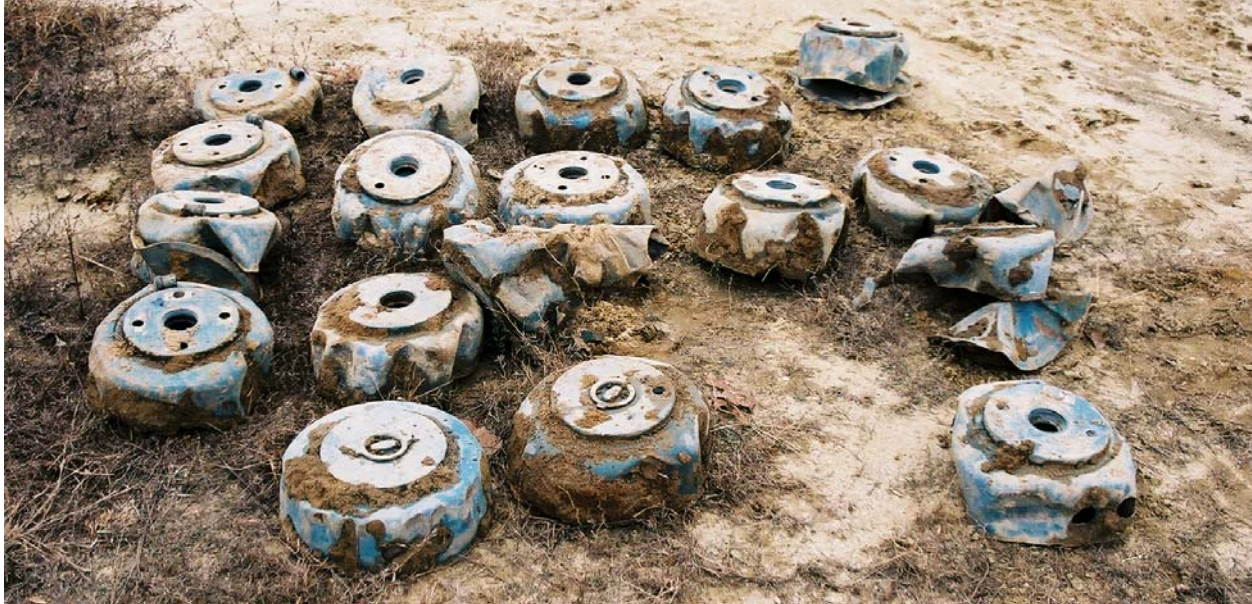
**Figure 15. AT Test Mines Recovered from 30 cm Burial**

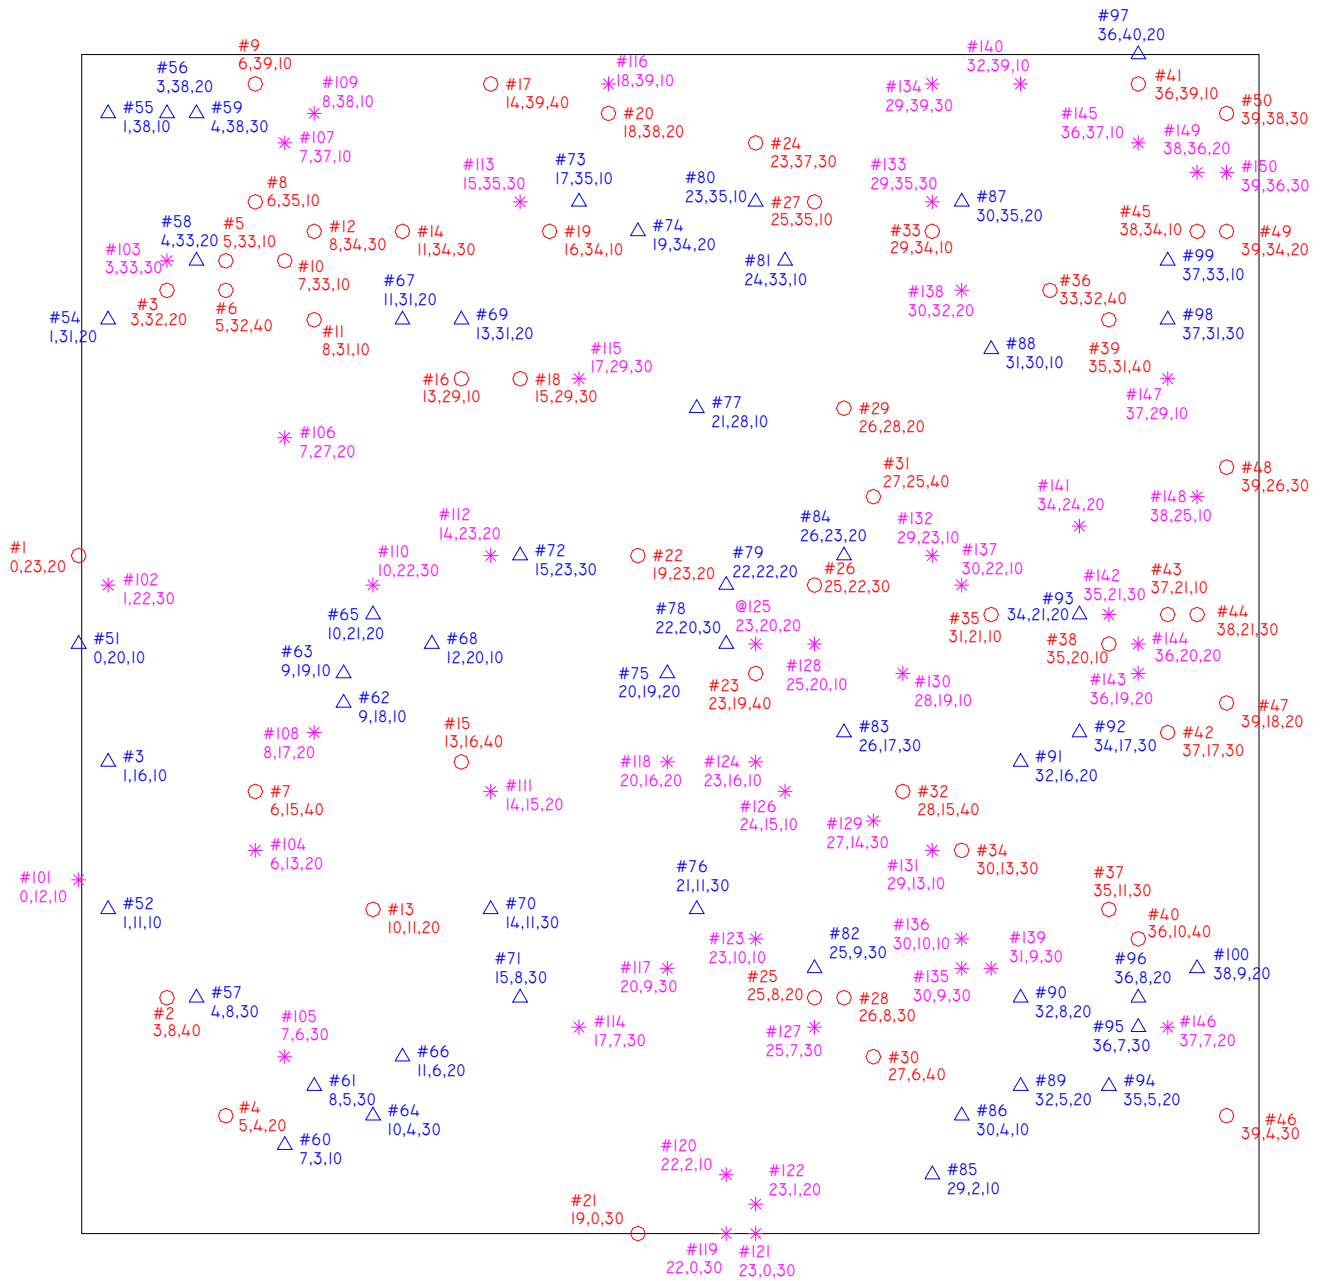
Figure 16. MINE COORDINATES AND BURIAL DEPTH
