## Report on the Mine Clearing Rake Test

October 2006

Prepared by  
Institute for Defense Analyses  
4850 Mark Center Drive  
Alexandria, VA 22311-1882

**Operational Evaluation Test Report  
on the  
Mine Clearing Rake**

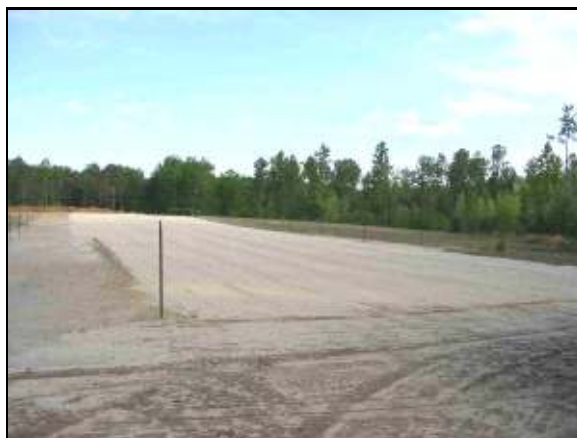
**Figure 13. Test Site 2 (Sand Test Site)**

There was no need for any preparation of the sand test area (see Figure 13).

Test Site 2, the sand soil test area, required no preparation before MCR testing. While there was spotty evidence of wild grass seed having germinated in the sand, the lack of nutrients in the sand caused the grass shoots to quickly die.

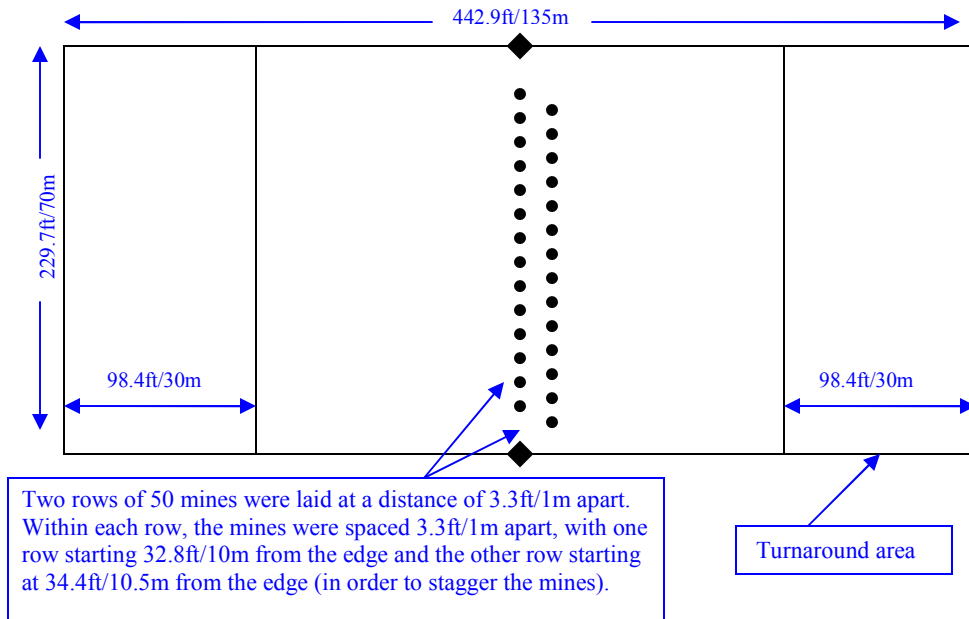
**Figure 14. Layout of Test Site 1 Showing Mine Location and Pattern**

A total of 100 test mines were buried in the center of the Test Site 1 before any area preparation (cutting, plowing, cultivating) was done. The mines were buried at a depth of 5cm to the top of each mine, with 50 mines at 1m intervals in each of two staggered rows. There was a 1m separation between the rows. There was a 10m unmined area between the end of each row and the sides of the test area. All mines were models of actual AP mines. The types and numbers of each mine were:

A layout of Test Site 1 is shown in Figure 14.

A drawing of Test Site 1 area is shown in Figure 14. The area devoted to the actual test of the MCR was 75m x 70m, with 30m at each end set aside to allow adequate room to perform 180° turns without tipping the MCR between successive passes through the prepared test area.

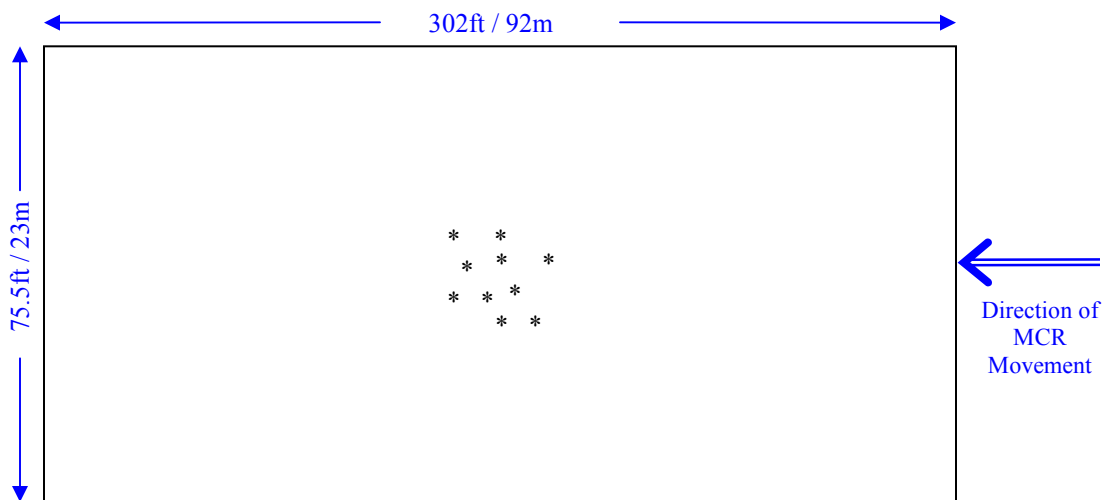
**Figure 15. Layout of Test Site 2 Showing Mine Location and Pattern**

At Test Site 2, the sand site, ten mines were buried. These mines were of the same size and type as those used in Test Site 1. The mines were buried in a scattered pattern along a 1.5m strip in the center of the field to a depth of 5cm to the top of the mine. A layout of the Test Site 2 is shown in Figure 15.

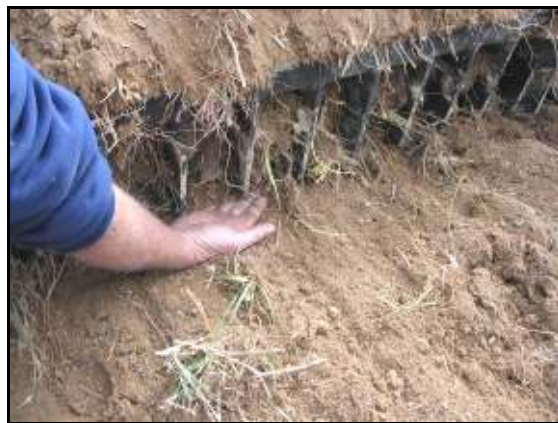
The MCR was towed through the test area by the Fendt Tractor at speeds varying from about 3 mph (5 kph) to 6 mph (10 kph). Regardless of the speed, a bow wave of dirt formed along the front edge of the rake (in front of the knives). (The higher speeds were tried to see if the dirt would flow over the rake structure rather than build up into a bow wave. Very slow speeds, 1 to 1.5 mph (1.4 to 2.5 kph), were tried but only resulted in the rake portion of the MCR coming totally out of the ground.) Smaller buildups of dirt formed in front of the front tow bar, the rear drag bar, and at various spots under the drag mat. The drag caused by the MCR's buildup of dirt required that the tractor be operated in 4-wheel drive. Maximum dirt buildup was achieved within 3-4 MCR lengths from start of towing. The bow wave in front of the knives achieved a height that consistently measured  $\sim 19\frac{1}{2}$  inches (49.5 cm) at which point the dirt cascaded down the backside of the wave and was processed by the agricultural drag mat. The amount and weight of the dirt accumulated in front of the knives was so great that the easiest way to clean the MCR, thus allowing a fresh restart of the test, was with the assistance of a front end loader. When it was observed that the bow wave of dirt caused the knives to come out of the ground, the tow chain attachment points were moved back to the second set of attachment holes. However, the knives still came out of the ground. Pictures of the dirt buildup in the MCR and the knives out-of-the-ground are shown in Figures 17 and 18.

**Figure 17. MCR Bow Wave**

**Figure 18. Knives out of the Ground**

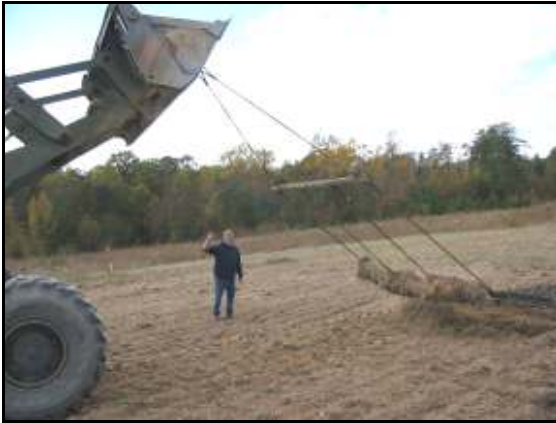
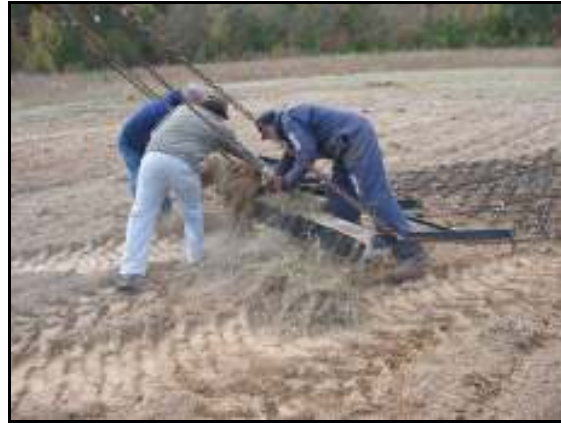
To clean the MCR, the towing ring of the MCR was removed from the Fendt tractor and looped over one of the teeth of a standard digging bucket attached to an Army front end loader. The bucket was then raised to pull the rake clear of the dirt bow wave

and the front end loader was backed away so that the MCR could be pulled out of and away from the debris heap. After the rake was cleared from the heap, people manually cleaned any remaining grass or roots from the tines and detached the MCR from the front end loader. The procedures used to clean the rake involve, at a minimum, two personnel (equipment operator and person on foot to attach/detach/clean the MCR) and a front loader. In this test, three personnel were used to clean the MCR (Fendt operator, front loader operator, attach/detach personnel), taking a total of 5min, 40 sec to complete the cleaning process. Pictures of the movement of the MCR by the front end loader and the manual cleaning of the rake are presented in Figures 19 and 20.

**Figure 19. Clearing the MCR**

**Figure 20. Cleaning the MCR**

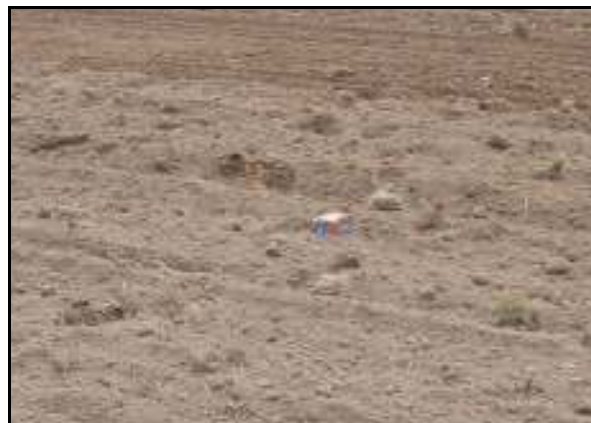
**Figure 21. Surface-Laid Mine**

After testing the MCR on buried mines, a test of surface-laid anti-personnel mines was performed within the Test Site 1 field. Two mines were laid on top of the prepared field and within the path of the MCR, cleaned of debris prior to this test. The mines were placed at a point 40m and at 50m from the start of the MCR run. Figure 21 shows the condition of the field and the placement of the mines in the field.

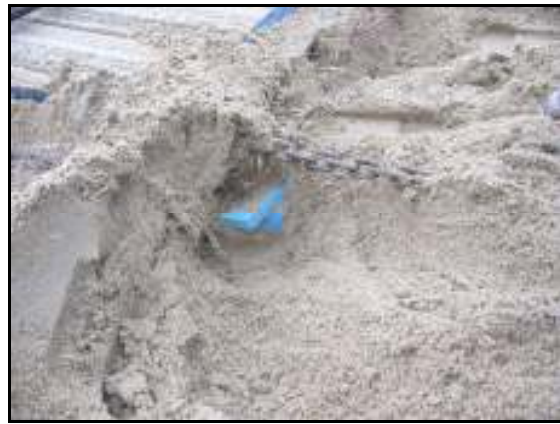
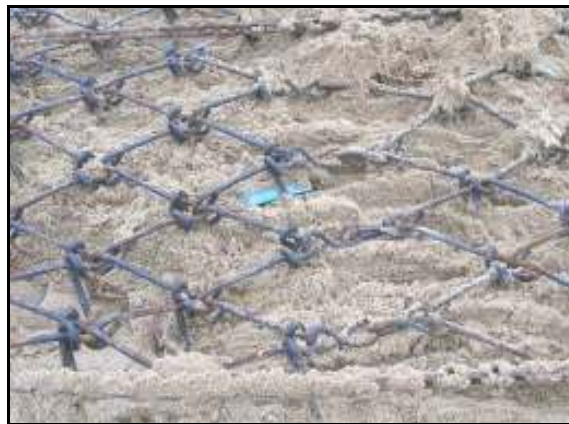
After one pass of the MCR, the field and the MCR accumulation mounds were closely examined for mines. This investigation found seven mines within the accumulation in front of the digging knives, one under the drag mat, one mine slightly exposed in its original location, and the last mine buried in its original location. Of the seven mines found within the sand accumulation in front of the digging knives, none were visible by the tractor operator during or after the test. The locations of these mines were not discovered until the buildups in front of the digging knives and within the drag mat were shoveled away. The final orientation of the mines within the front buildup varied from their original (burial) orientations indicating that they had been tumbled and rolled within the sand. Pictures of the mines discovered within the MCR sand accumulation are shown in Figures 25, 26, and 27.

**Figure 25. Mine Found in Accumulation Heap**

**Figure 26. Two Mines Found Stacked within Accumulation Heap**

**Figure 27. Mine Found within Drag Mat Accumulation**

Only one mine was exposed, but not moved or brought to the surface by the MCR during the sand soil test. When the sand buildup in front of the digging knives array was shoveled away, seven of the mines were found buried in the sand against the front edges of the digging knives and one was found buried in the sand accumulation under the drag mat. An analysis of the location of where the mines were found showed that once the mines were engaged by the rake-portion of the MCR, the mines were pushed along in front of the rake rather than flowing up the front of the knives and being deposited on the surface. The distance from the point of burial to where the sand buildup was removed by shovel was 145 feet (44 m). After the test, the last mine was uncovered with a shovel at its original burial position.

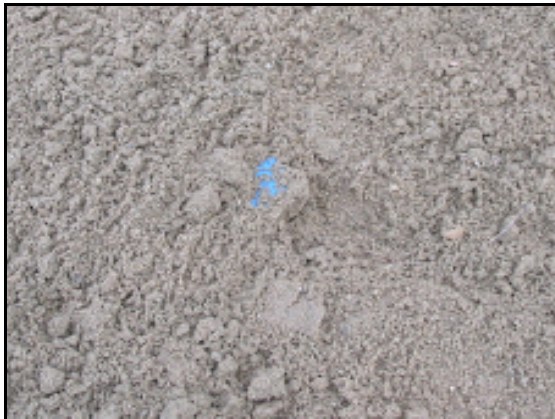
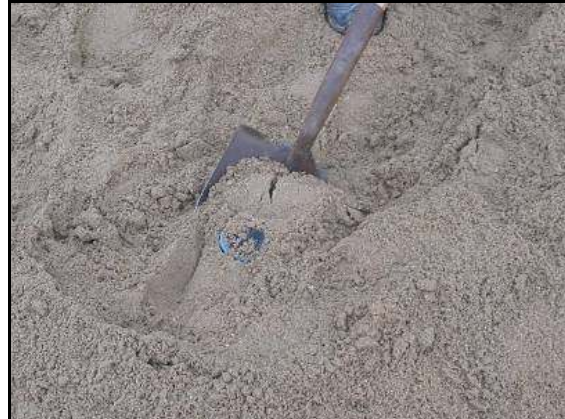
The remaining two mines were left in their original burial location. The uncovered mine was not shifted from its original burial location and was only visible due to its bright blue paint color and after close inspection of the area. The second mine

appeared untouched by the MCR and was uncovered by shovel after the test was complete. Pictures of these two mines are found in Figures 28 and 29.

Figure 28. Exposed Mine in Original Location

Figure 29. Tenth Mine Found after Shoveling
