Report on the Mine Clearing Rake Test

October 2006

**Operational Evaluation Test Report
on the
Mine Clearing Rake**

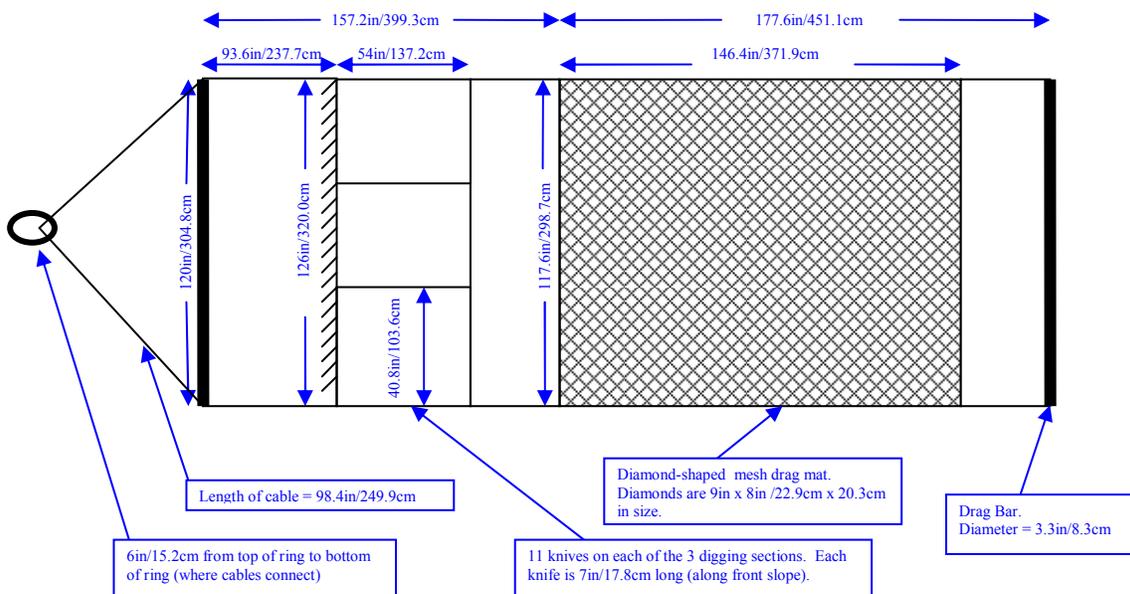
The MCR is comprised of three digging knife units and a drag mat/chain harrow. The MCR, as tested, is shown in Figure 1. This configuration, with the digging knives in a straight line across the front of the MCR, was selected during familiarization runs with the MCR as the one offering the best MCR performance and control of the

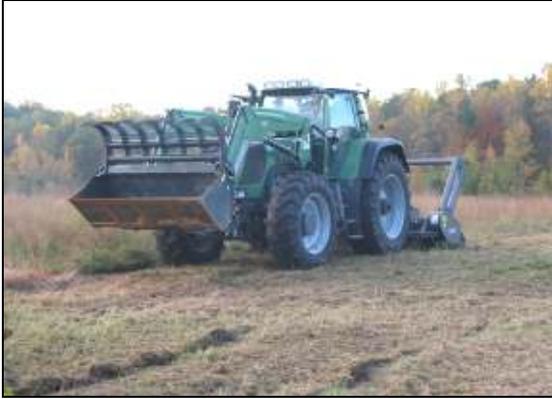
Figure 2. Fendt 918 Tractor

MCR while towing and turning. The tools used in the MCR test were a Fendt 918 Vario tractor (Figure 2), a Loftness 918 Timber Ax Extreme vegetation cutter (Figure 3), a Krause 4830-730F Chisel Plow (Figure 4), an Unverferth Perfecta II Spring Cultivator (Figure 5), and the MCR (Figure 6).

Table 1. Fendt 918 Vario Tractor

Item	Measurement / Dimension
Max Height, to top of cab	10.15/3095 ft/mm
Min Working Clearances under axles	1.98/605 ft/mm
Max Width	8.17/2490 ft/mm
Max Length	16.2/4938 ft/mm
Max Shipping Weight	17945/8138 lbs/kg
Fuel Capacity	530 liters
Oil Capacity	24 liters
Hydraulic Fluid Capacity	65 liters

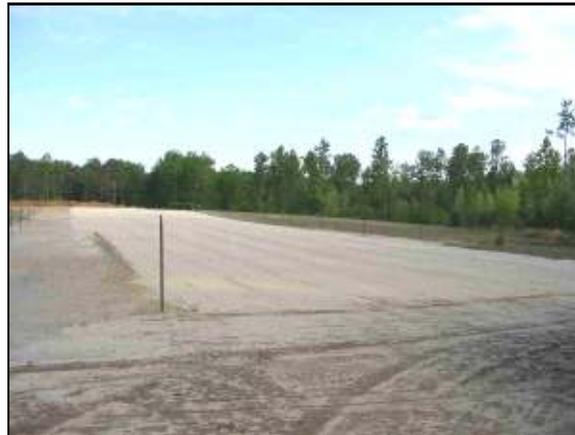
There was no need for any preparation of the sand test area (see Figure 13).

Figure 13. Test Site 2 (Sand Test Site)

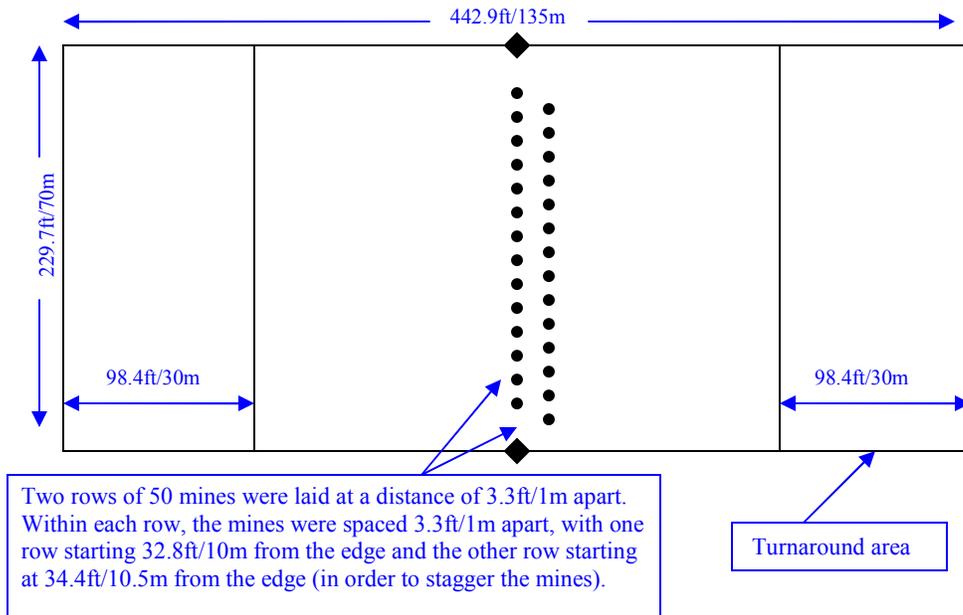
A total of 100 test mines were buried in the center of the Test Site 1 before any area preparation (cutting, plowing, cultivating) was done. The mines were buried at a depth of 5cm to the top of each mine, with 50 mines at 1m intervals in each of two staggered rows. There was a 1m separation between the rows. There was a 10m unmined area between the end of each row and the sides of the test area. All mines were models of actual AP mines. The types and numbers of each mine were:

A layout of Test Site 1 is shown in Figure 14.

Figure 14. Layout of Test Site 1 Showing Mine Location and Pattern

A drawing of Test Site 1 area is shown in Figure 14. The area devoted to the actual test of the MCR was 75m x 70m, with 30m at each end set aside to allow adequate room to perform 180° turns without tipping the MCR between successive passes through the prepared test area.

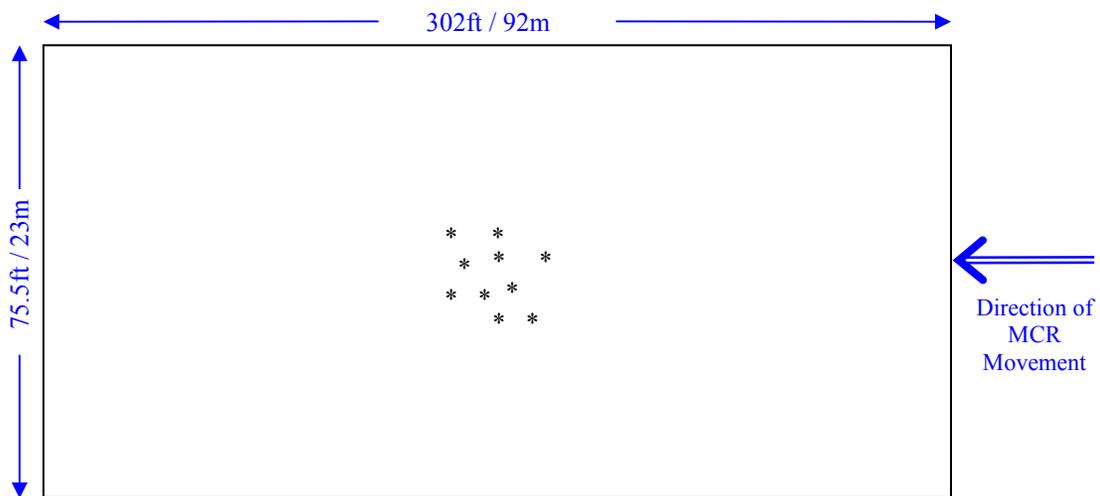
At Test Site 2, the sand site, ten mines were buried. These mines were of the same size and type as those used in Test Site 1. The mines were buried in a scattered pattern along a 1.5m strip in the center of the field to a depth of 5cm to the top of the mine. A layout of the Test Site 2 is shown in Figure 15.

Figure 15. Layout of Test Site 2 Showing Mine Location and Pattern

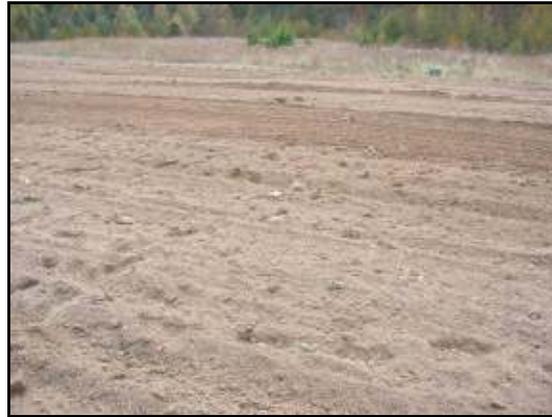
Mowing of the 135m x 70m area took 2 hours 10 minutes. Average mowing speed was 1.5 mph (2.5 kph). Plowing the MCR test area (75m x 70m) took 3 hours 4 minutes until the soil was judged to be sufficiently broken up to be ready for working with the spring cultivator. Plowing speeds ranged from very slow to a maximum of 5 mph (8.3 kph). The MCR test area was worked with the spring cultivator for 3 hours 21 minutes to insure that the test area was free clumps of sod at speeds of 1.5 to 5 mph (2.5 to 8.3 kph). At this point in the preparation process, the test area resembled mine-cleared areas ready for final quality assurance testing. Figure 16 shows the prepared Test Site 1 field.

Figure 16. Field Ready for MCR Test

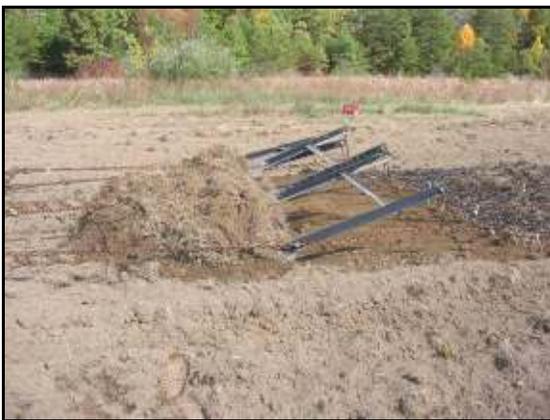
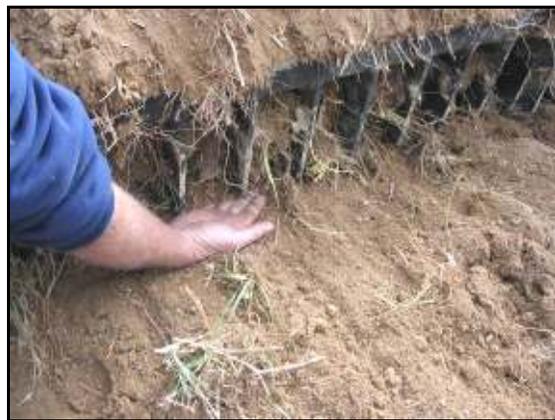
The MCR was towed through the test area by the Fendt Tractor at speeds varying from about 3 mph (5 kph) to 6 mph (10 kph). Regardless of the speed, a bow wave of dirt formed along the front edge of the rake (in front of the knives). (The higher speeds were tried to see if the dirt would flow over the rake structure rather than build up into a bow wave. Very slow speeds, 1 to 1.5 mph (1.4 to 2.5 kph), were tried but only resulted in the rake portion of the MCR coming totally out of the ground.) Smaller buildups of dirt formed in front of the front tow bar, the rear drag bar, and at various spots under the drag mat. The drag caused by the MCR's buildup of dirt required that the tractor be operated in 4-wheel drive. Maximum dirt buildup was achieved within 3-4 MCR lengths from start of towing. The bow wave in front of the knives achieved a height that consistently measured $\sim 19\frac{1}{2}$ inches (49.5 cm) at which point the dirt cascaded down the backside of the wave and was processed by the agricultural drag mat. The amount and weight of the dirt accumulated in front of the knives was so great that the easiest way to clean the MCR, thus allowing a fresh restart of the test, was with the assistance of a front end loader. When it was observed that the bow wave of dirt caused the knives to come out of the ground, the tow chain attachment points were moved back to the second set of attachment holes. However, the knives still came out of the ground. Pictures of the dirt buildup in the MCR and the knives out-of-the-ground are shown in Figures 17 and 18.

Figure 17. MCR Bow Wave

Figure 18. Knives out of the Ground

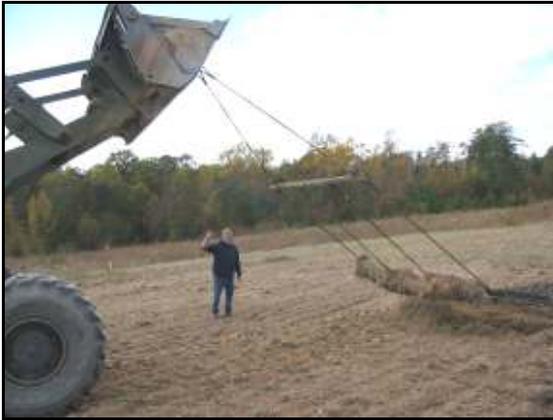
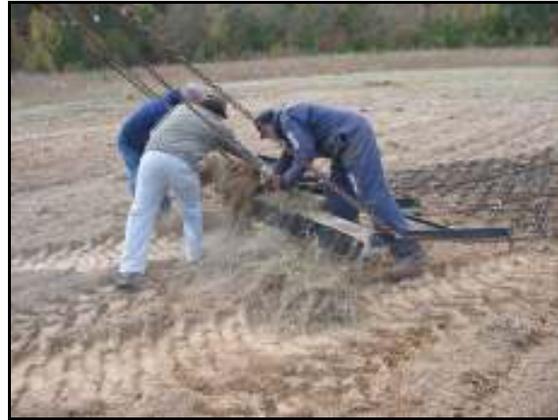
To clean the MCR, the towing ring of the MCR was removed from the Fendt tractor and looped over one of the teeth of a standard digging bucket attached to an Army front end loader. The bucket was then raised to pull the rake clear of the dirt bow wave

and the front end loader was backed away so that the MCR could be pulled out of and away from the debris heap. After the rake was cleared from the heap, people manually cleaned any remaining grass or roots from the tines and detached the MCR from the front end loader. The procedures used to clean the rake involve, at a minimum, two personnel (equipment operator and person on foot to attach/detach/clean the MCR) and a front loader. In this test, three personnel were used to clean the MCR (Fendt operator, front loader operator, attach/detach personnel), taking a total of 5min, 40 sec to complete the cleaning process. Pictures of the movement of the MCR by the front end loader and the manual cleaning of the rake are presented in Figures 19 and 20.

Figure 19. Clearing the MCR

Figure 20. Cleaning the MCR

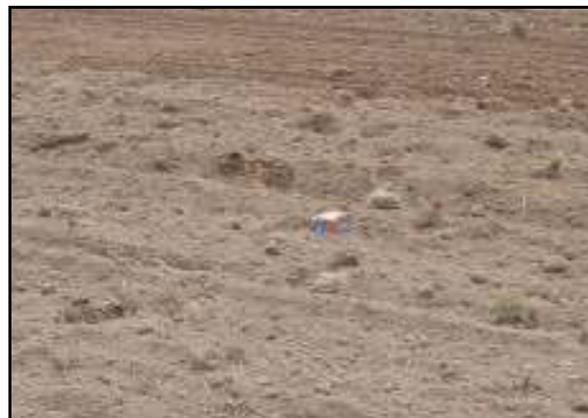
After testing the MCR on buried mines, a test of surface-laid anti-personnel mines was performed within the Test Site 1 field. Two mines were laid on top of the prepared field and within the path of the MCR, cleaned of debris prior to this test. The mines were placed at a point 40m and at 50m from the start of the MCR run. Figure 21 shows the condition of the field and the placement of the mines in the field.

Figure 21. Surface-Laid Mine

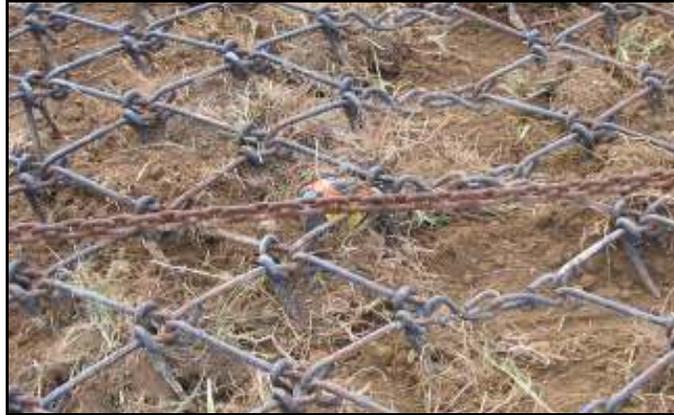
As the tractor and MCR passed over the mines, one mine was covered with dirt by the MCR and the other remained in place as the MCR drag mat moved across the top of the mine. The mine that remained in place was captured by photograph as the drag mat crossed over the top, as shown in Figure 22.

Figure 22. Surface-Laid Mine Remaining on Ground

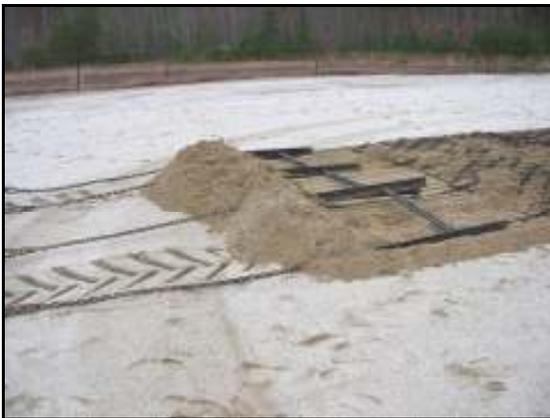
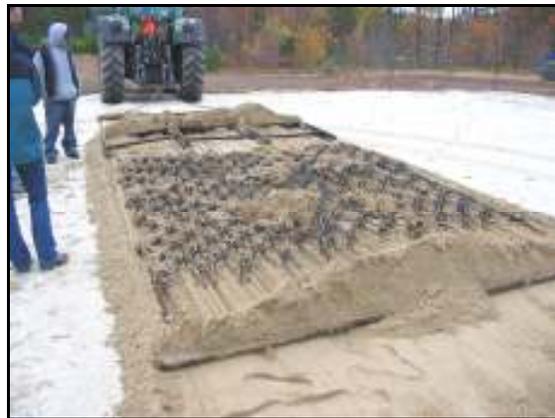
As in Test 1, the MCR was towed through the sand area by the Fendt Tractor at speeds varying from 3 to 5 mph (5 to 8.3 kph). Sand accumulated along the front edge of the digging tines, in locations under the drag mat during MCR movement, and in front of the rear drag bar. When the MCR reached the end of the test area, the bow wave in front had reached a height of 19in (48.2 cm) along the front of the digging tines. This accumulation prevented the tines, 17.8 cm in length, from fully penetrating the ground. The maximum digging depth of the tines by the end of the test run was measured to be 7.6 cm. Pictures of the sand accumulation are shown in Figures 23 and 24.

Figure 23. Accumulation at the Digging Tines

Figure 24. Accumulation within the Drag Mat

Ten mines were buried in the sand soil test area in an array that would allow the all ten mines to be exposed or surfaced by the MCR in a single pass. While the MCR did stay in the soil to some extent for the entire sand soil test, the buildup of sand in front of the digging knives limited the penetration to half the length of the digging knives.

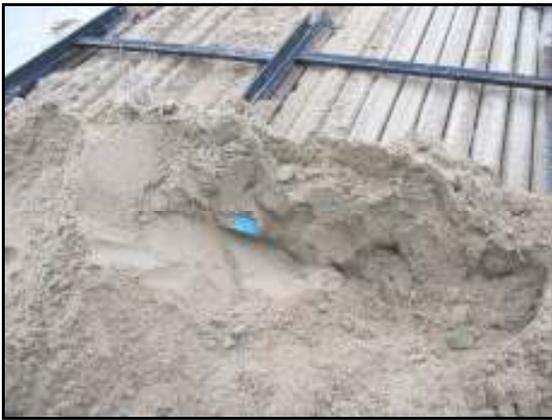
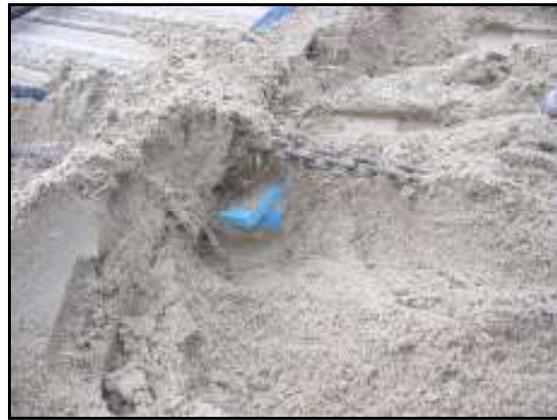
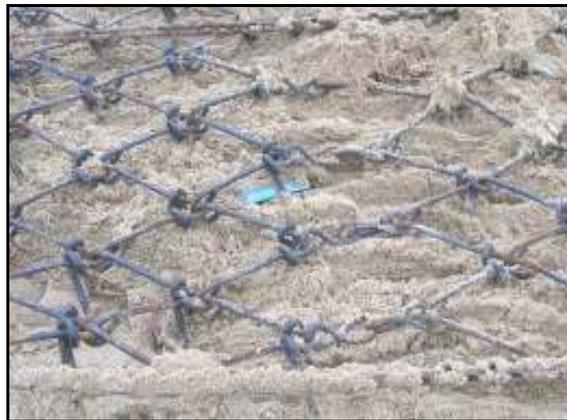
After one pass of the MCR, the field and the MCR accumulation mounds were closely examined for mines. This investigation found seven mines within the accumulation in front of the digging knives, one under the drag mat, one mine slightly exposed in its original location, and the last mine buried in its original location. Of the seven mines found within the sand accumulation in front of the digging knives, none were visible by the tractor operator during or after the test. The locations of these mines were not discovered until the buildups in front of the digging knives and within the drag mat were shoveled away. The final orientation of the mines within the front buildup varied from their original (burial) orientations indicating that they had been tumbled and rolled within the sand. Pictures of the mines discovered within the MCR sand accumulation are shown in Figures 25, 26, and 27.

Figure 25. Mine Found in Accumulation Heap

Figure 26. Two Mines Found Stacked within Accumulation Heap

Figure 27. Mine Found within Drag Mat Accumulation

Only one mine was exposed, but not moved or brought to the surface by the MCR during the sand soil test. When the sand buildup in front of the digging knives array was shoveled away, seven of the mines were found buried in the sand against the front edges of the digging knives and one was found buried in the sand accumulation under the drag mat. An analysis of the location of where the mines were found showed that once the mines were engaged by the rake-portion of the MCR, the mines were pushed along in front of the rake rather than flowing up the front of the knives and being deposited on the surface. The distance from the point of burial to where the sand buildup was removed by shovel was 145 feet (44 m). After the test, the last mine was uncovered with a shovel at its original burial position.

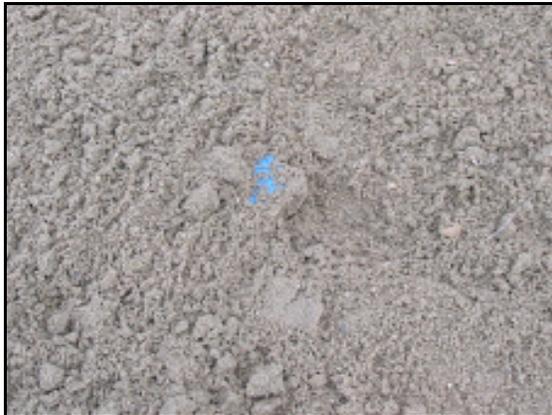
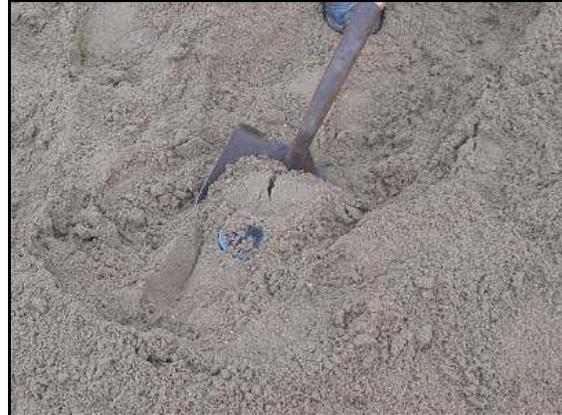
The remaining two mines were left in their original burial location. The uncovered mine was not shifted from its original burial location and was only visible due to its bright blue paint color and after close inspection of the area. The second mine

appeared untouched by the MCR and was uncovered by shovel after the test was complete. Pictures of these two mines are found in Figures 28 and 29.

Figure 28. Exposed Mine in Original Location

Figure 29. Tenth Mine Found after Shoveling
