# IMPROVED ANTI PERSONNEL MINE NEUTRALIZATION DEVICE TEST REPORT CHRISTOPHER WANNER FEBRUARY 2000

## 1.0 INTRODUCTION

This report describes the results and analysis of the field test of the Improved Anti Personnel Mine Neutralization Device (APMINUD). This is the second test of this equipment and follows a six month design and engineering effort on the equipment to correct and improve upon deficiencies identified in the initial version of the APMINUD.

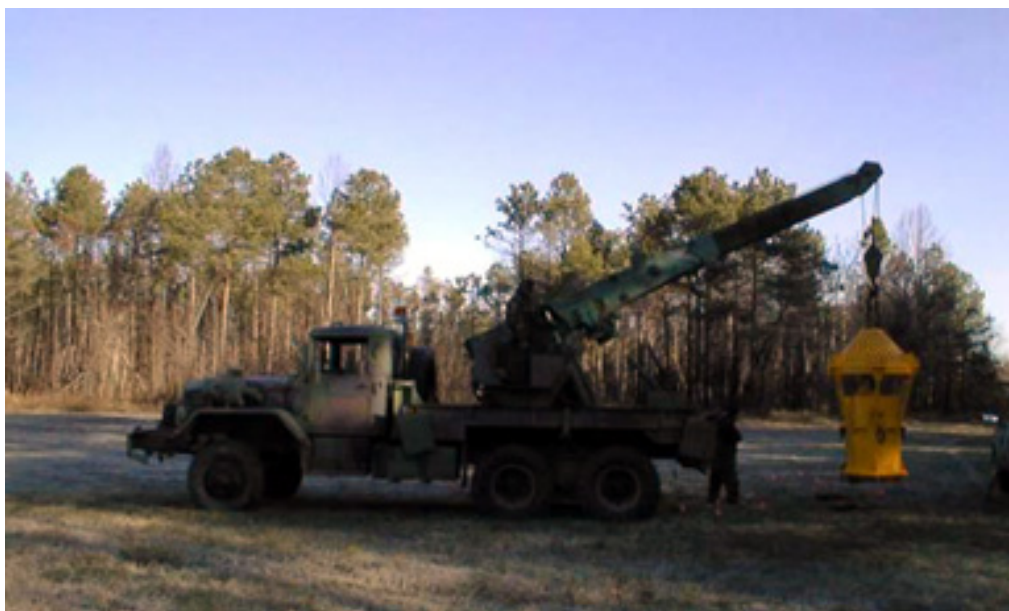
FIGURE 1. Improved APMINUD with Placement Wrecker

The APMINUD is a mechanical tool designed to safely detonate antipersonnel landmines as part of a peace time clearance operation. The APMINUD consists of a mobile blast and fragment containment shell, with a mechanical striker inside. It can be used in conjunction with a shielded, all terrain vehicle with crane. The vehicle is used to move and lower the shell over a marked mine location. The internal

striker is released and impacts the mine or ground above the mine and actuates the pressure fuze. The blast and fragments from the detonating mine are contained within, or are directed out the top of the shell and away from surrounding personnel and equipment.

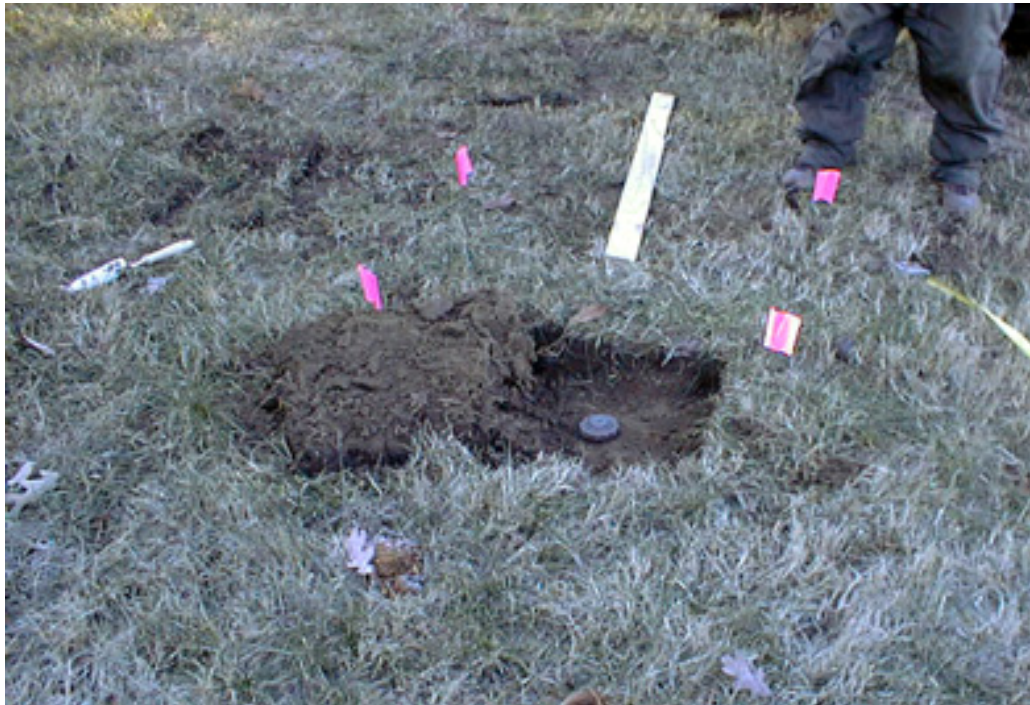
4.2.1 Effect of Vegetation Cover FIGURE 5. MKII Mine Burial in Sod

A series of tests was conducted with mines buried 4" in sod covered clay. These results were compared with results from the mines buried under similar conditions minus the vegetation from the core test program. A truly representative testing of the effect of overgrowth on the results would require burying the mines for a long period of time and allowing vegetation to develop, then performing the test. Since we were not able to create such a condition for this test, the best approximations to this were created in two ways. In most of the tests a square of sod larger than the APMINUD footprint was removed, the mine was buried in the hole left by the sod, and the sod was then replaced, and the test conducted. In some of the tests the burial hole was "drilled" into the sod exactly the size of the mine diameter. The standoff which is much larger than the hole would have to compress the sod all around the hole before impacting the ground above the mine. The method of burial didn't make much difference in the results. The vegetation produced a small reduction in the effectiveness. In these tests, all conducted at 4" burial, 89% of the mines were detonated. This compares to 94% success in the core tests with the same burial conditions except for the
