**THE SEVERE DUTY VEGETATION SHREDDER
TECHNICAL TESTING OF CAPABILITY
MAY 2002**

Severe Duty Vegetation Shredder Technical Test

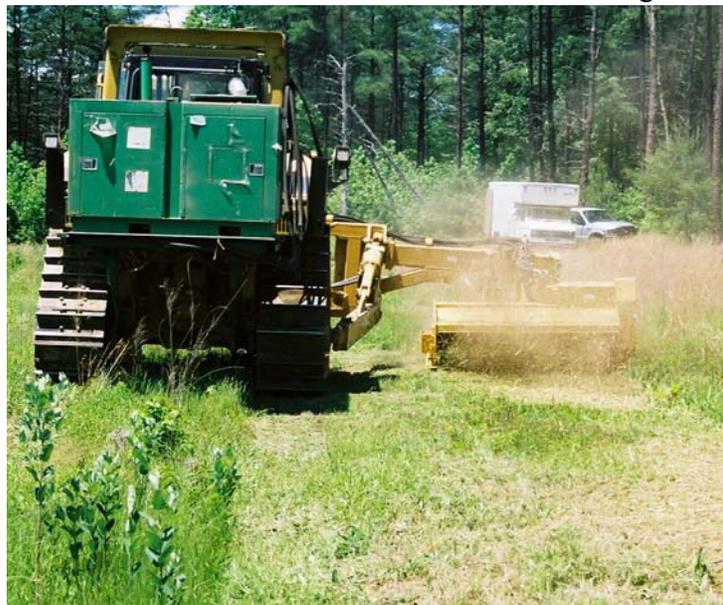
The system can be operated from a previously cleared lane in order to reduce/eliminate the vegetation from adjacent uncleared areas (see figure 1). It cuts a swath just under 2 meters wide and can be stowed in front of the vehicle blade for cross country travel purposes. The interface between the shredder and tractor is designed to allow freedom of movement between the tractor and the shredding implement to permit contour tracking over uneven ground.

Figure 1 Reaching in to suspect area

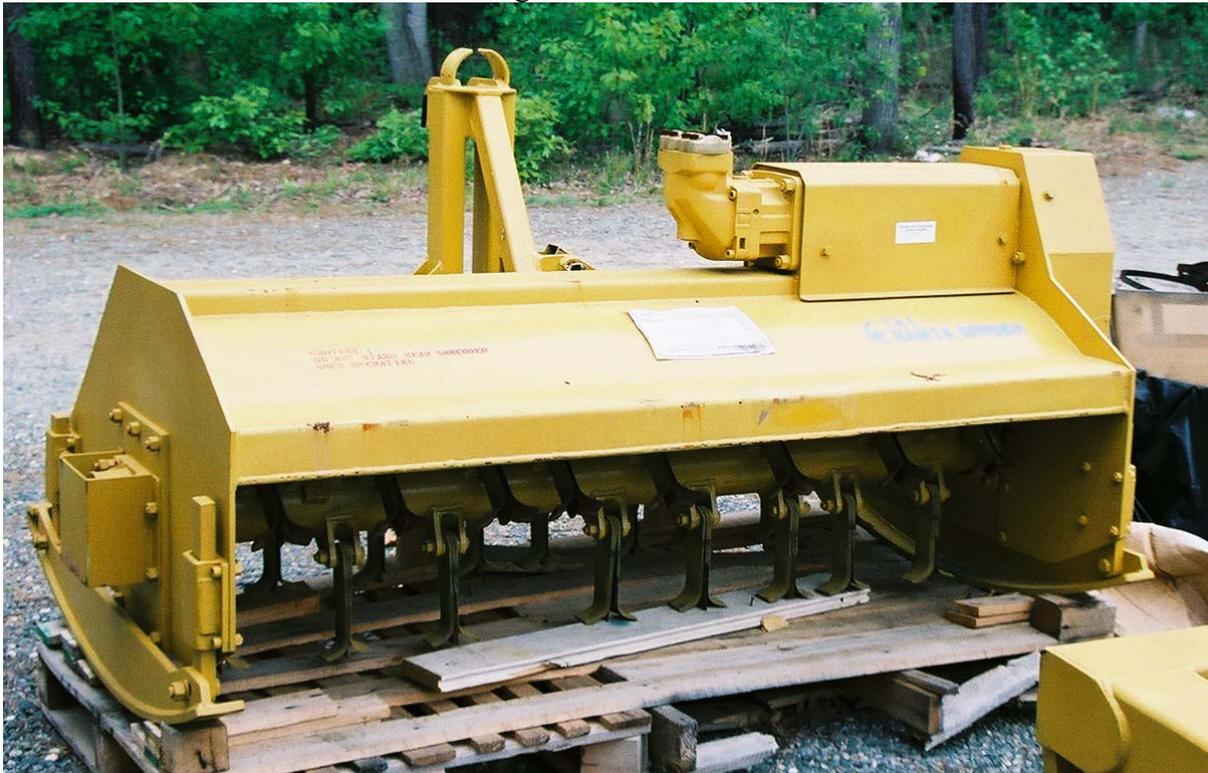
The shredding implement is a modified commercially available component (see figure 2). The shredding implement is hydraulically driven and has a horizontally rotating shaft with hardened cutting knives pinned to its surface. The drum rotates at 1800 RPM. The knives are commercially available “wear items” and can be replaced in about half an hour. The direction of rotation provides for an upward stroke of the knives on the leading edge of the system. Skids at the edges of the shredder provide a bearing surface for the shredder to ride on if the operator maneuvers the shredder too close to the ground surface.

Figure 2 Shredding Implement

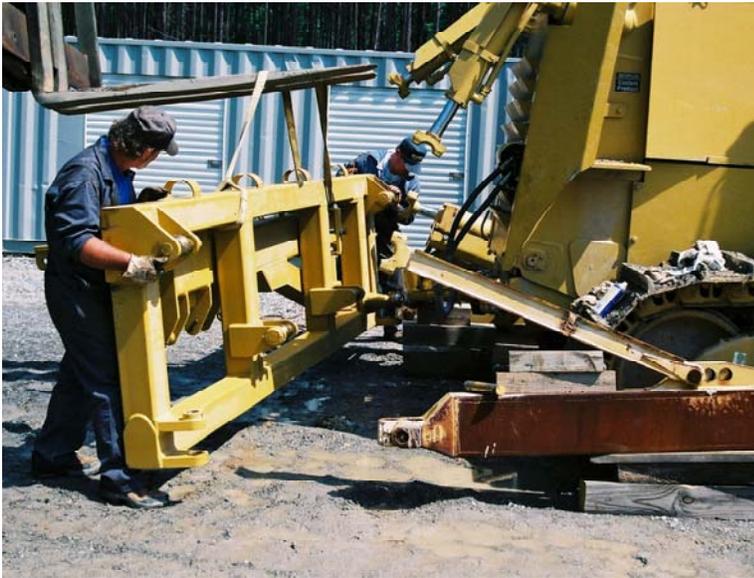
The mainframe ties in with the lift and lower features of the tractor and allows the cutter to operate from 1-2 feet below the surface of the tracks to 6 feet above the surface of the tracks (see figure 3). The tilt feature of the tractor/mainframe interface can contribute additional height and

Figure 3 Installation of Mainframe on tractor

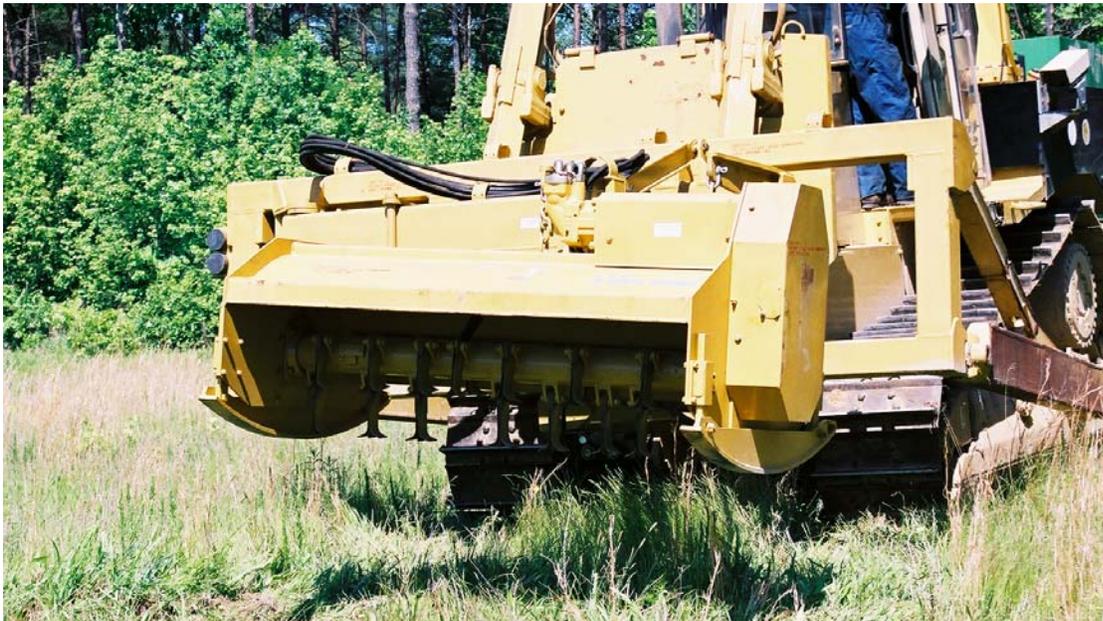
rotation of the shredding implement beyond the lift lower function and shredding implement rotation function. The “float” of the 3 point hitch allows the shredder a couple of degrees of rotation freedom and several inches of elevation freedom so the operator is not required to precisely control the terrain tracking of the shredder. In addition, the mainframe provides for the shredder to be folded around to the front of the tractor into a travel position (see figure 4).

Figure 4 Travel Position

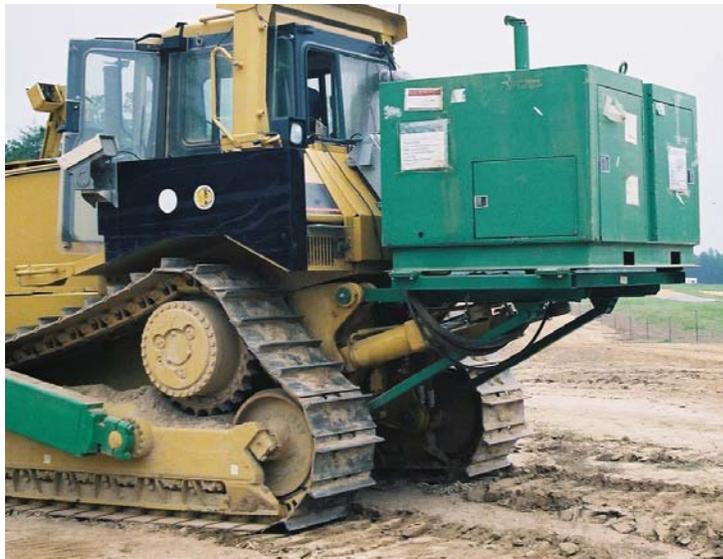
The hydraulic power pack supplies up to 80 kw of hydraulic power to turn the cutting rotor. The pack weighs approximately 1000 kg and is designed to mount on the rear of the tractor using the

attachment pins for the standard ripper (see figure 5). The pack features a load sensing system designed to efficiently match flow conditions with working demand. Hydraulic hoses are routed along the left side of the tractor to power the shredder. Rotor speed is infinitely variable from 0 to 1800 rpm with the power pack operating at full speed. The hydraulic power pack is driven from an air cooled diesel engine and houses an 80 gallon hydraulic oil reservoir and 20 gallon fuel tank. It is capable of operating 6-8 hours depending upon conditions.

Figure 5 Rear Mounted Hydraulic Power Pack

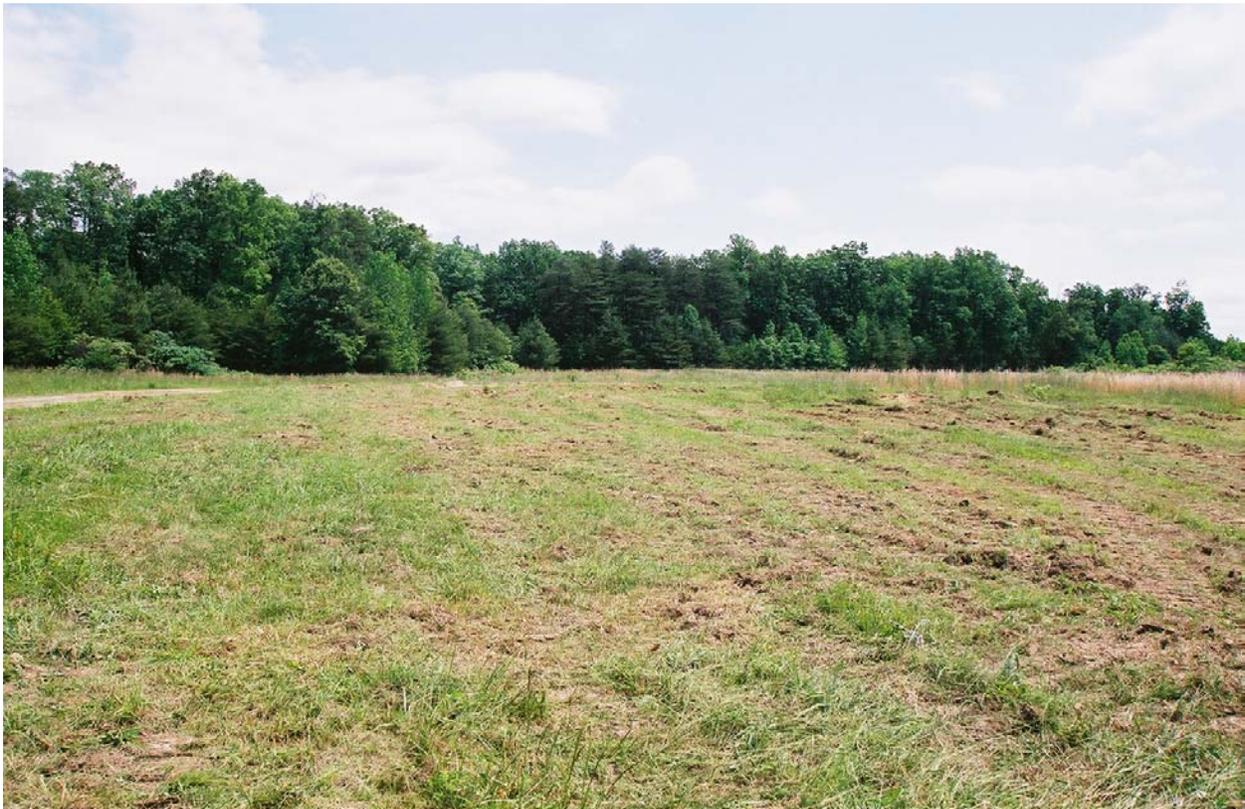
The performance of the SDVS was measured through a series of timed tests cutting increasingly difficult vegetation and terrain features. The first tests were performed in 1 meter high grass. The portion of the field shown in figure 6 was cleared in 1 hour with no difficulty. Operation in

this area did highlight the need for a minimum level of operator training. It is possible for the right lower corner of the mainframe to plow soil while the operator concentrates on the left side and the shredder. Once the test operator was familiar with this possibility, no further problems of this kind were encountered. The uniformity of cut while not as good as a grass mower, was adequate. In total 1404 sq meters were cut giving a rate for an inexperienced operator of .35 acres/hour. The area was sufficiently cleared to give access to all sites for hand held detector sweeping and mine excavation.

Figure 6 Category 1, Grassy Test Area (After Shredding)

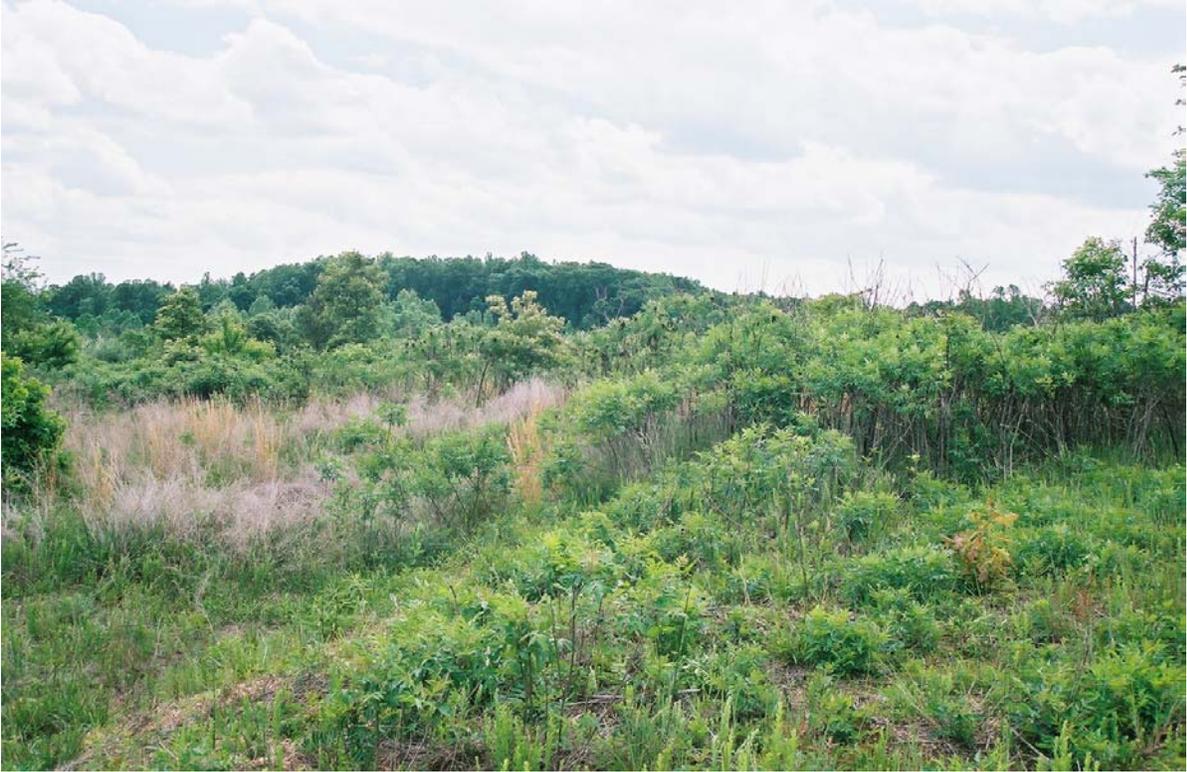
The second test area in which the Severe Duty Vegetation Shredder performed consisted mainly of 1 to 2 meter high, dense scrub brush with occasional large bushes and saplings in the range of 10-15 centimeter diameter stalks on a gently sloping hillside. The shredder operated in this area for 3.4 hours and cleared 2615 sq. meters of land giving a clearance rate of .18 acres/hr. Again, no problems were encountered in this field and the clearance was performed in a continuous operation. Some stubs in the 3-5 centimeter range were left, and in places the mulch was thick enough to require clearing by hand to expose the ground surface. Figure 7 and 8 show the area before and after the shredding operation from approximately the same vantage point. Some inadvertent plowing with the mainframe occurred but this tendency was significantly reduced by the end of the test.

Figure 7 Category 3 Vegetation Before Shredding

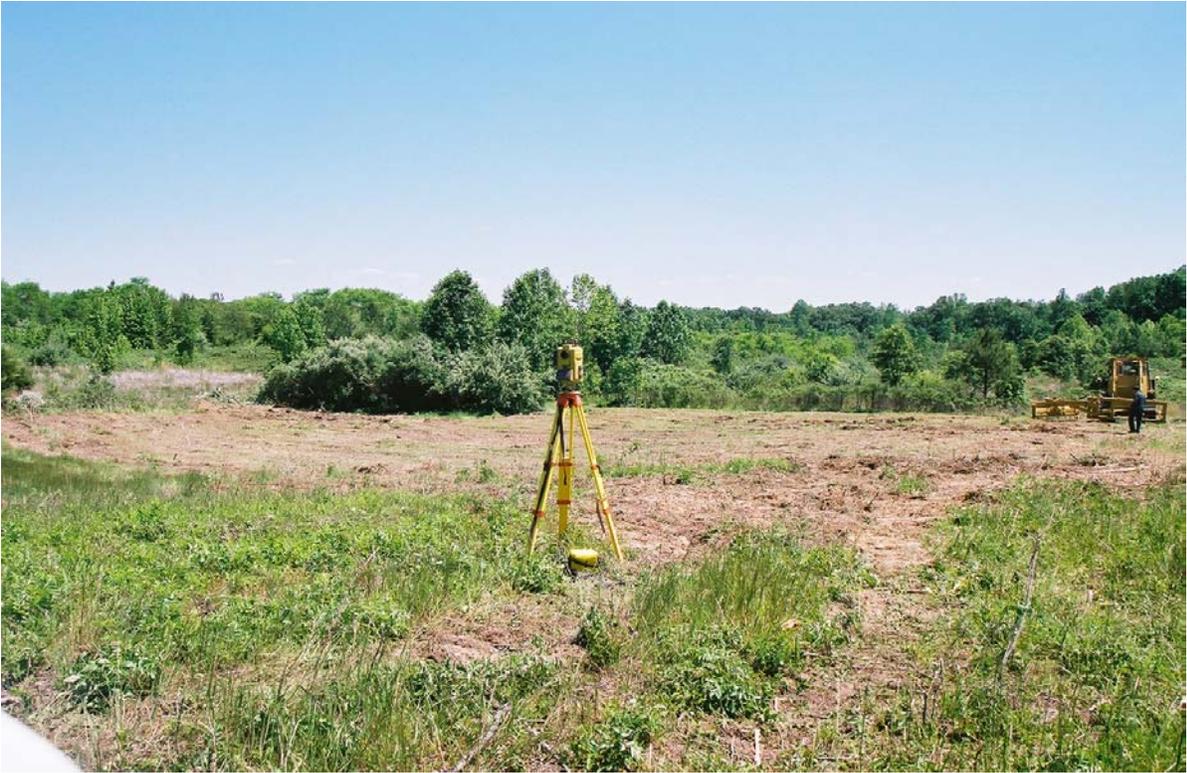
Figure 8 Category 3 Vegetation After Shredding

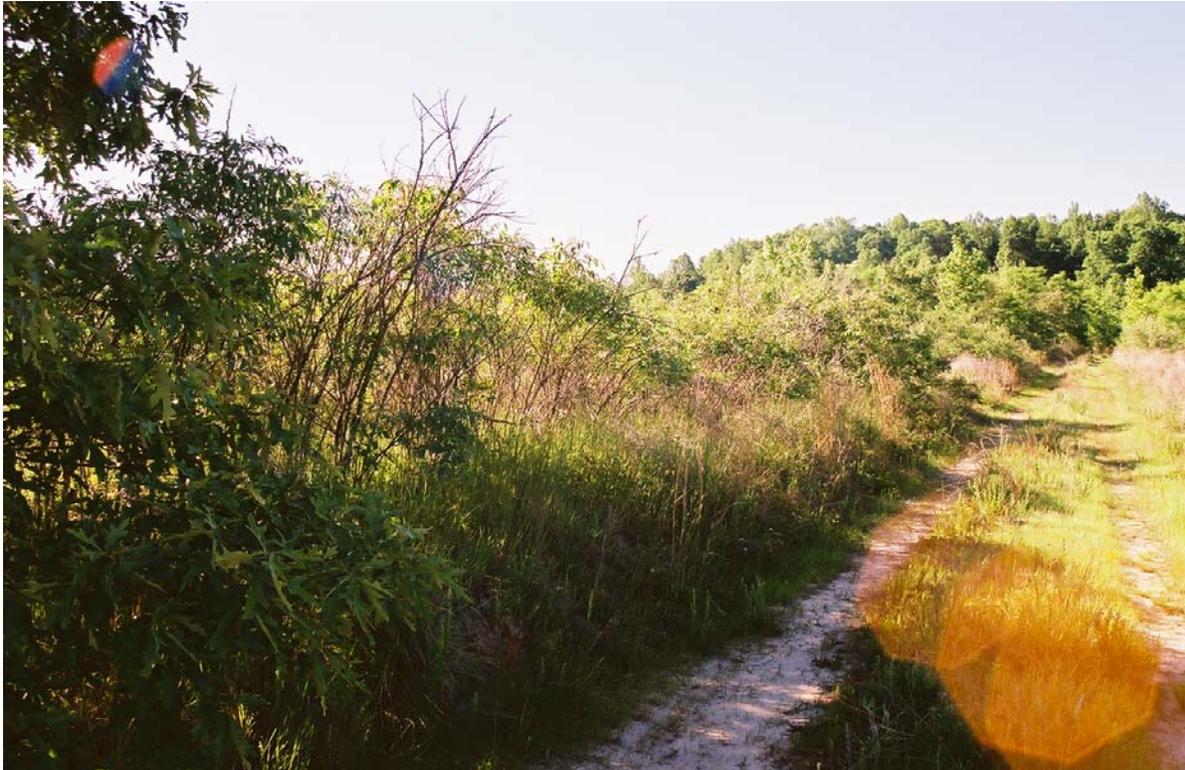
The final vegetation category in which the shredder was operated consisted of a mix of dense brush with trees ranging in diameter from 10 – 25 centimeters and up to 10 meters high. Figure 9 shows the test area before the shredding took place. Most of the dense tree growth in the figure is near the far end of the test area.

Figure 9 Category 4 Vegetation Before Shredding

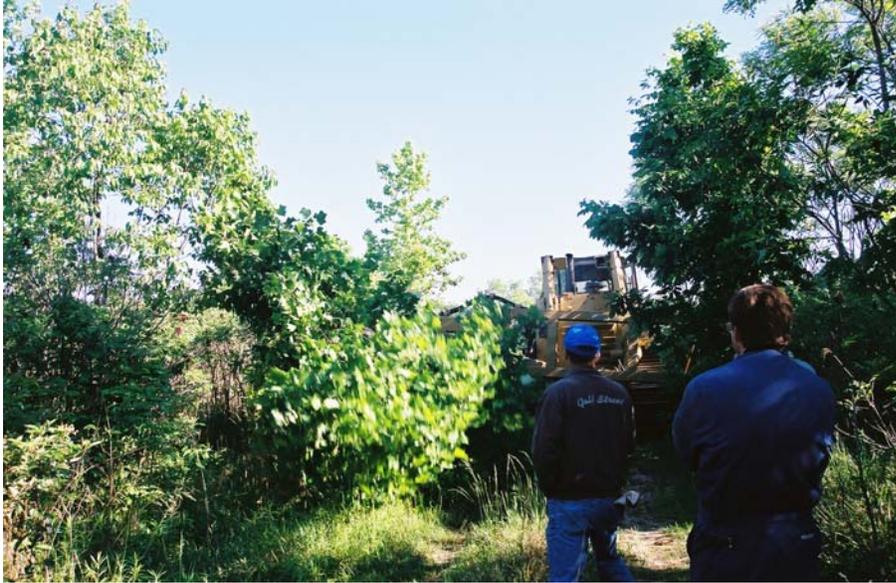
Trees up to 12 centimeters in diameter could be mowed down with the shredder in pretty much continuous fashion. Trees in range of 12-20 centimeters could be efficiently felled by raising the shredder high and pushing the tree over and then bringing the shredder down on top of the bent stalk (see figure 10).

Figure 10 Bringing Down 10 m Tree

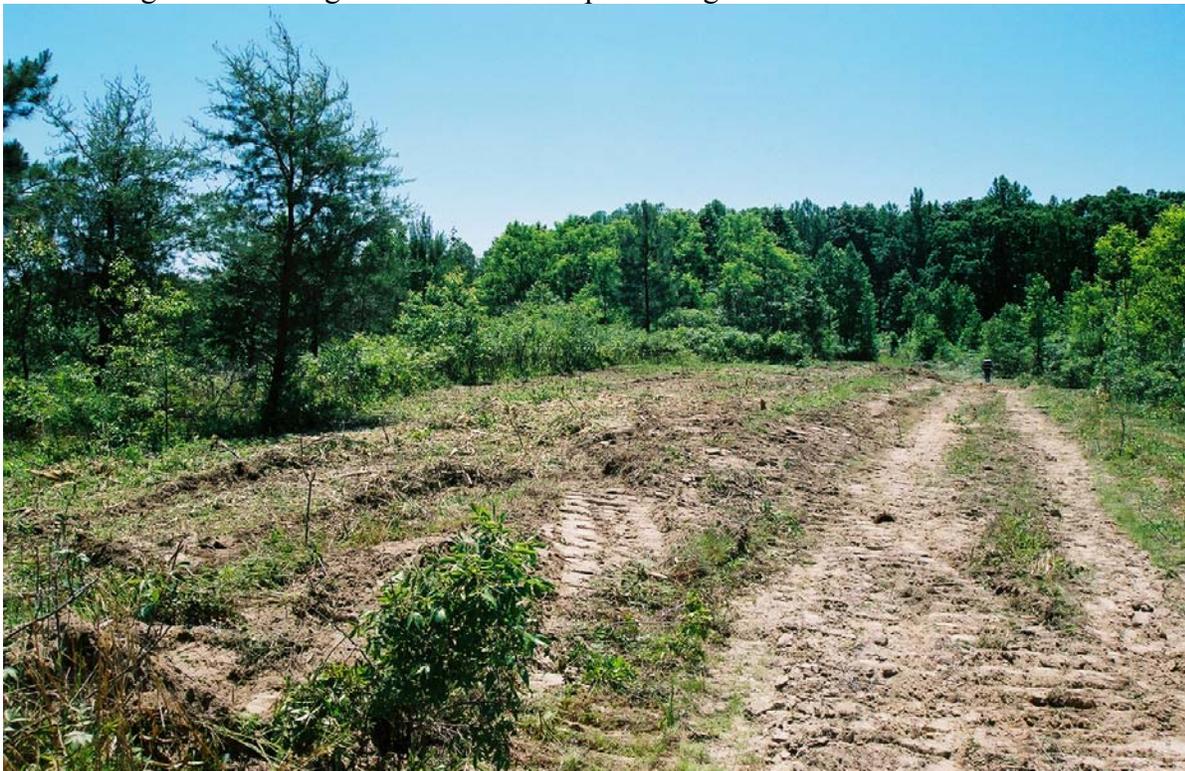
Trees in the range of 20-25 centimeters could also be brought down, but the strain on the system was heavy and large residue is likely. After two hours of operation in this category 3 and 4 vegetation, the shredder knives were examined. Two were heavily bent but still in place and contributing to the shredding action. All knives showed evidence of minimal wear. At one point in the testing a barbed wire coil became tangled in the shredder. The after action photo is shown in figure 11. Half way down the cleared land on the left is a protrusion of uncleared bush surrounding the remaining barbed wire fence protruding into the now cleared area.

Figure 11 Category 4 After Shredder

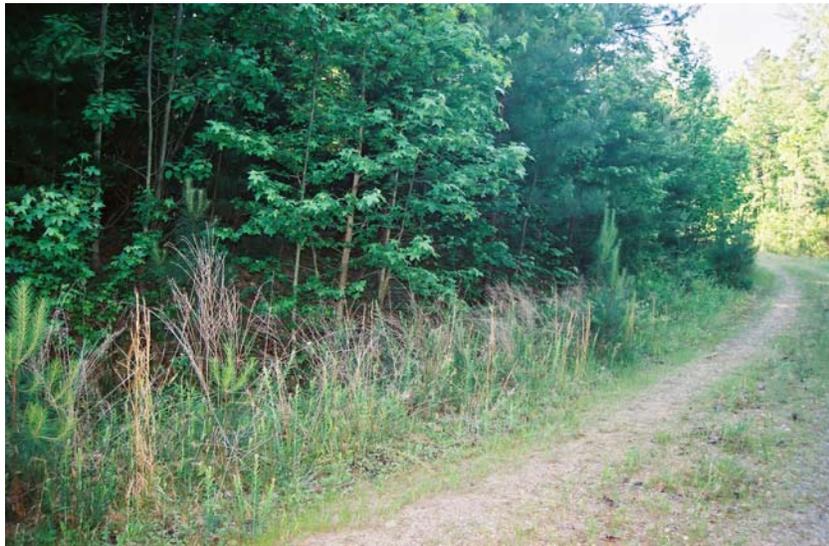
Two final areas were cut in which a significant discontinuity in the elevation and slope of the terrain was present between the path of travel of the tractor and the path of the cutter. The first area was an uphill embankment along a roadway approximately 70 meters in length. The strip contained mainly category 2 vegetation consisting of weeds and saplings up to 10 centimeters in diameter. The highest point reached on the embankment was 1.4 meters above the road surface on which the tractor traveled. The slope of the embankment relative to the road surface varied between 25 and 32 degrees. The before and after photographs of the area are shown in figures

12 and 13. In all 342 sq. meters were cleared along this embankment. The only problem encountered was a bottoming out of the cutter in the soil as the operator tried to reach the highest points from the roadway. This did stall the cutter drum, but resulted in no damage to the machine. The time spent clearing the strip was 40 minutes, giving a clearance rate on the uphill, category 2 vegetation of .13 acres/hour.

Figure 12 Uphill Embankment

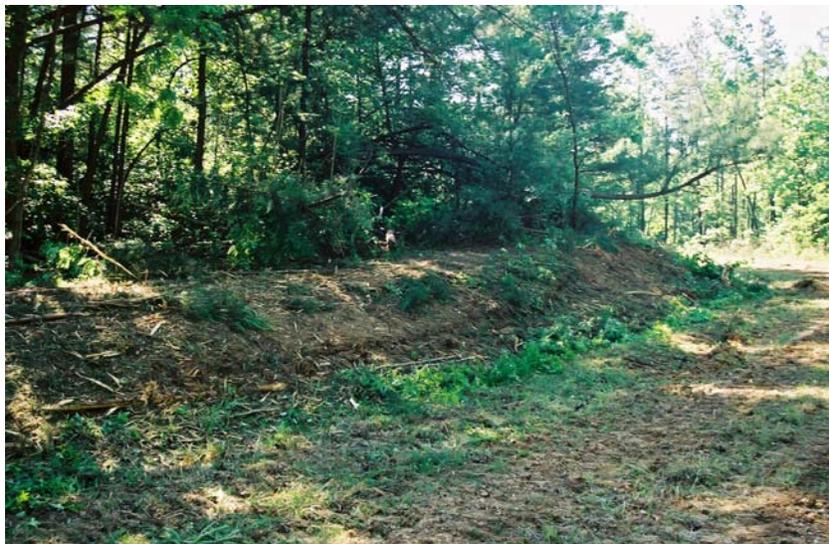
Figure 13 Uphill Embankment, After Shredding

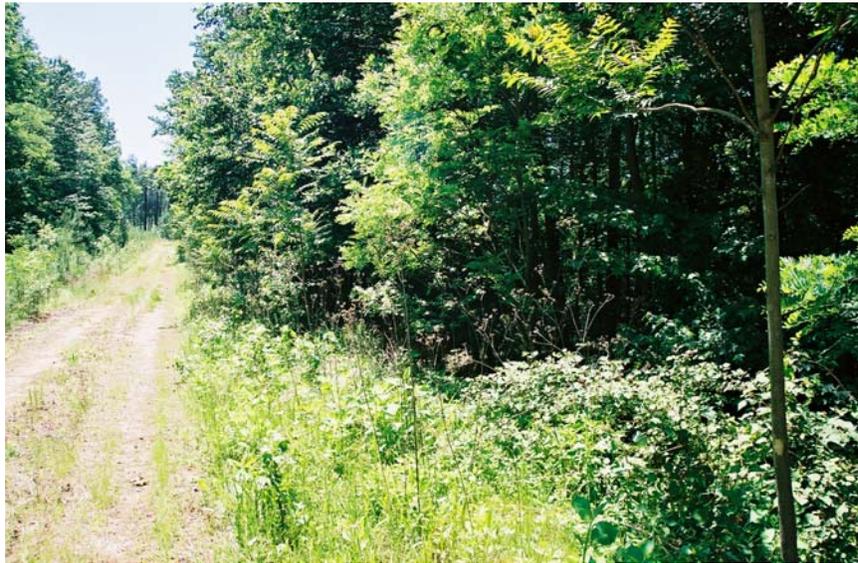
case. The cleared areas were along the sides of a stretch of roadway 230 meters in length. Clearing proved much easier in cutting banks sloping downhill from the side of the tractor than uphill from the side of the tractor. Both sides of the roadway were cleared in 65 minutes with no problems. See figures 14 and 15. The total area cleared was 1542 sq. meters for an effective clearance rate of .38 meters/hour.

Figure 14 Downhill Embankment, Before Shredding

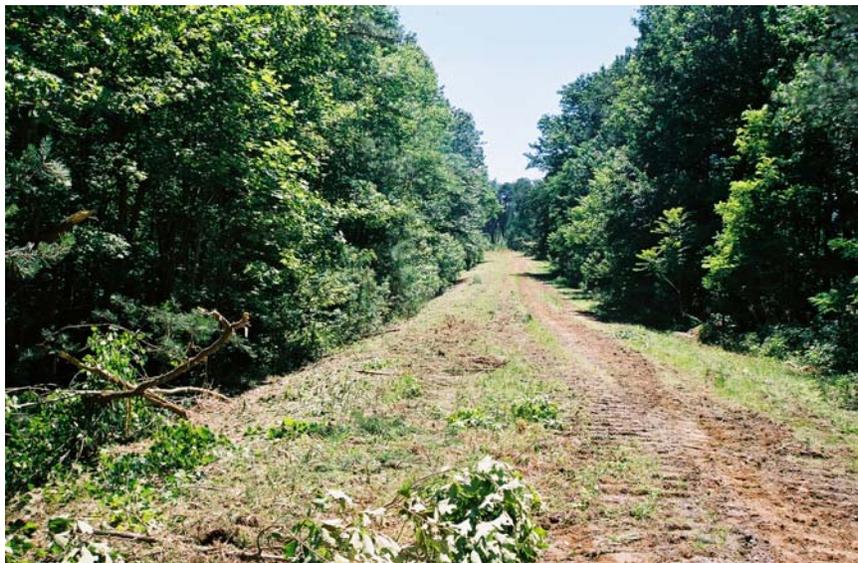
Figure 15 Downhill Embankment, After Shredding

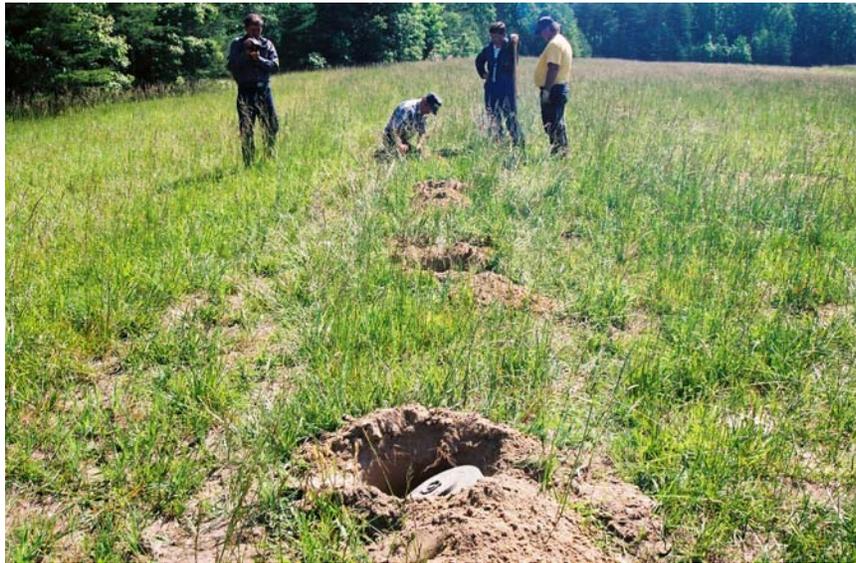
A simple and quick test of the tendency of the shredder to cause unwanted detonations of landmines during operations was performed. Four M15 landmines containing functional smoke generating fuzes were buried under 1 inch of soil cover. The shredder was maneuvered such that the weight bearing skids would pass over each of the mines. The first pass of the tractor was

made with the skids appearing to just make contact with the ground surface. The height of the upper pins on the three point hitch were measure at 68.5 centimeters above the ground, and each subsequent pass was made with the pins 2.5 centimeters lower in order to gradually increase the ground pressure applied to the mines. The first pass caused one of the mines to detonate, and each of the 3 successive passes caused one of the remaining mines to detonate. Clearly the risk to the shredder and vehicle is high if the operator allows the shredder to ride on the skids in areas

Figure 16 Mine Burial for Sensitivity Test

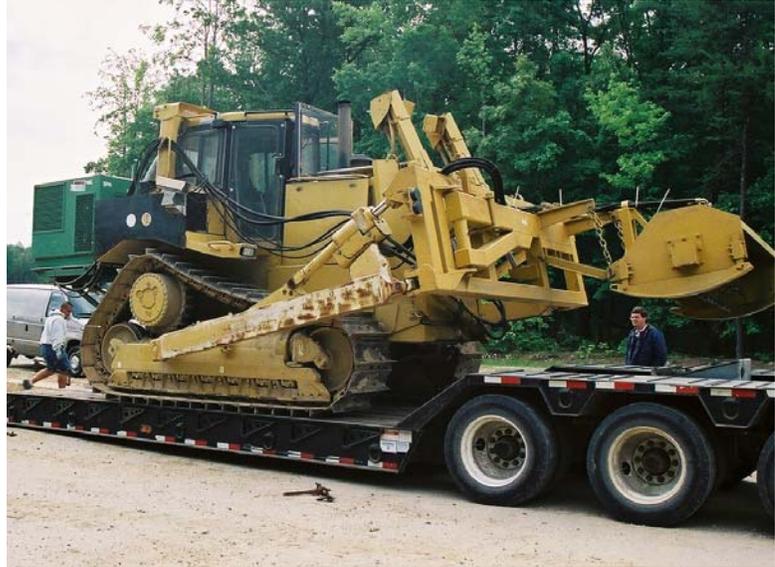
The system (less the tractor) was shipped from Israel to the US by sea vessel, then by commercial truck to the test site. The system and all components were placed on shipping pallets for transportation but could have fit within one 20' ISO Container. The system is transportable by truck, rail, vessel, and C-130 aircraft or other larger aircraft. In its unassembled state, the system and all components other than the tractor can be containerized for shipment. Once on site the system was assembled and installed on the D7R crawler tractor. The installed system was transported between sites at the test range on a flat bed trailer (see figure 17).

Figure 17 Shredder System and Tractor on Trailer

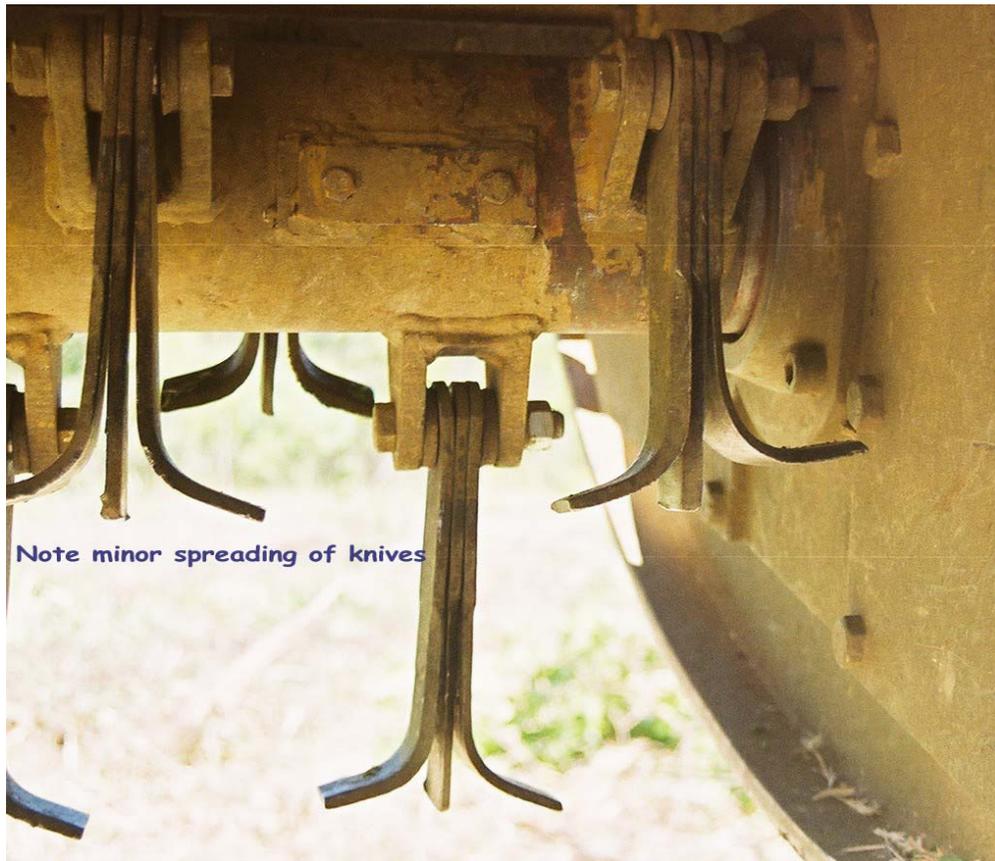
The D7 is supportable worldwide. The shredder and hydraulic portions of the system are constructed of standard components and are supportable. Most items unique to the shredder are field repairable. Daily maintenance on the SDVS required less than 30 minutes to accomplish. During the conduct of the test, two repairs were required on the D7 tractor, 1 repair on the hydraulic power supply, and none on the shredding implement and mainframe. The tractor repairs were unrelated to the SDVS system. The hydraulic power supply hydraulic thermostat did fail and was bypassed for the duration of the test. The only operational problem occurred when the shredding implement encountered and tangled a wire fence. Approximately 45 minutes and heavy wire cutters were required to unwrap the cutting drum. Wear from category 1, 2, and 3 vegetation is expected to be slow and knives may be expected to last hundreds of hours. Wear in the areas containing thick hard wooded trees was heavy and knives may need replacement every 1 or 2 days. Minor spreading and bending of some of the knives required them to be

replaced at the test conclusion, see figure 18. The manufacturer provided an Operation and Maintenance Manual which is comprehensive and well written.

Figure 18 Knives Wear at Test Conclusion
