Tractor Accessorized Zerriest Series II (TAZ II)

Capabilities Demonstration

September 10-11 and October 2-3, 2001

Night Vision & Electronic Sensors Directorate (NVESD)
DoD Humanitarian Demining Research & Development Program

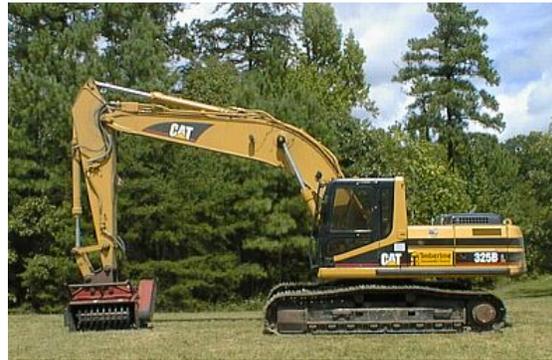
Graphic 1 – TAZ II

The TAZ II is a large tracked Caterpillar Corporation vehicle (325B L Excavator) with a specialized vegetation cutting attachment developed by Timberline Environmental Services. See graphic 1. Timberline Environmental Services has been involved in vegetation clearance for nearly 23 years, supporting both civilian and military organizations. Military support missions have dealt primarily with unexploded ordnance (UXO). By utilizing the Caterpillar base carrier, the TAZ II System has the worldwide product support of the Caterpillar Corporation. The system is capable of masticating all vegetation ranging from light grasses to large trees, as well as excavating the ground. For demining purposes, this tool could be used in conjunction with other tools (rakes, magnets, rollers, etc.) to clear large areas of vegetation, allowing deminers and dogs to completely clear the area and perform quality assurance. The TAZ II is not currently armored or remote controlled to provide safety to operators, but could conceivably be modified to have these capabilities.

The TAZ II system is a large Caterpillar track vehicle with a specialized mastication head designed by Timberline Environmental Services. This system is manually operated and capable of clearing all vegetation ranging from light grasses to large trees. Even though the system is capable of grass cutting, cutting grass is an inefficient way to use this system. The TAZ II is best suited for masticating small to medium size trees. It demonstrated a clearance rate of approximately 1600m²/hour of the category 3 vegetation.

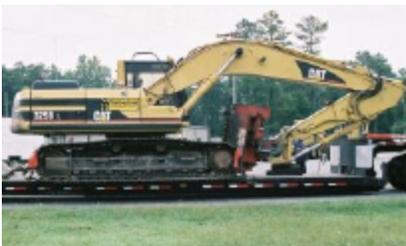
Graphic 6 – TAZII on trailer

The TAZ II was transported to the test site on a “low-boy” trailer in one piece as seen in graphic 6, below, therefore, assembly of the system prior to operations was not required. TAZ II was driven off of the trailer and with a quick pre-operations check the system was ready for operations. The TAZ II is transportable by truck, rail or vessel. However, due to its weight and width, many restrictions are imposed on its truck transport in the U.S. This is an issue that must be considered in relation to demining efforts in third world countries that have poor road and bridge infrastructure. A support package could easily be moved in a standard 20 or 40-foot ISO container, depending on the contents of the package. The system is a rugged tracked system and is mobile in most conditions, but very steep hills, slopes or rocky conditions would affect its maneuverability.

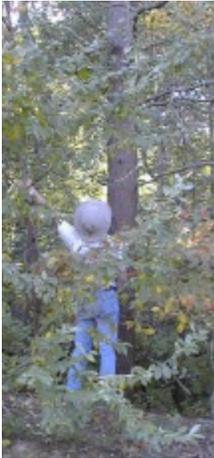
| Tree/hardness | Height (~) | Diameter | Time (min:sec) | Comments |
|---|---|---|---|---|
| Pine/soft wood | 18.5m | .31m | 4:50 | The wood was splintered into chards. |

Graphic 22 – Pine Tree
.31m in diameter

Tree Cutting: TAZ II masticated four trees of varying hardness and height. Graphics 21-28 on the next page are pictures of the trees before and after they were cut. All of the trees' tops were cut off as high up as possible and then the remaining trunks were mulched down to the ground. The treetops were not mulched up. The amount of time that TAZ II took to cut off the top and mulched up the trunk was recorded for each tree. Table 2, below, displayed the tree type and dimensions, and the time the TAZ II took to cut down the trees.

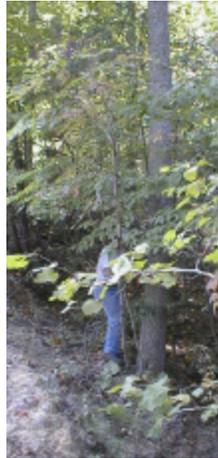
| Tree/hardness | Height (~) | Diameter | Time (min:sec) | Comments |
|---|---|---|---|---|
| Poplar/medium hard wood | 33.8m | .31m | 8:00 | TAZ II shredded the tree to chips/dust. TAZ II cut the tree with the cutting head perpendicular to the tree and had to stop cutting a dozen times to build up rpm's. |

Graphic 23 – Poplar Tree
.31m in diameter

While operating the cutter head perpendicular to the poplar tree, the operator had to stop operations several times allowing the cutter head to build up speed. This problem appeared to be solved later by holding the head at a 45° angle while cutting the oak tree. Timberline said that faster times could be achieved if sharper blades were used. The current blades were old and dull in anticipation of ground excavation. Dramatic differences were seen in the TAZ II's ability to handle .21m verses .31m diameter trees. Although the TAZ II system may not be as fast as other systems when working with extremely large trees, it does handle all tree sizes and can also excavate the ground to minimize the remaining stumps.

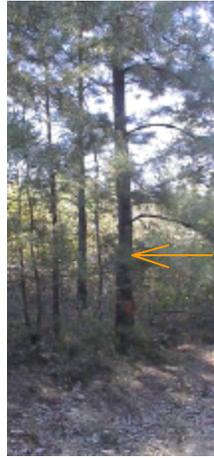
| Tree/hardness | Height (~) | Diameter | Time (min:sec) | Comments |
|---|---|---|---|---|
| Pine/ soft wood | 7.7m | .21m | 0:59 | TAZ II quickly reduced the tree to splintered mulch almost in one motion. |

Graphic 24 – Pine Tree
.21m in diameter

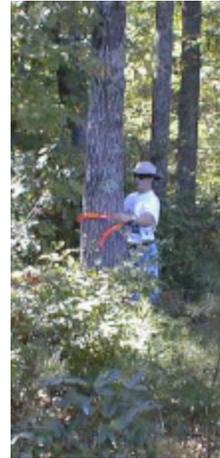
| Tree/hardness | Height (~) | Diameter | Time (min:sec) | Comments |
|---|---|---|---|---|
| Oak/ hard wood | 30.8m | .38m | 6:00 | The cutter head was at a 45° angle and did not require stopping to build up the rpm. The tree was shredded to chips/dust. |

Graphic 25 – Oak Tree
.38m in diameter

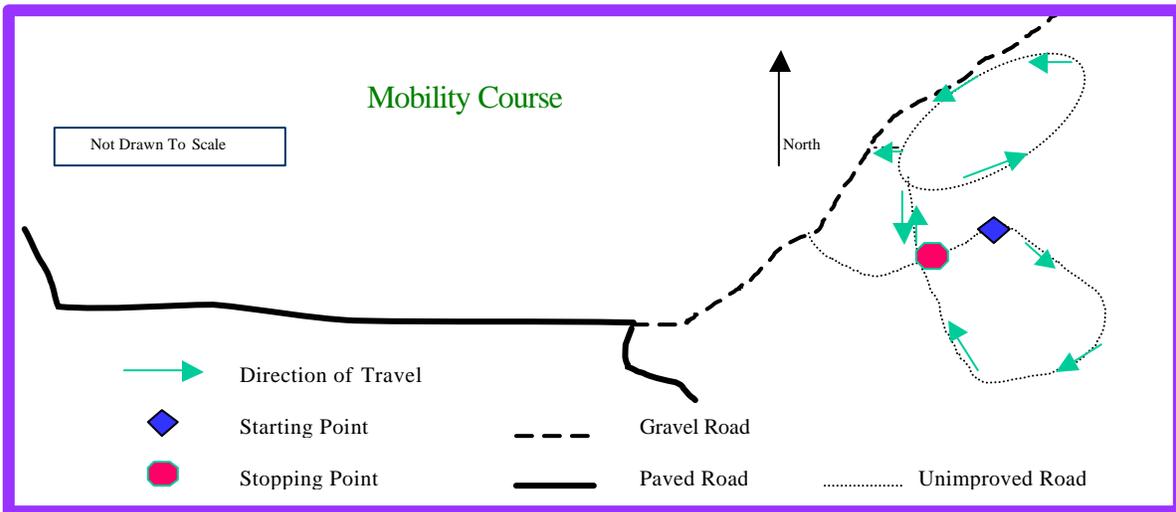
Graphic 30 – Mobility Course

Operational Mobility: A designated mobility course was laid out for this portion of the demonstration. This course consisted of rugged dirt trail and improved secondary road with a few dips and hills. The route was approximately 3.0km long (see graphic 30 below.) TAZ II completed the route in 42 minutes at a pace of ~0.07 km/minute and scored a 3 for this task. TAZ II can transverse any terrain with slopes less than 40°. Obstacles and vegetated/wooded areas are not a problem for this machine, and it can create most paths needed for self-propelled transportation. The major concerns about this system towards mobility are its extremely slow speed, the destructive nature of its steel treads, and its weight in extremely muddy or soft ground. Speed is not so much of an issue in demining operations, however for long distances, the TAZ II should be transported by other means of transportation. Theoretically it can run on paved road surface without significant damage. However, with repetitive travel over the same stretch of road, the road will eventually break down due to the cleats in the tracks and the weight of the vehicle. The system can travel on solid dry, slightly damp and extremely muddy ground. However if the mud is 1 meter or more deep, there is a good possibility that the TAZ II could get stuck due to its weight.

TAZ II can traverse most terrain with less than 40-degree slopes. Obstacles and wooded/vegetated areas posed no problems for the TAZ II.

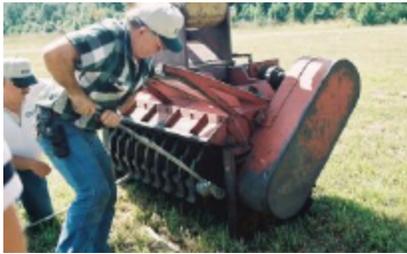
Graphic 31 – Knife changing demonstration

The special cutting head does not have a technical manual or parts manual to determine level of effort to support it, however, most of the parts for the cutting head are repairable or are considered consumable. It is assumed that simple servicing of cutting knife (blade), cutting disc and bearing repair/replacement would be required, as a minimum. Because of the proprietary hydraulic and electrical configuration used to run the cutter head, Timberline would require one of their mechanics to install the cutter head system onto the Caterpillar vehicle. Most general maintenance can be done on the cutter head with one or two people. Timberline demonstrated that two people could change a cutting knife in 6 minutes as shown below in graphic 31. The following tools were used during the knife changing demonstration: a sledge hammer, a large socket wrench, a pry bar, a solid round stock, and a small mallet. The tools are shown in graphic 32 below.
