# Tractor Accessorized Zerriest Series II (TAZ II)

## Capabilities Demonstration

September 10-11 and October 2-3, 2001

United States Army  
Communications-Electronic Command  
Research, Development & Engineering Center  
Fort Belvoir, Virginia 22060-5806

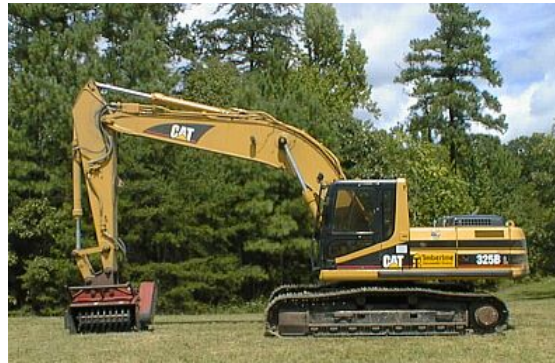
Graphic 1 – TAZ II

The TAZ II is a large tracked Caterpillar Corporation vehicle (325B L Excavator) with a specialized vegetation cutting attachment developed by Timberline Environmental Services. See graphic 1. Timberline Environmental Services has been involved in vegetation clearance for nearly 23 years, supporting both civilian and military organizations. Military support missions have dealt primarily with unexploded ordnance (UXO). By utilizing the Caterpillar base carrier, the TAZ II System has the worldwide product support of the Caterpillar Corporation. The system is capable of masticating all vegetation ranging from light grasses to large trees, as well as excavating the ground. For demining purposes, this tool could be used in conjunction with other tools (rakes, magnets, rollers, etc.) to clear large areas of vegetation, allowing deminers and dogs to completely clear the area and perform quality assurance. The TAZ II is not currently armored or remote controlled to provide safety to operators, but could conceivably be modified to have these capabilities.

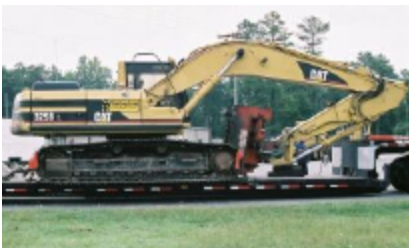
Graphic 6 – TAZII on trailer

The TAZ II was transported to the test site on a “low-boy” trailer in one piece as seen in graphic 6, below, therefore, assembly of the system prior to operations was not required. TAZ II was driven off of the trailer and with a quick pre-operations check the system was ready for operations. The TAZ II is transportable by truck, rail or vessel. However, due to its weight and width, many restrictions are imposed on its truck transport in the U.S. This is an issue that must be considered in relation to demining efforts in third world countries that have poor road and bridge infrastructure. A support package could easily be moved in a standard 20 or 40-foot ISO container, depending on the contents of the package. The system is a rugged tracked system and is mobile in most conditions, but very steep hills, slopes or rocky conditions would affect its maneuverability.

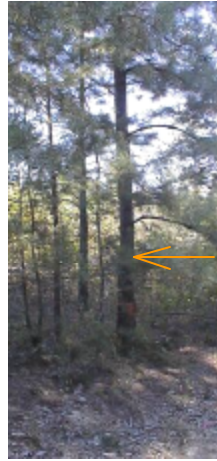
**Tree Cutting:** TAZ II masticated four trees of varying hardness and height. Graphics 21-28 on the next page are pictures of the trees before and after they were cut. All of the trees' tops were cut off as high up as possible and then the remaining trunks were mulched down to the ground. The treetops were not mulched up. The amount of time that TAZ II took to cut off the top and mulched up the trunk was recorded for each tree. Table 2, below, displayed the tree type and dimensions, and the time the TAZ II took to cut down the trees.

Graphic 24 – Pine Tree  
.21m in diameter

Tree/hardness	Height (~)	Diameter	Time (min:sec)	Comments
Pine/soft wood	18.5m	.31m	4:50	The wood was splintered into chards.
Poplar/medium hard wood	33.8m	.31m	8:00	TAZ II shredded the tree to chips/dust. TAZ II cut the tree with the cutting head perpendicular to the tree and had to stop cutting a dozen times to build up rpm's.
Oak/ hard wood	30.8m	.38m	6:00	The cutter head was at a 45° angle and did not require stopping to build up the rpm. The tree was shredded to chips/dust.
Pine/ soft wood	7.7m	.21m	0:59	TAZ II quickly reduced the tree to splintered mulch almost in one motion.

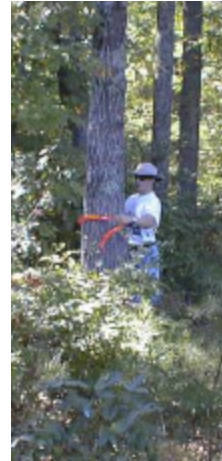
Graphic 25 – Oak Tree  
.38m in diameter

While operating the cutter head perpendicular to the poplar tree, the operator had to stop operations several times allowing the cutter head to build up speed. This problem appeared to be solved later by holding the head at a 45° angle while cutting the oak tree. Timberline said that faster times could be achieved if sharper blades were used. The current blades were old and dull in anticipation of ground excavation. Dramatic differences were seen in the TAZ II's ability to handle .21m verses .31m diameter trees. Although the TAZ II system may not be as fast as other systems when working with extremely large trees, it does handle all tree sizes and can also excavate the ground to minimize the remaining stumps.

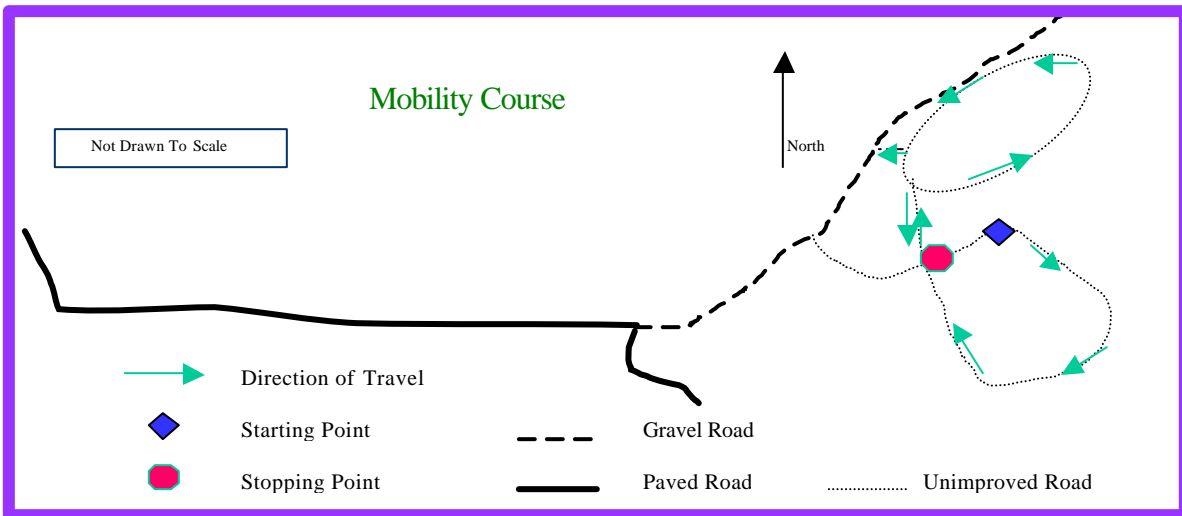
Graphic 30 – Mobility Course

**Operational Mobility:** A designated mobility course was laid out for this portion of the demonstration. This course consisted of rugged dirt trail and improved secondary road with a few dips and hills. The route was approximately 3.0km long (see graphic 30 below.) TAZ II completed the route in 42 minutes at a pace of ~0.07 km/minute and scored a 3 for this task. TAZ II can transverse any terrain with slopes less than 40°. Obstacles and vegetated/wooded areas are not a problem for this machine, and it can create most paths needed for self-propelled transportation. The major concerns about this system towards mobility are its extremely slow speed, the destructive nature of its steel treads, and its weight in extremely muddy or soft ground. Speed is not so much of an issue in demining operations, however for long distances, the TAZ II should be transported by other means of transportation. Theoretically it can run on paved road surface without significant damage. However, with repetitive travel over the same stretch of road, the road will eventually break down due to the cleats in the tracks and the weight of the vehicle. The system can travel on solid dry, slightly damp and extremely muddy ground. However if the mud is 1 meter or more deep, there is a good possibility that the TAZ II could get stuck due to its weight.
